ASBESTOS ENVIRONMENTAL INSPECTION ACTIVITIES

HIGHTSTOWN YMCA AND MUNICIPAL COMPLEX
230 MERCER STREET
HIGHTSTOWN, NEW JERSEY 08520

May 27, 2020

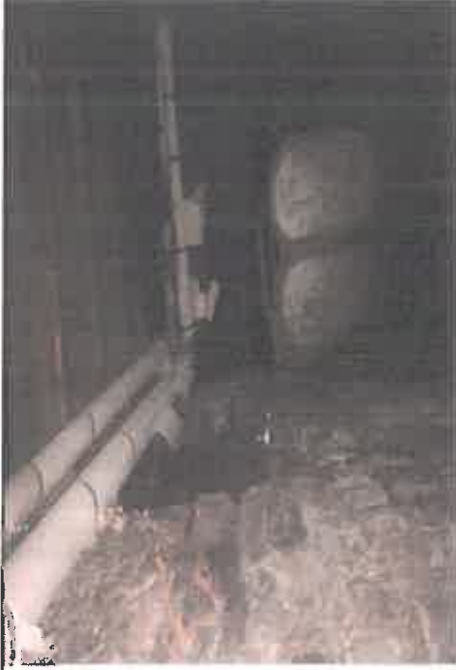
Photo 2: Basement, Old Boiler Room

Material Description	Location	Approx. Quantity	Condition
Pipe Insulation	Old Boiler Room, Basement	100 LF	Fair
Pipe Insulation	Corridor Near Old Boiler Room, Basement	100 LF	Fair

The facility will be undergoing renovations in the future. Whitman’s inspection team identified various sizes of pipe insulation and associated elbow joints that contain asbestos located within the old boiler room and room bordering the old boiler room.

Whitman recommends that the asbestos-containing pipe insulation be removed utilizing intact wrap and cut procedures if the piping associated with the asbestos insulation is being upgraded by a New Jersey Department of Labor (NJDOLE) certified Asbestos Abatement Contractor who employs NJDOLE-certified asbestos workers in either phase during times when the library is closed. The design of the asbestos abatement of the pipe insulation depends on the renovation scope of work. There are two options:

Option 1: Remove the asbestos-containing pipe insulation with elbow and joint insulation utilizing tent and glove bag procedures with negative air in an unoccupied facility in accordance with the requirements of N.J.A.C. 5:23-8.

Option 2: Remove the asbestos containing pipe insulation with elbows and joints utilizing Intact wrap and cut procedures with critical barriers and negative air.

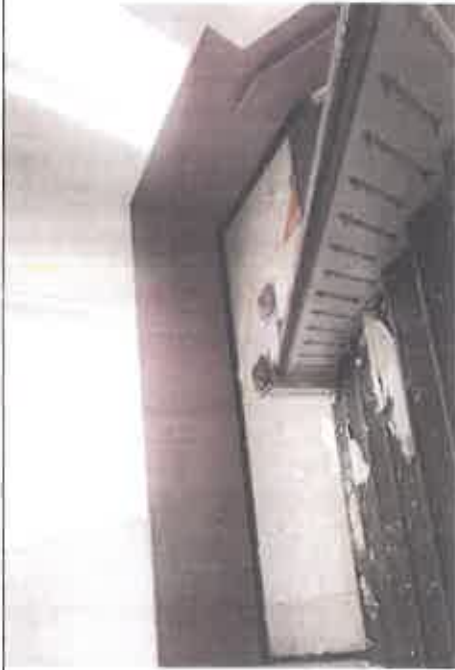
Photo 15: Stairwell

Lead based paint was detected in two (2) paint chip samples collected during the investigation. Two (2) of the samples that tested positive for lead based paint (above .5% by weight) was located on a wall and ceiling stairwell.

Whitman recommends that lead-safe procedures, be developed for the handling of materials that have tested positive for the presence of lead be developed and added to the general contractors bid documents.
