October 3, 2025

RE: Structural Inspection
YMCA 230 Mercer St, Hightstown, NJ
MPP Project No: 25-1625

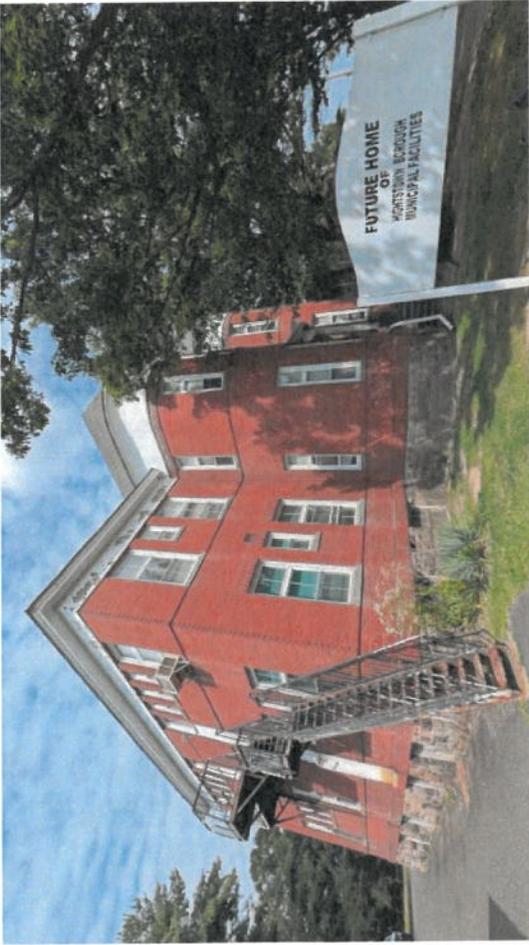
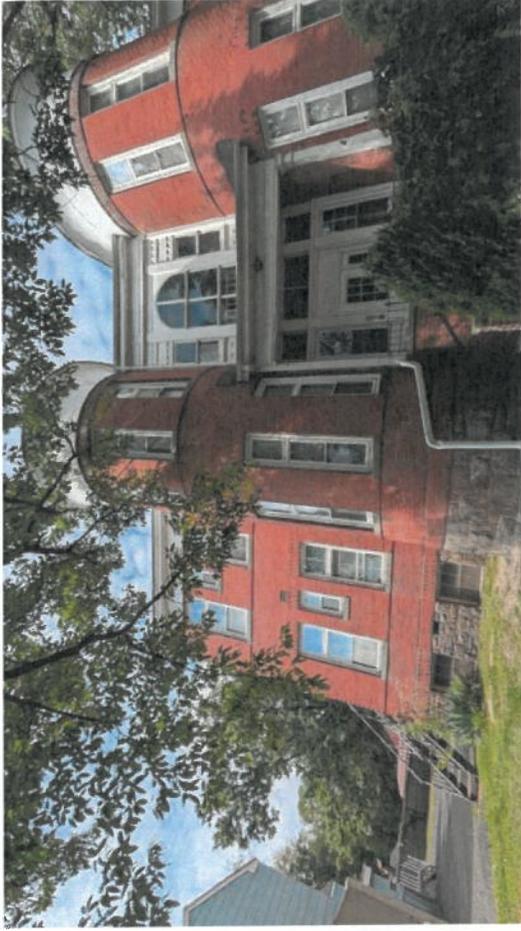
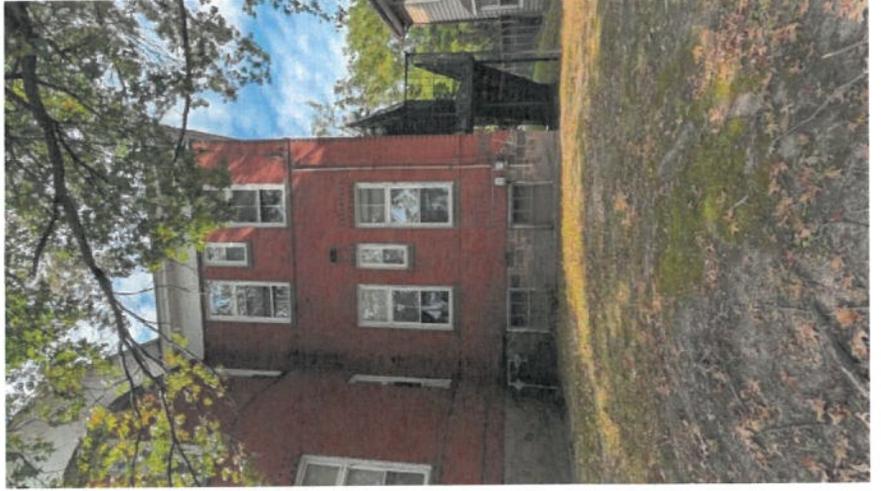
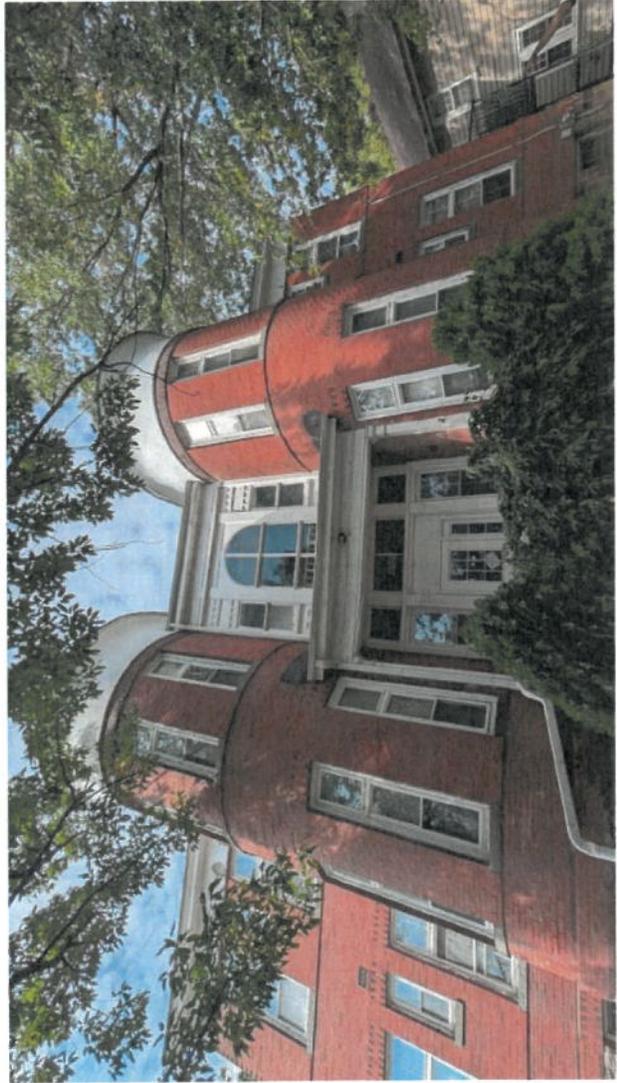
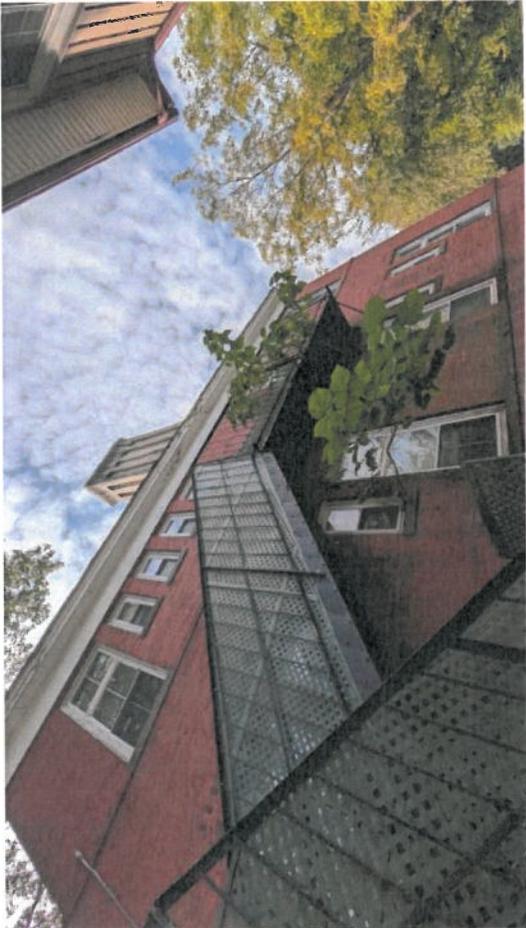
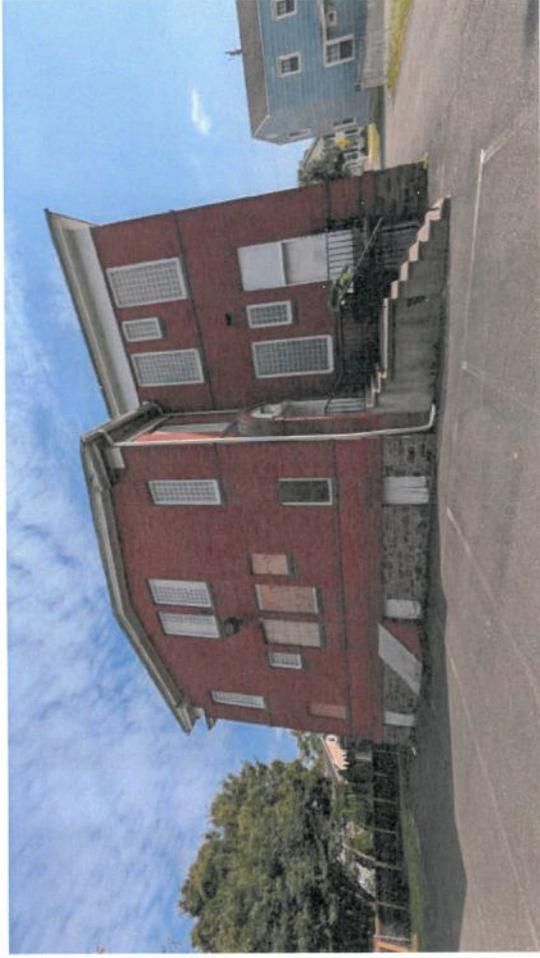
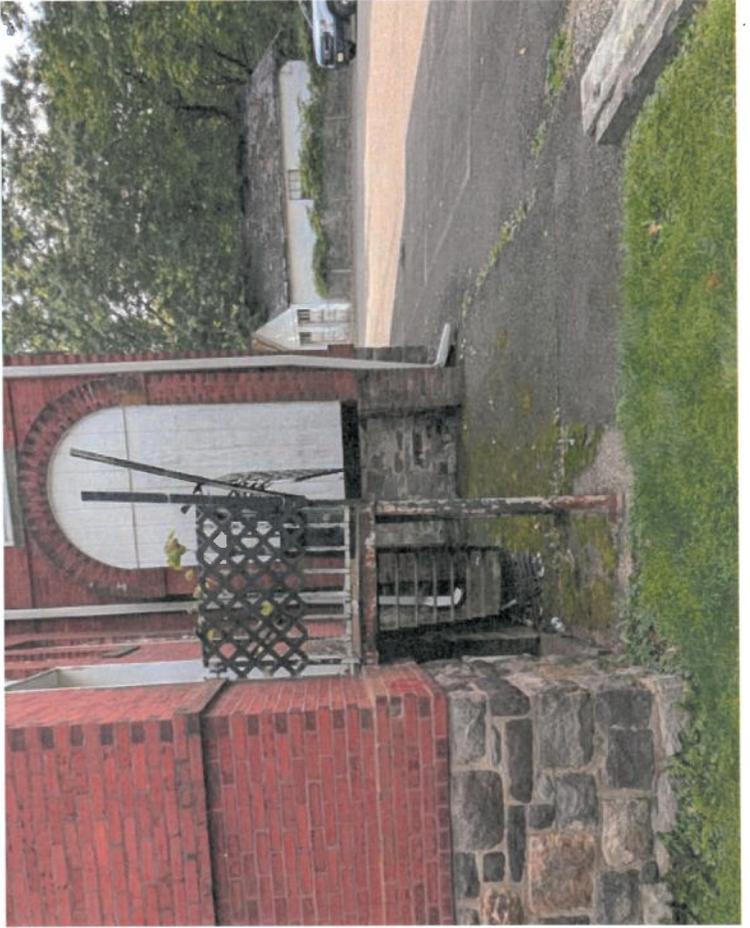
Photo set #1 & #2 – General exterior photos of the front, side and back of the existing building when viewed from the exterior. The building is clad with brick.

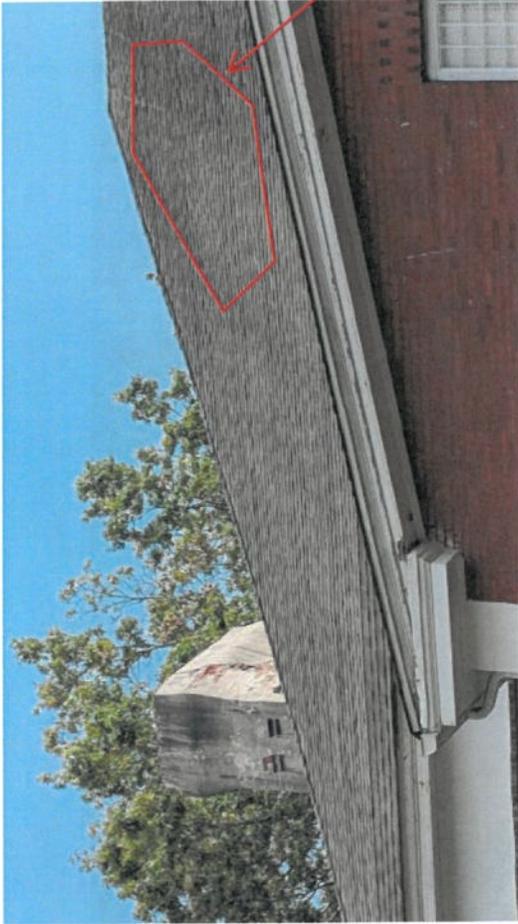
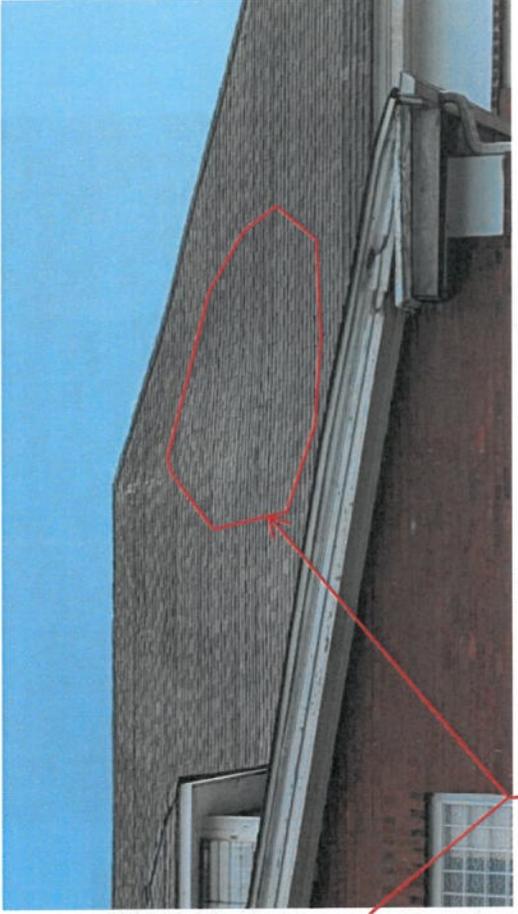
PHOTOS SET #3

Photo set #3 – There are many signs of the roof being either shifted and/or settled when viewed from the front and side of the property. There are many signs indicating the roof is not levelled and has racked causing various elements to shift out of alignment.

The roof structure has several undulations (hip and hip line bending) and with the evidence of mold from the inside (the attic), it indicates that the roof structure is severally damaged and hence needs to be demolished and replaced. The chimney on the roof is also severally damaged. It may collapse during heavy wind conditions and hence, needs to be demolished and replaced in kind.

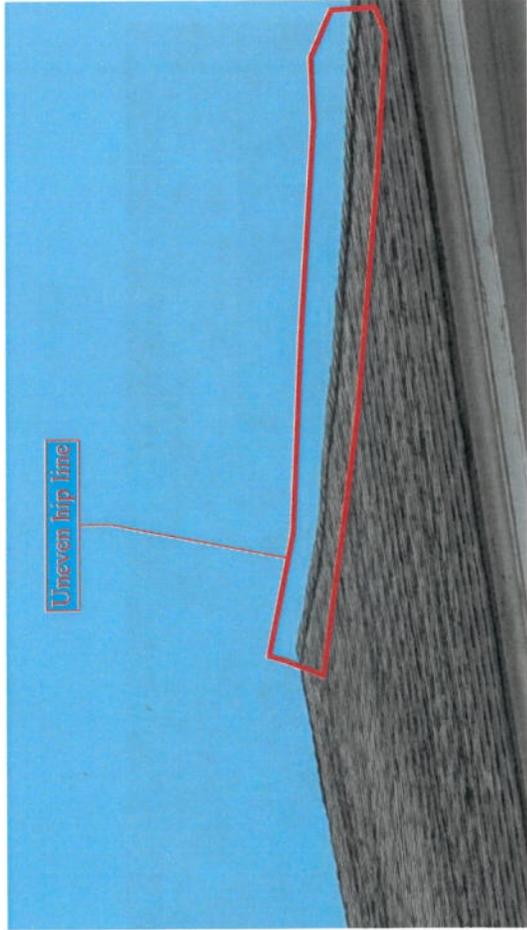
Undulation in roof

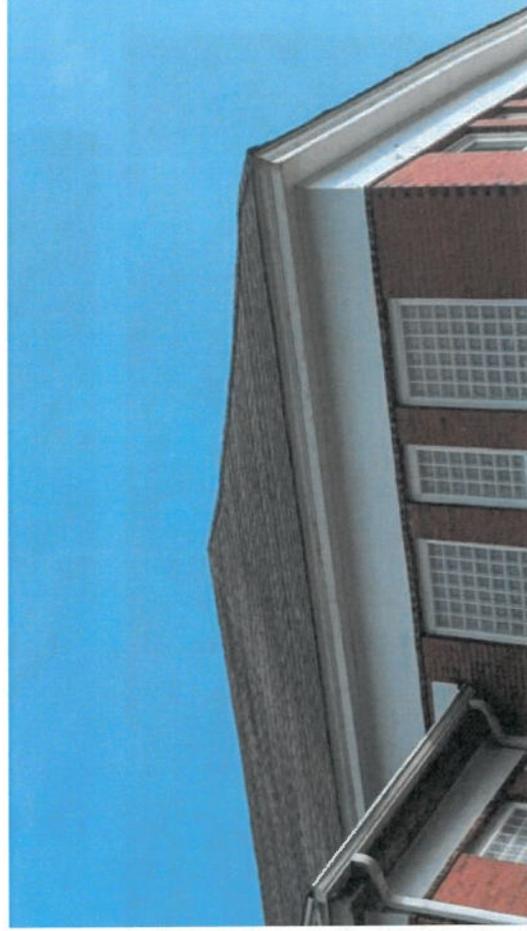
Uneven hip line

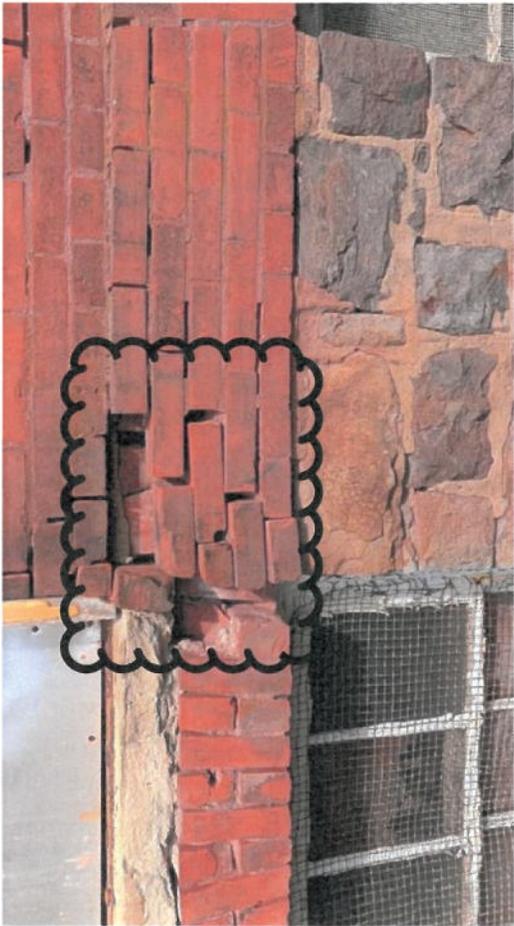
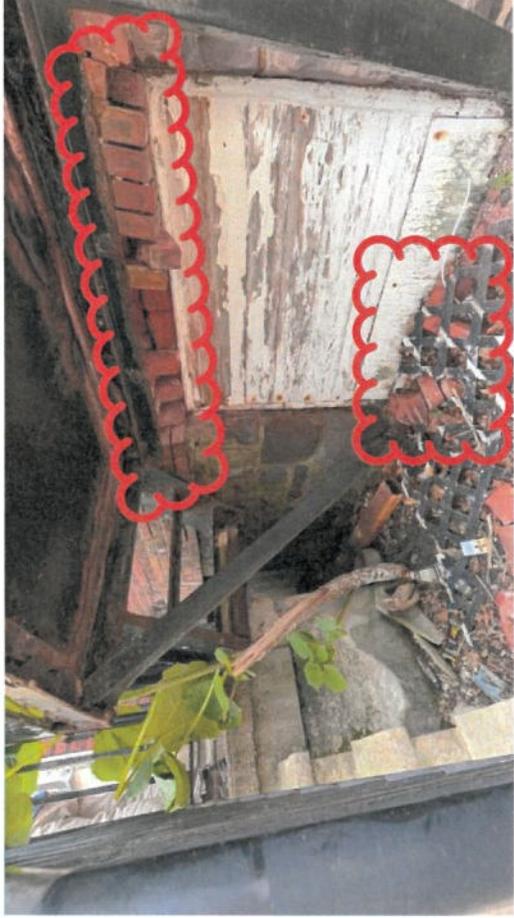
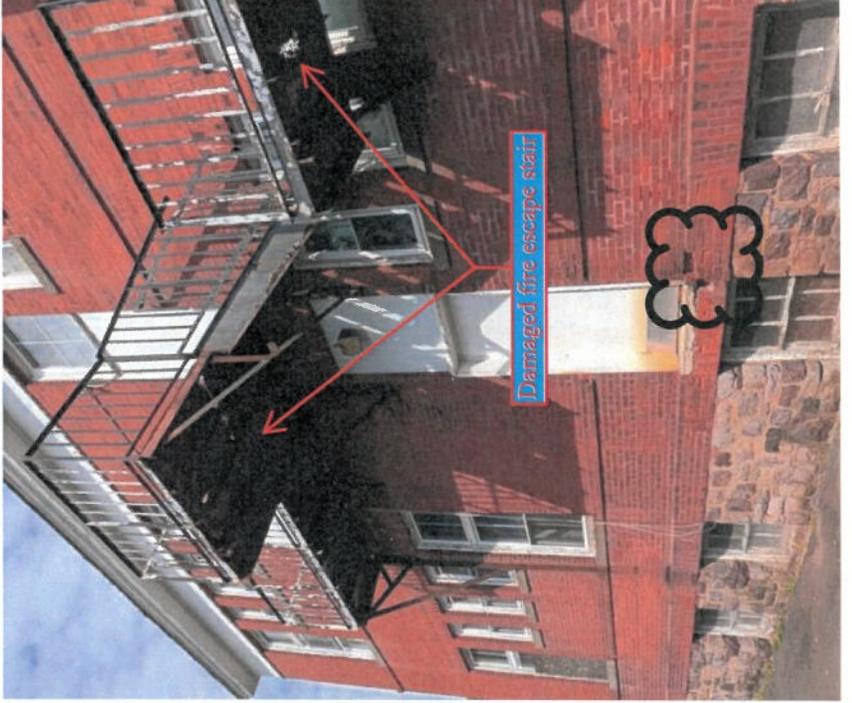
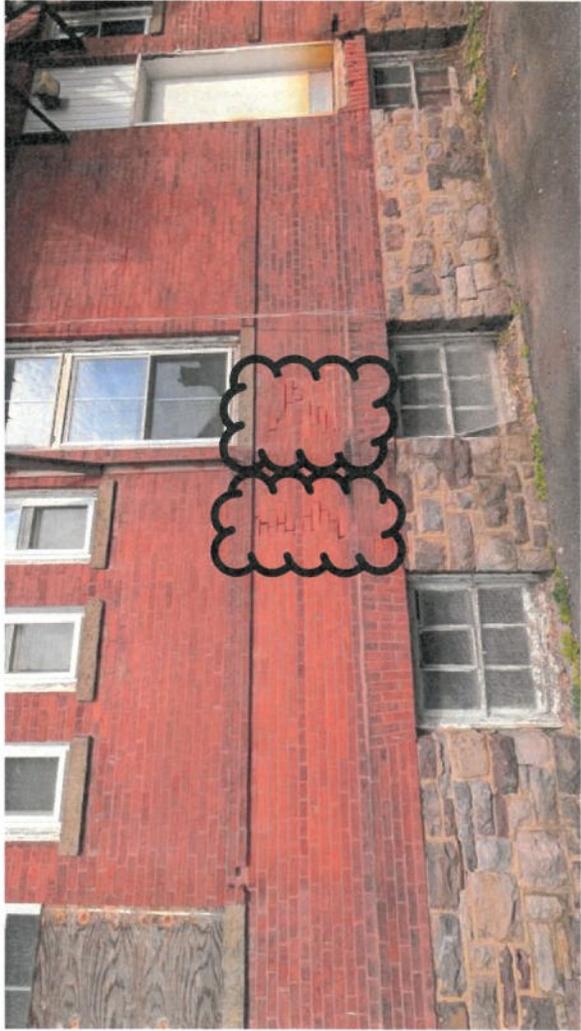
PHOTOS SET #4

Photo set #4 – There are several cracks in the exterior façade and some of the bricks in the façade are either loose or missing (repointing).

There is vegetation growth in many areas of the building which indicates that there are internal cracks in the building. This indicates severe structural damage of the exterior wall system due to water seepage which would explain the mold and water stains in the walls, ceiling and floors of the building. These cracks will weaken the wall system and with the evidence of cracks from the inside of the building, this indicates potential failure of the wall system and therefore, the wall system would require extensive repair. Loosened or missing bricks in the exterior façade indicate brick repointing which also need to be repaired and replaced.

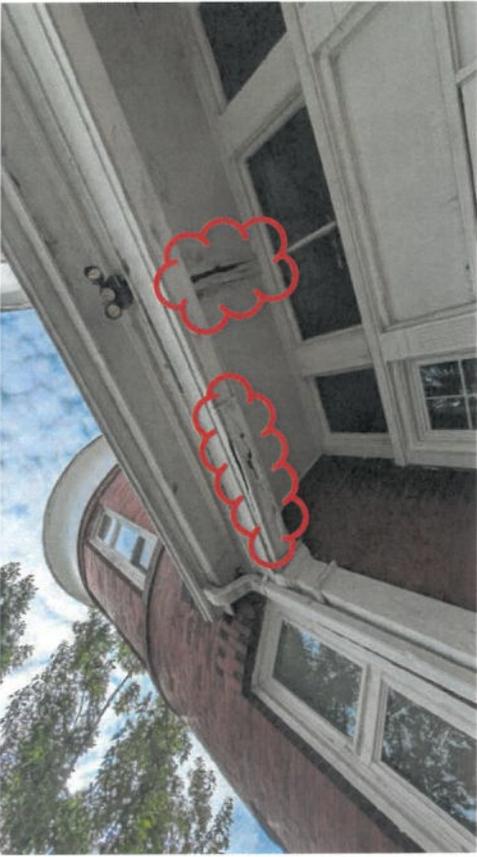
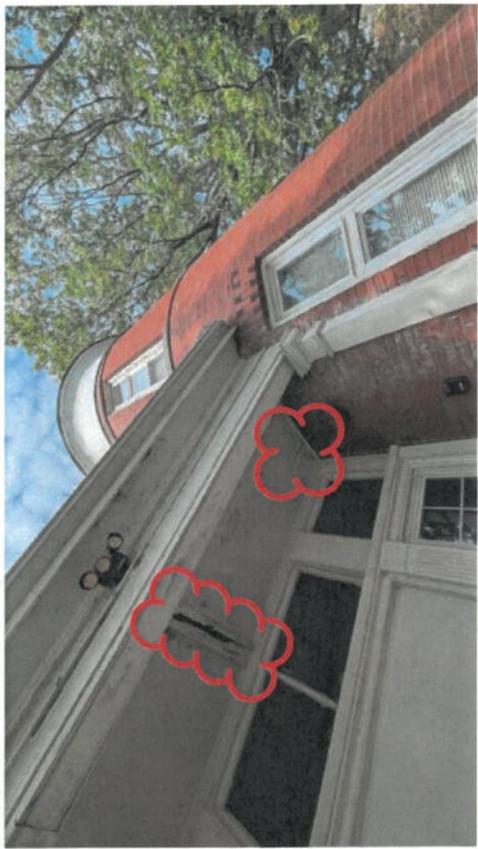
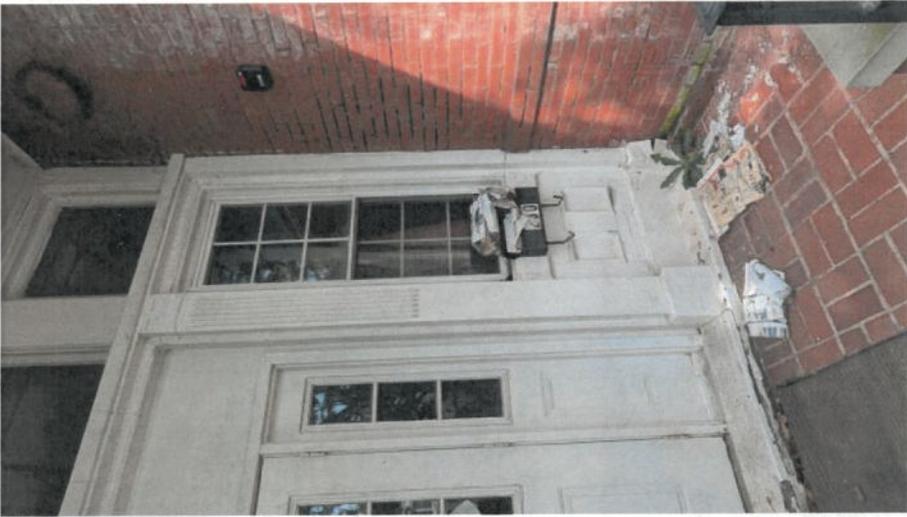
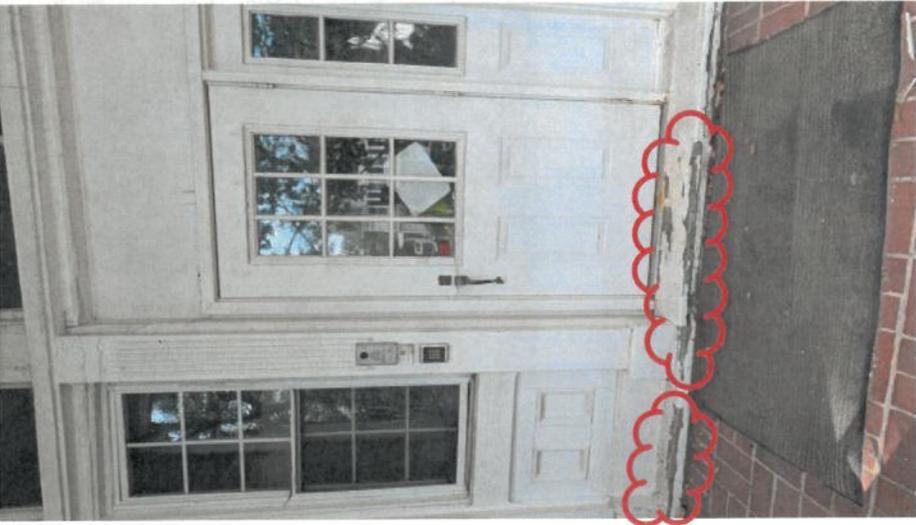
PHOTOS SET #5

Photo set #5 – The front porch is severally damaged and exhibits cracks.

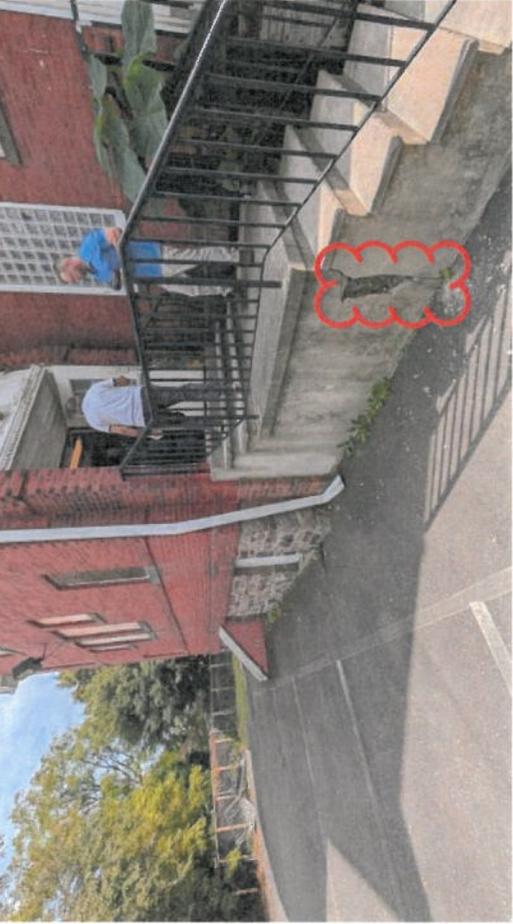
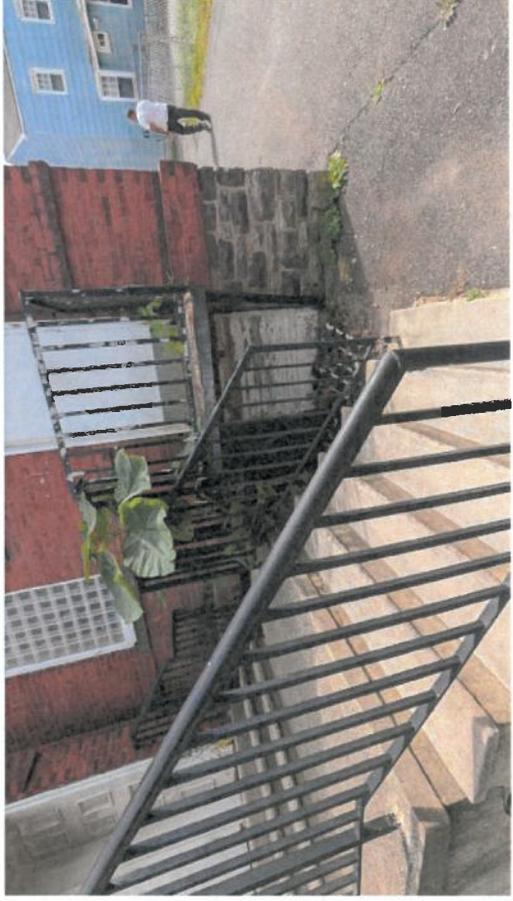
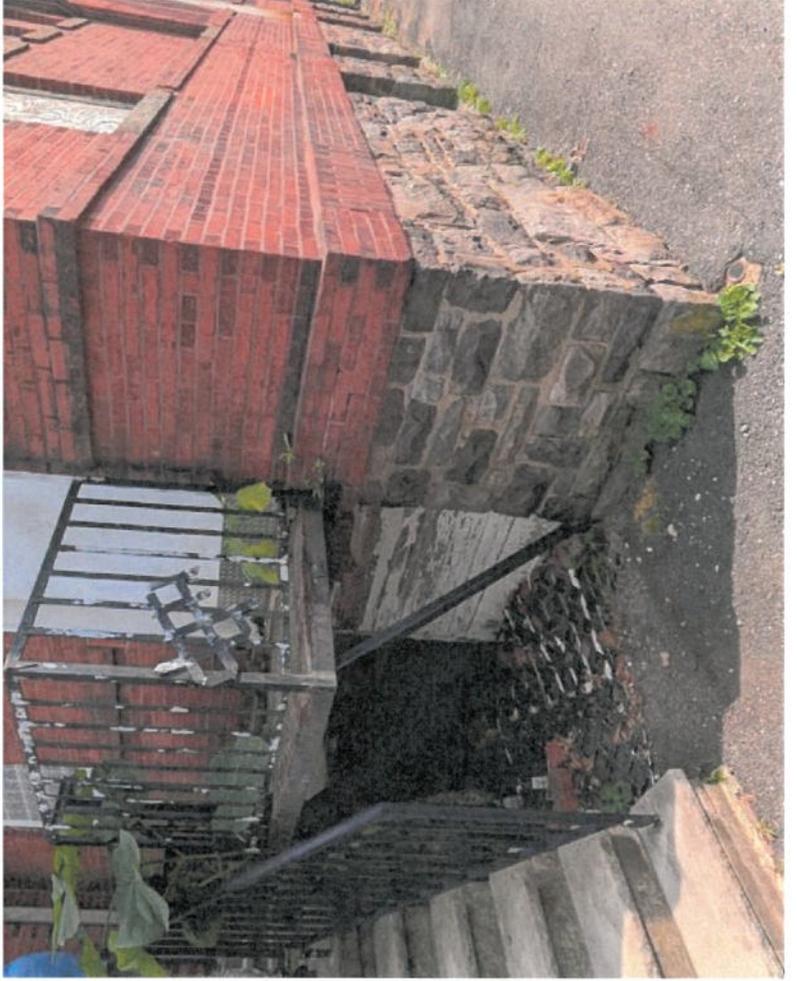
PHOTOS SET #6

Photo set #6 – The concrete stair on the back side of the building is severally damaged and exhibits cracks.

Photo set #6 & #7 – There is also evidence of vegetation growth in several areas of both the exterior façade and the ground level.

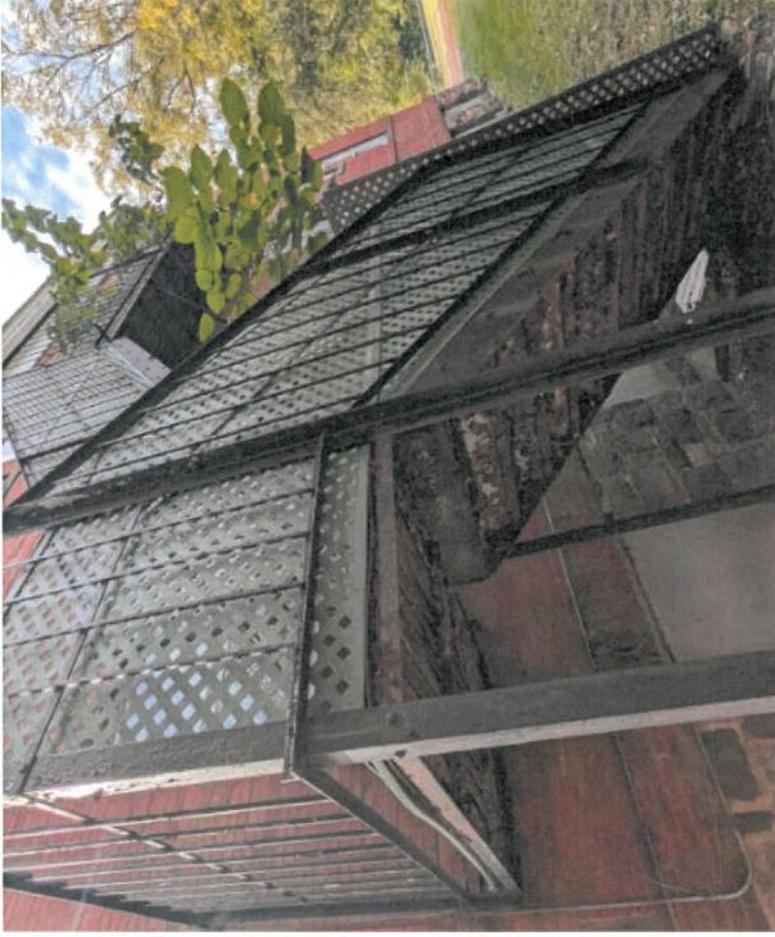
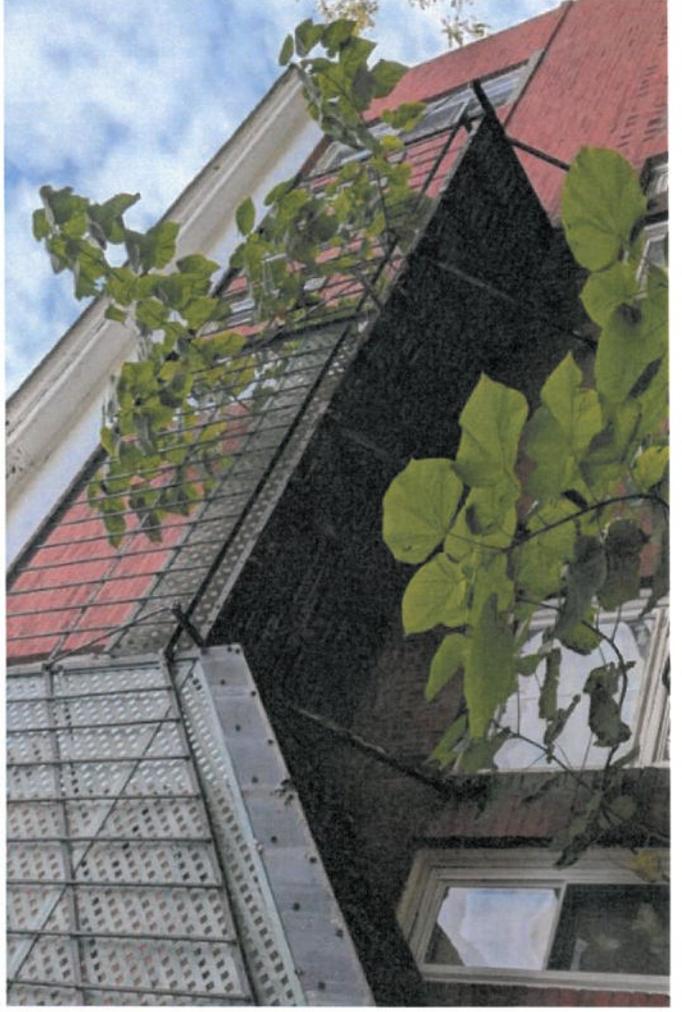
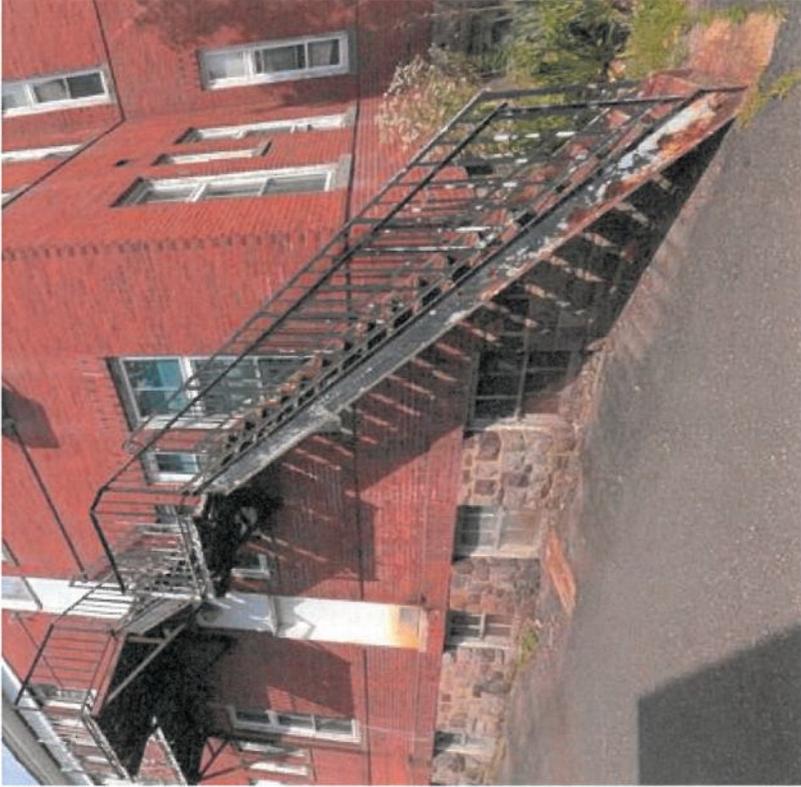
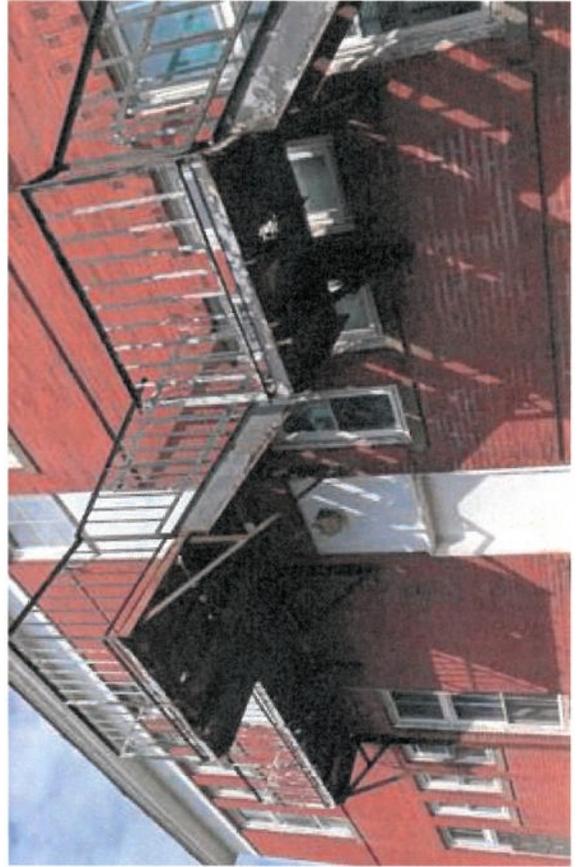
PHOTOS SET #8

Photo set #8 – The fire escape stair on both sides of the building are severely damaged and corroded.

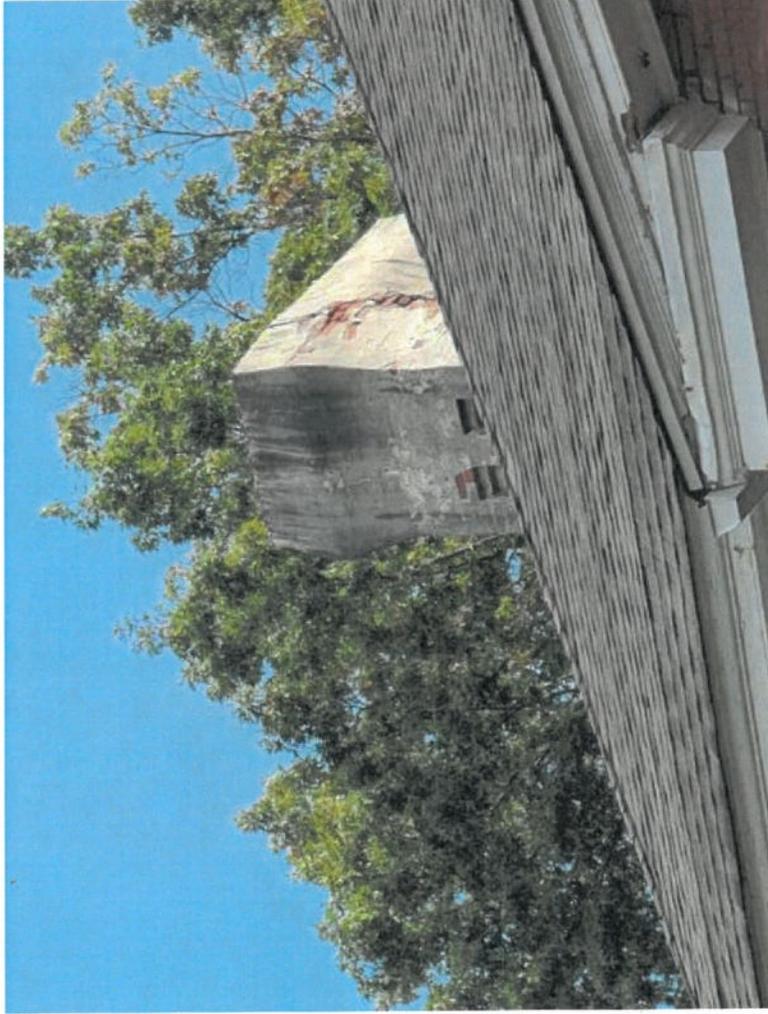
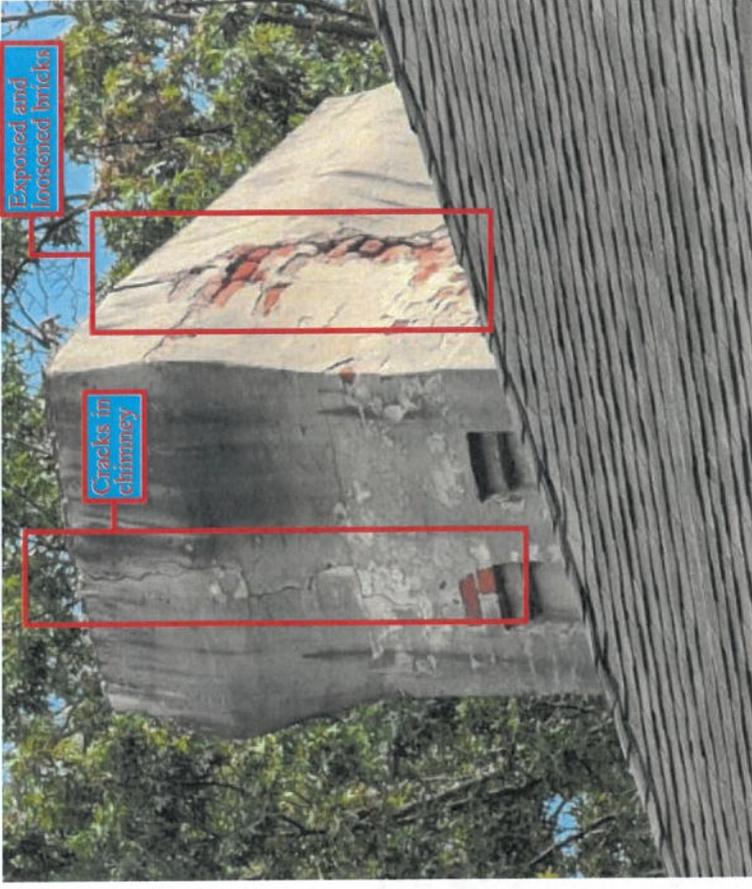
PHOTOS SET #9

Photo set #9– The chimney on the roof is damaged by evidence of cracks and exposed bricks.

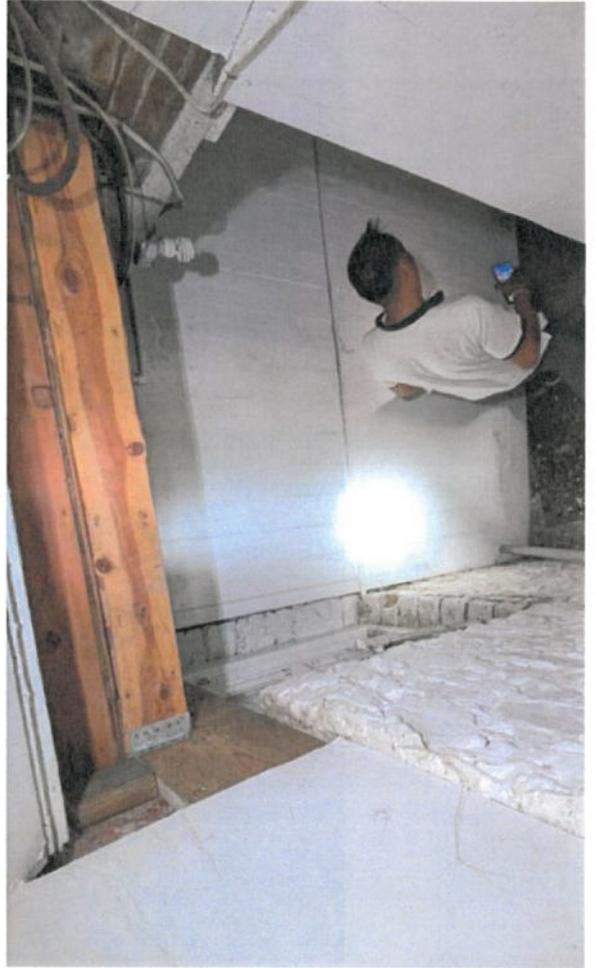
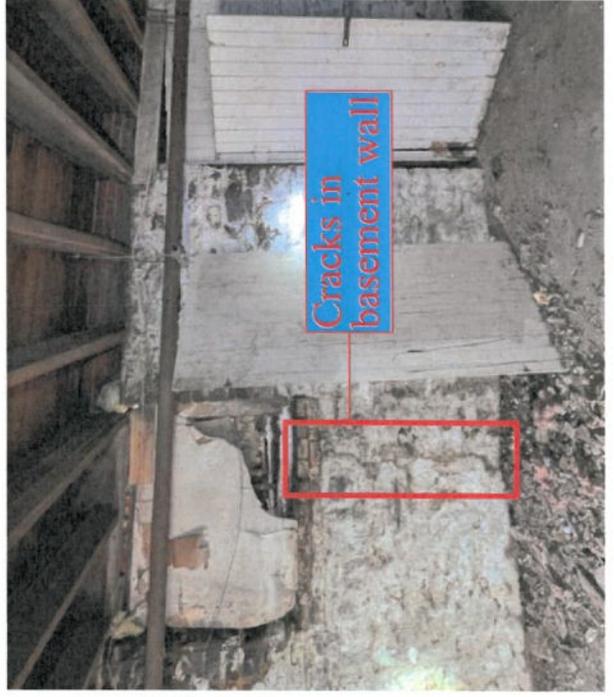
PHOTOS SET #10

Photo set #10 – The building has a full basement with basement walls constructed with rubble stone masonry and it has thin and round “lolly” columns and masonry columns that support the first floor’s floor system of 2x conventional wood framing. The walls showed cracks in some locations.

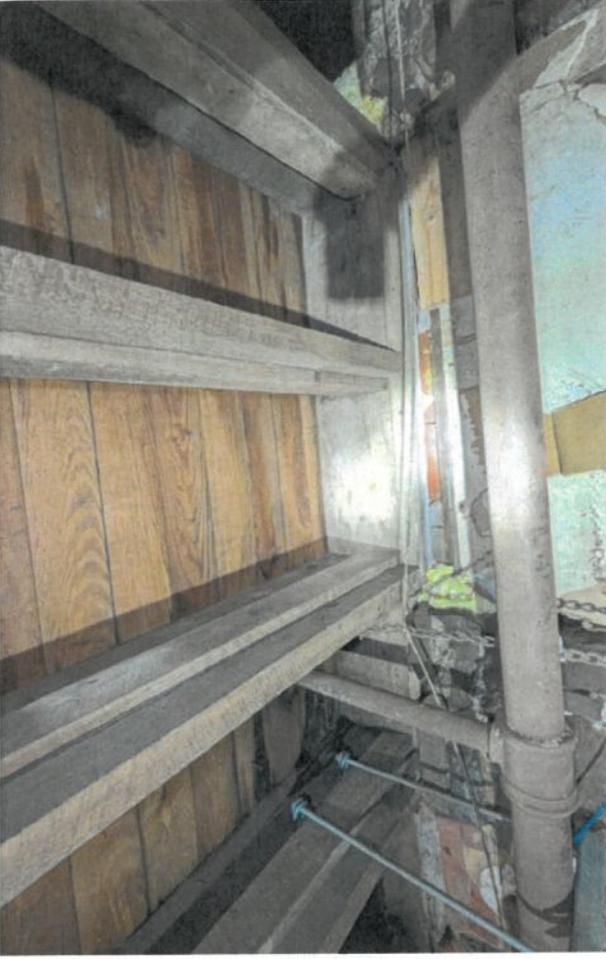
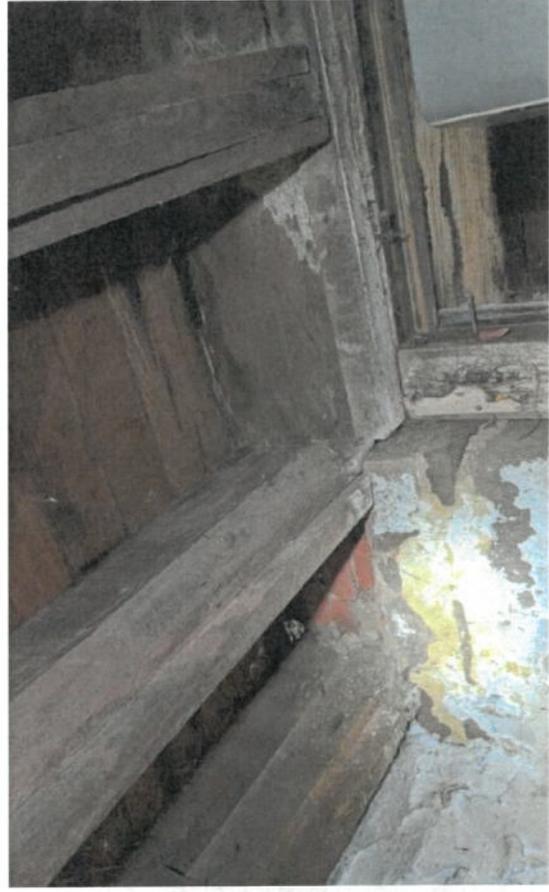
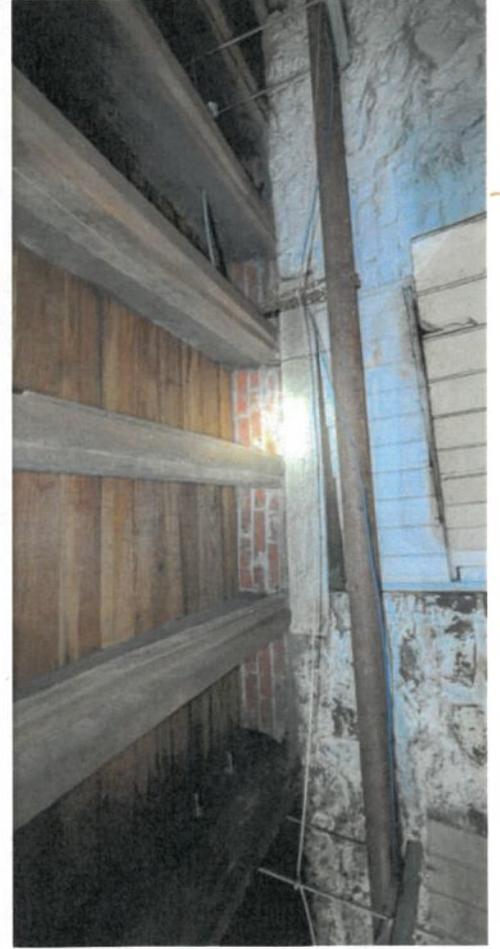
PHOTOS SET #11

Photo set #11– The round columns were corroded along its length and very severely corroded at the base at some locations, compromising integrity of the same. It was observed that the original joists were improperly connected at the point of bearing on the foundation wall i.e. no adequate bearing and/or mechanical connection to the basement walls, with some joists being connected by means of ledges.

At the basement level, the wood girder beam supporting the first floor's wood framing has mold at the location just above the column. This indicates that the girder beam has been in contact with water which would weaken it and therefore, the beam would have to be replaced. The columns are also heavily corroded at the base and hence, they would have to be either repaired or replaced.

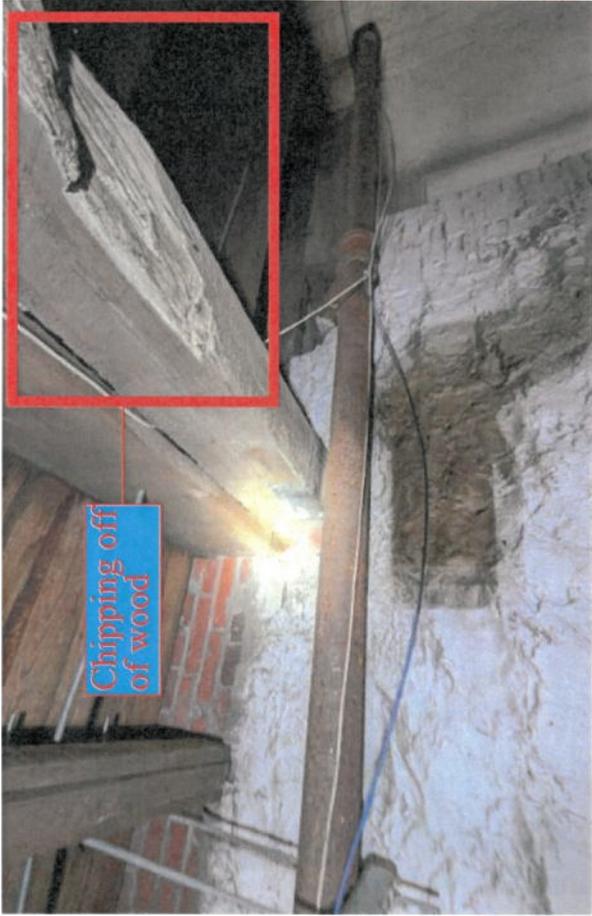
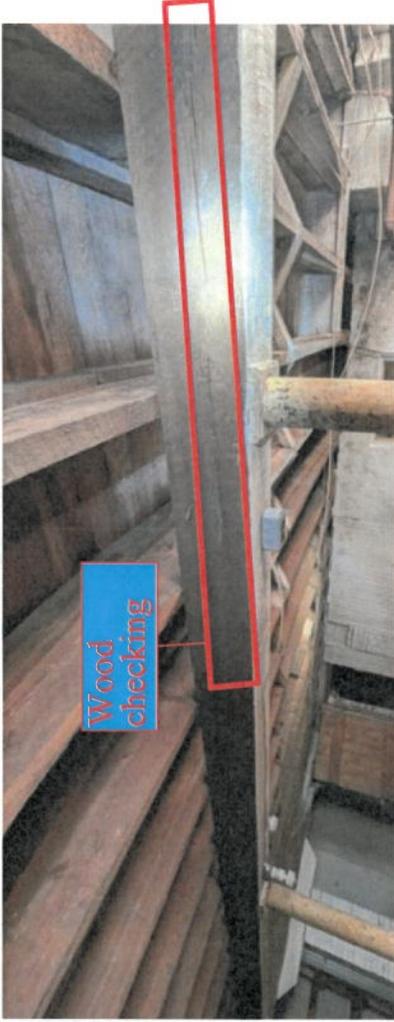
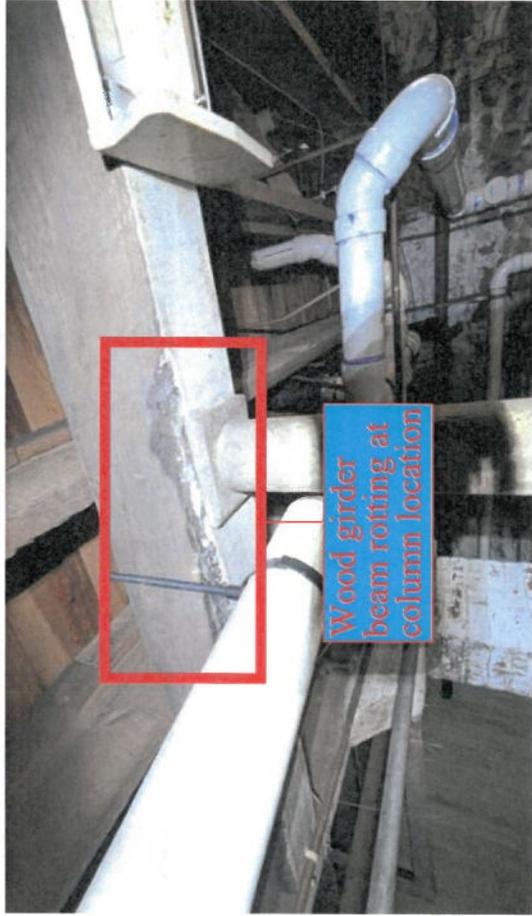
PHOTOS SET #12

Photo set #12 – The joists were slightly rotted at various locations. The wood girder beam supporting the wood joists exhibits wood checking (cracks along the beam length), wood chipping and severe rotting near the column location.

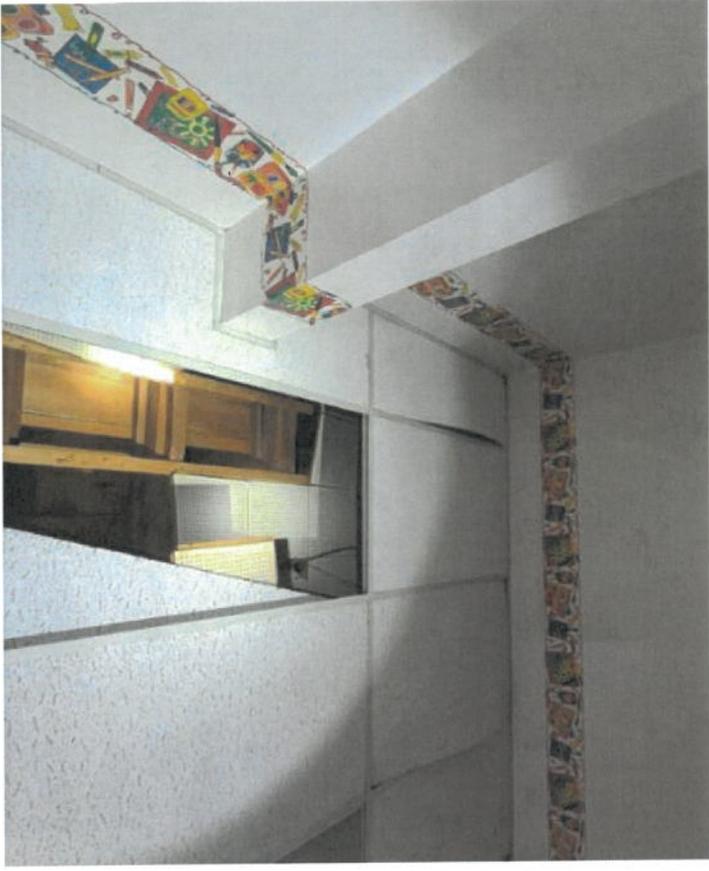
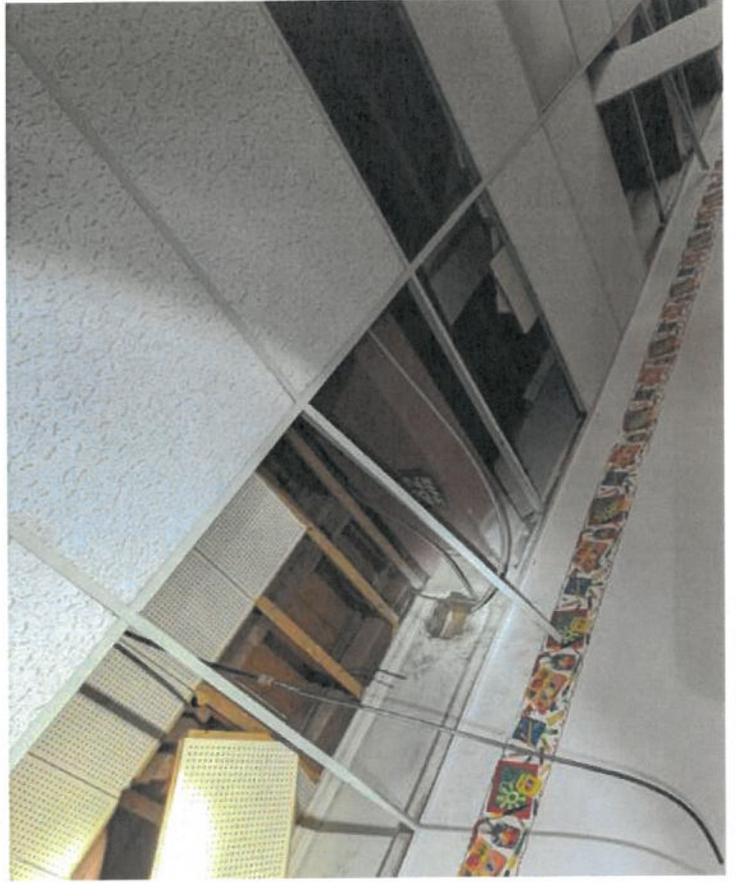
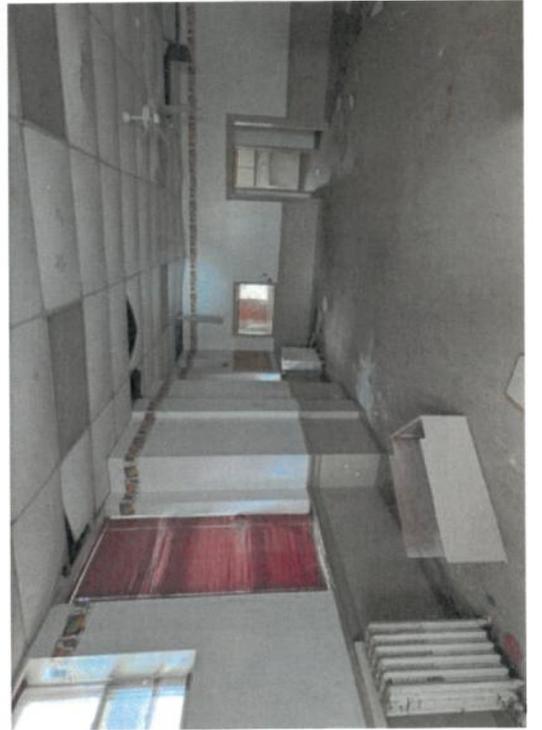
PHOTOS SET #13

Photo set #13 & #14 – The photos show the general interior condition of the first and second floors. The floor framing consists of wood framing supported by steel wide flange beams. There are portions of the walls, ceilings and floor finishes that will require repairs. These may also require many cosmetic repairs.
