October 3, 2025

RE: Structural Inspection
YMCA 230 Mercer St, Hightstown, NJ
MPP Project No: 25-1625

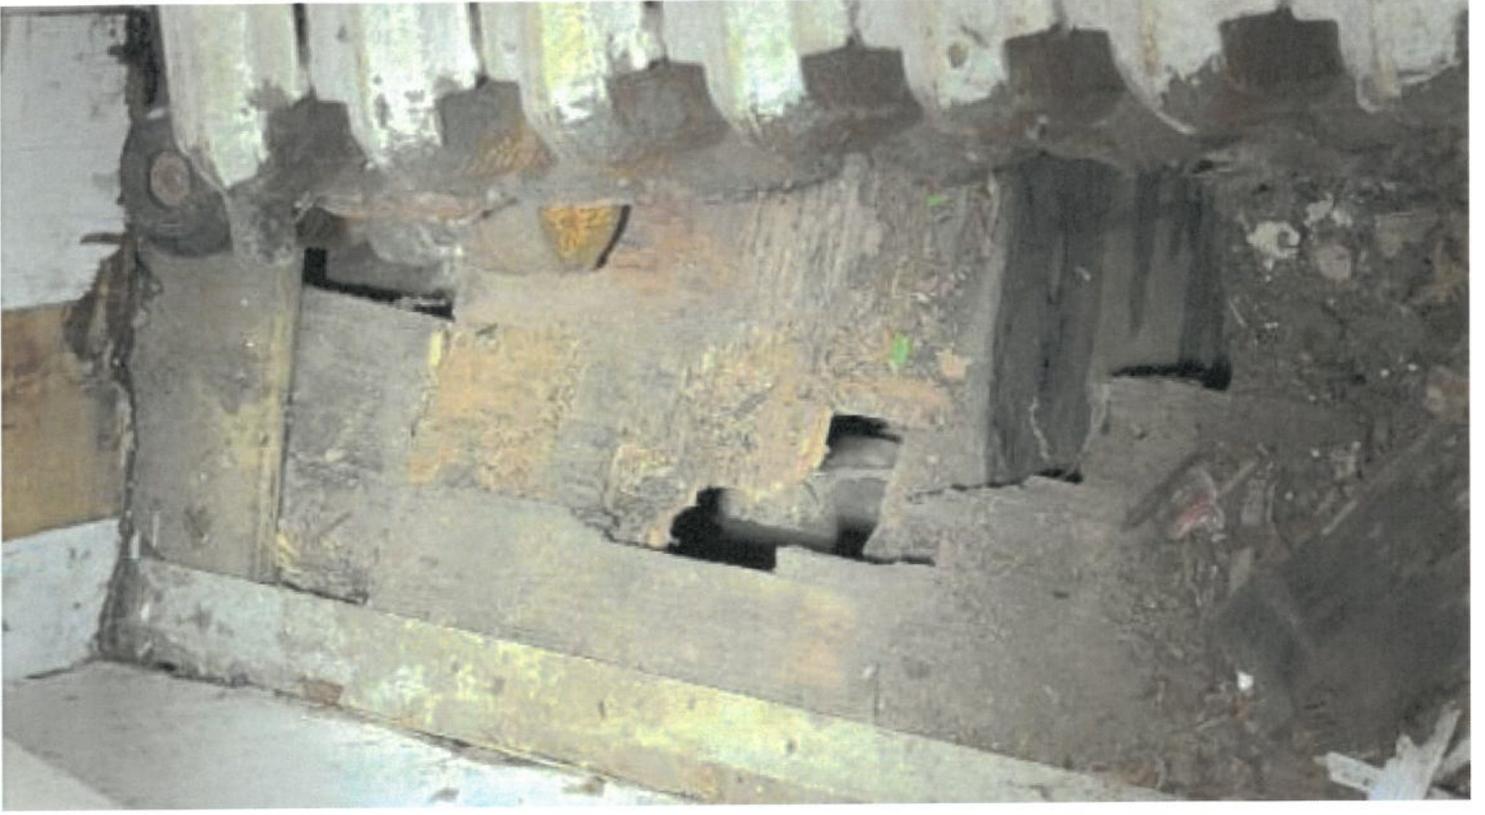
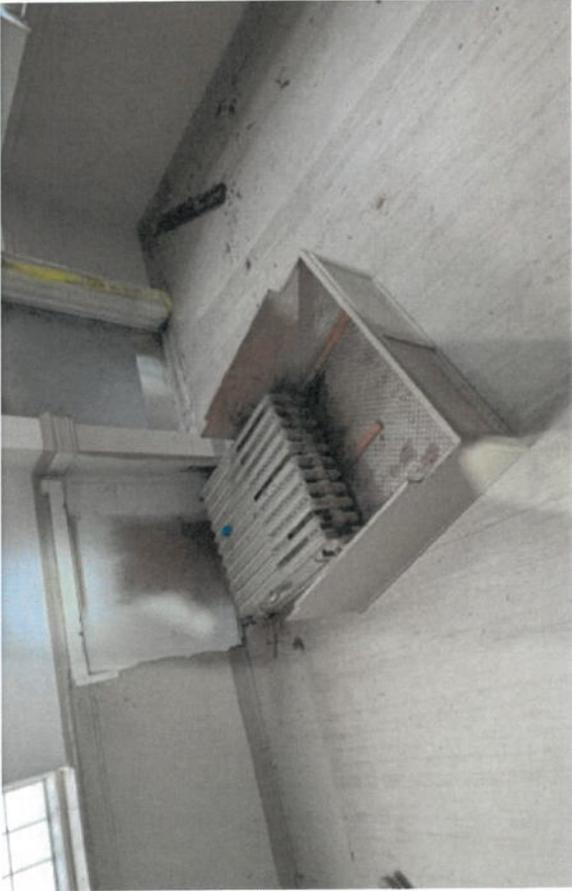
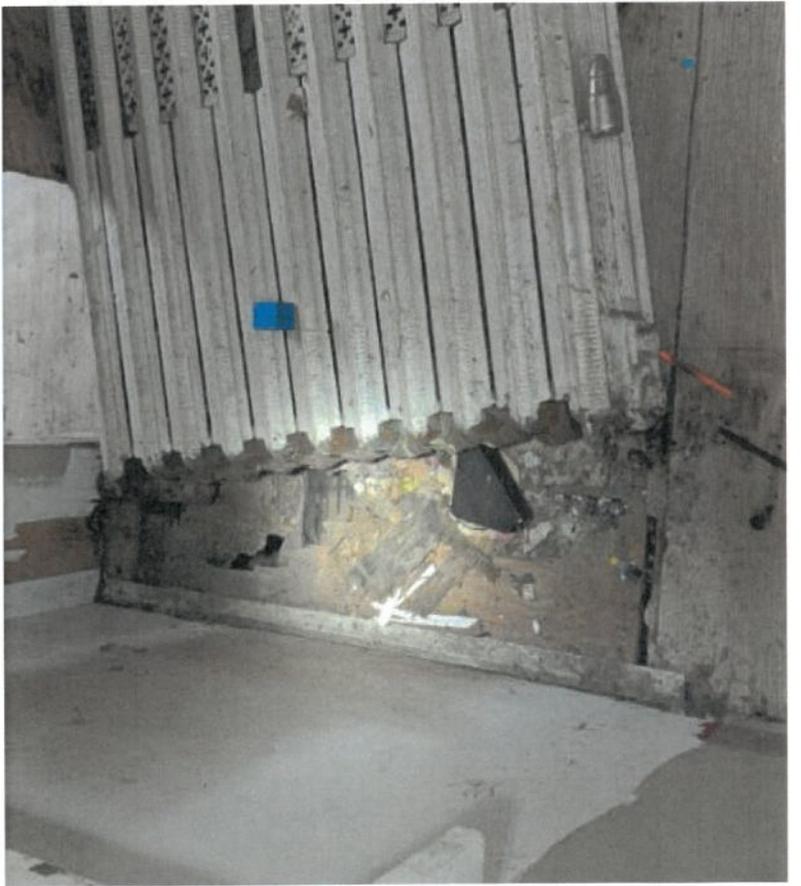
PHOTOS SET #15

Photo set #15 – In the corner of one of the rooms at the first floor, there is severe damage in the floor where the floor meets the exterior wall. The floor exhibited cracks and holes.

In one of the rooms on the first floor, there is severe damage to the floor system. The floor system would have to be replaced in kind at that location.

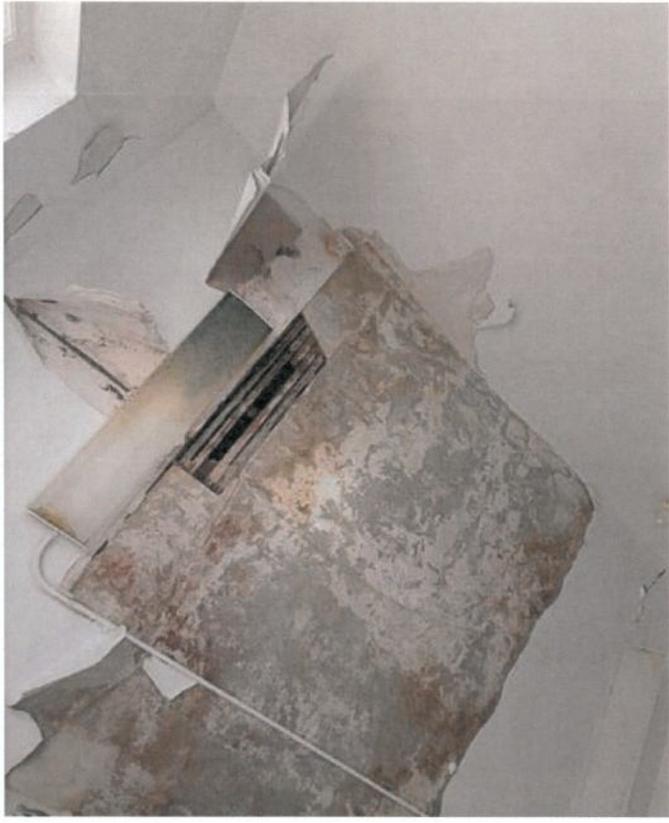
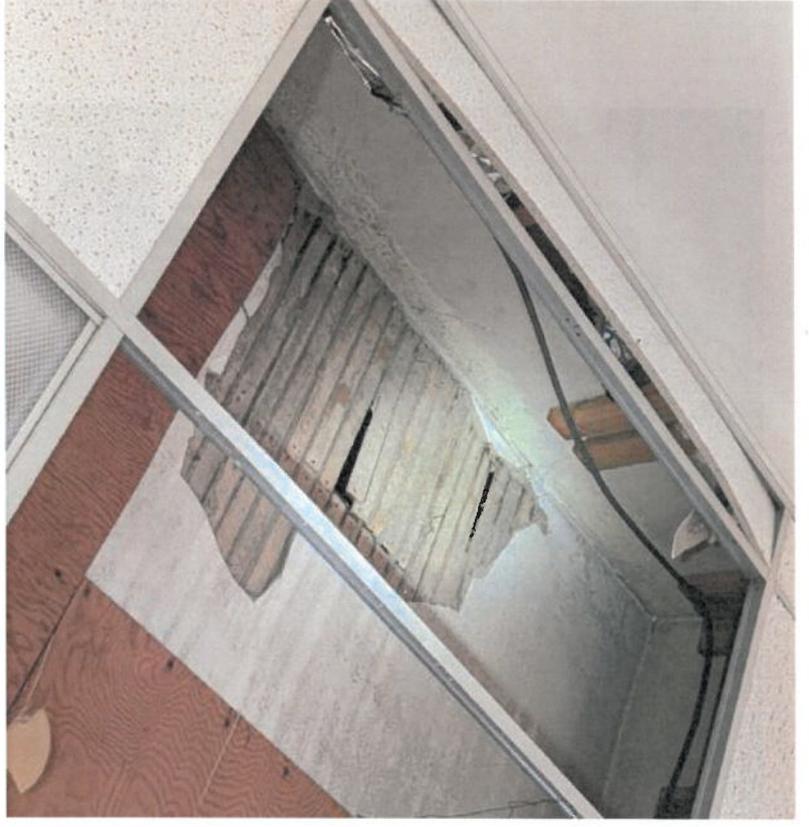
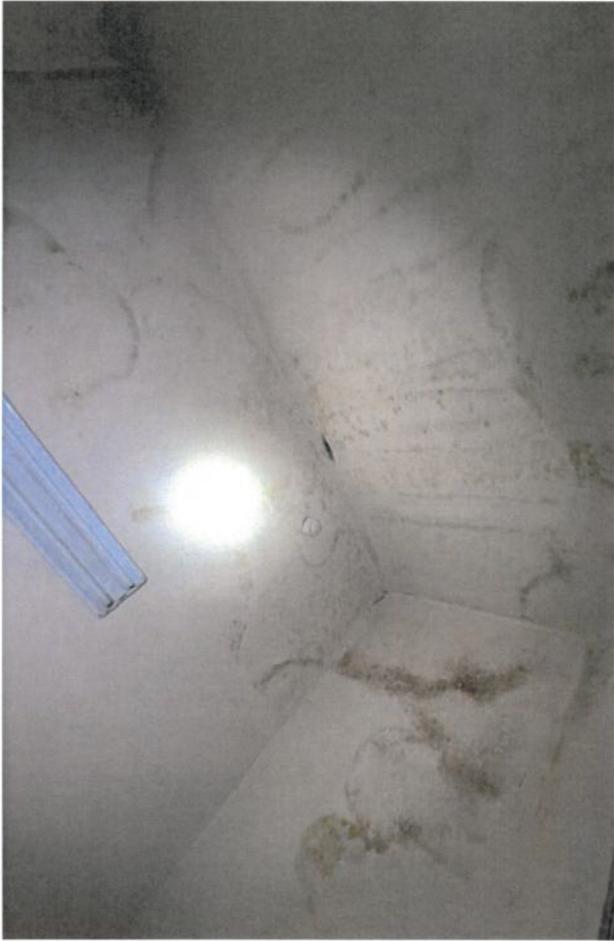
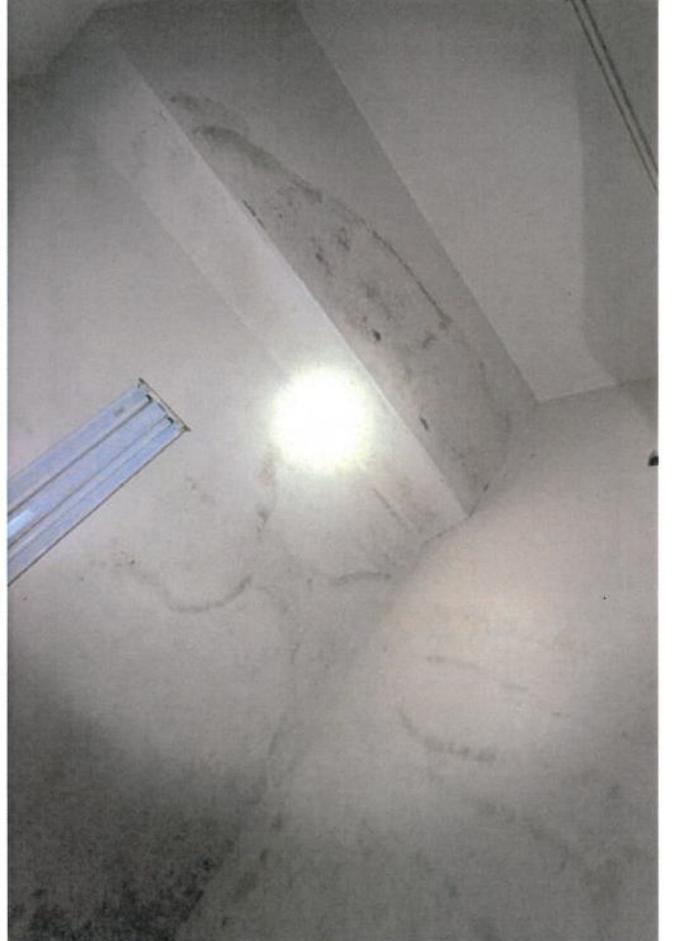
PHOTOS SET #16

Photo set #16 – The walls and ceiling in some rooms had mold and stains which are evidence of water damage. There are many areas of the ceiling where the ceiling support members are snapped and broken and would require repairs.

The floor system on the second floor exhibits settlement and with the evidence of water damage (stains), it can be concluded that the floor system is compromised, severally damaged and needs extensive repair. Presence of mold, water stains and cracks in the walls and ceiling of both the first and second floors indicate that the walls and ceiling are weakened, compromised and need to be repaired extensively.

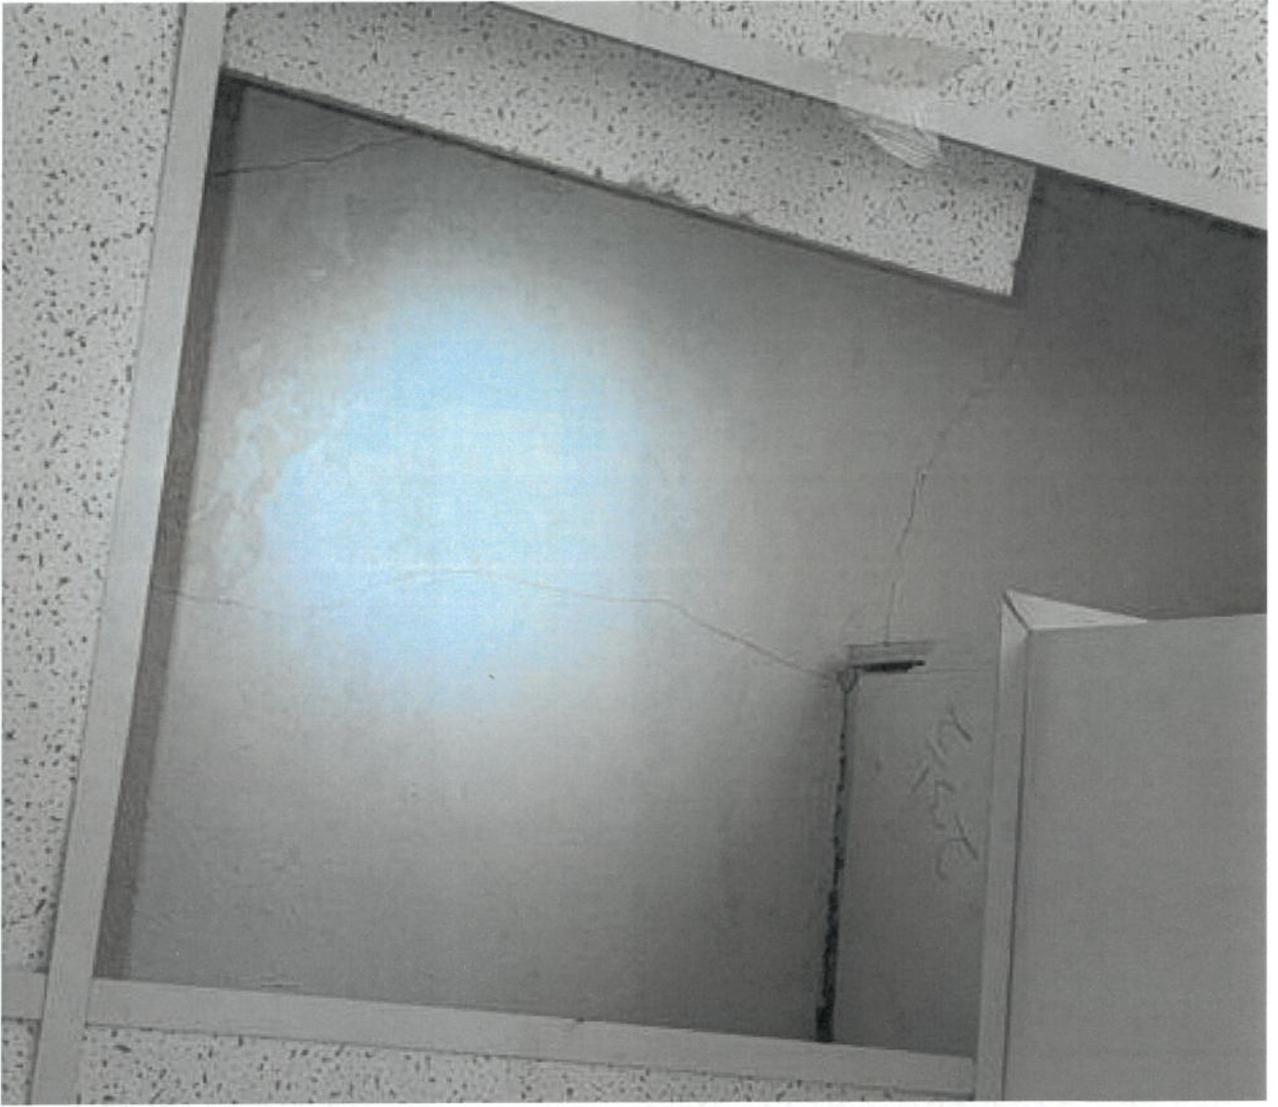
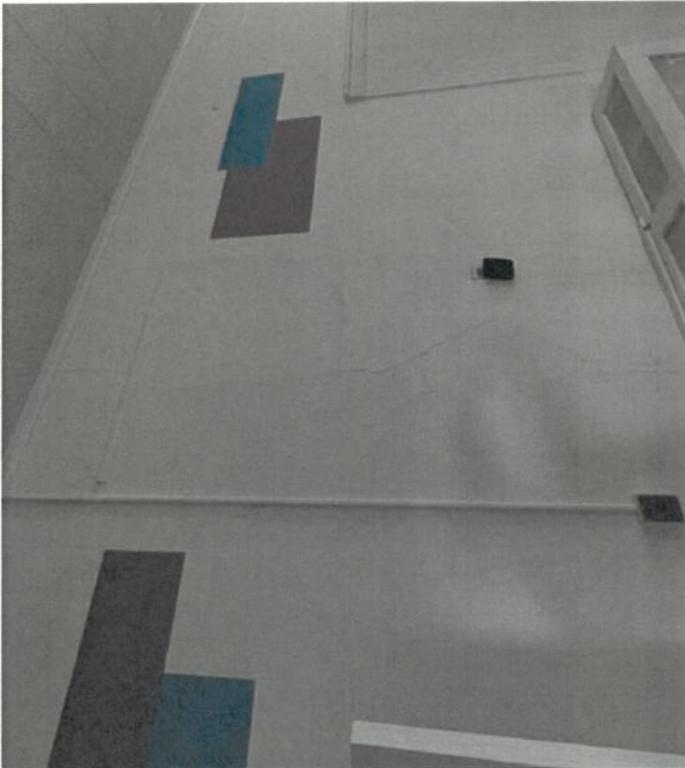
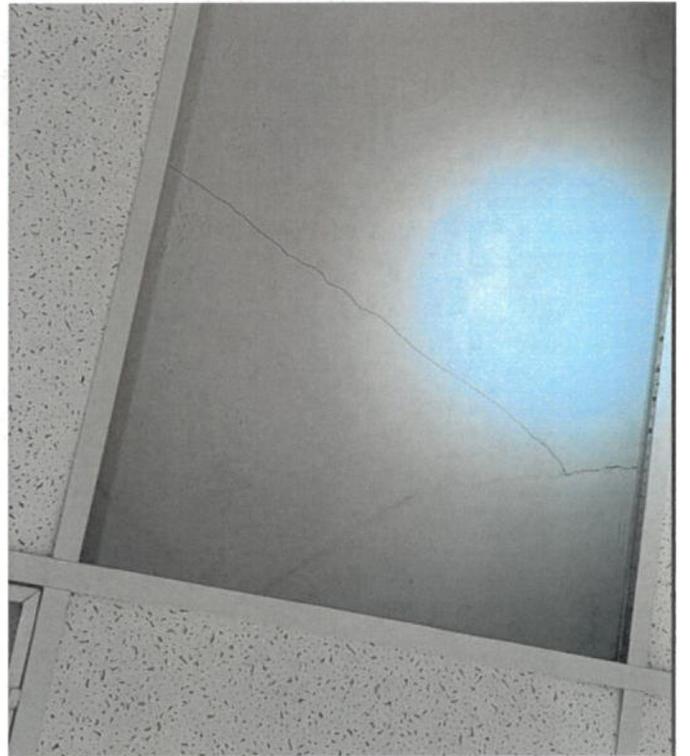
PHOTOS SET #17

Photo set #17 – It was also observed throughout the building, that there were significant cracks and separations between corners of perpendicular walls, and corners where the wall and ceiling intersect.

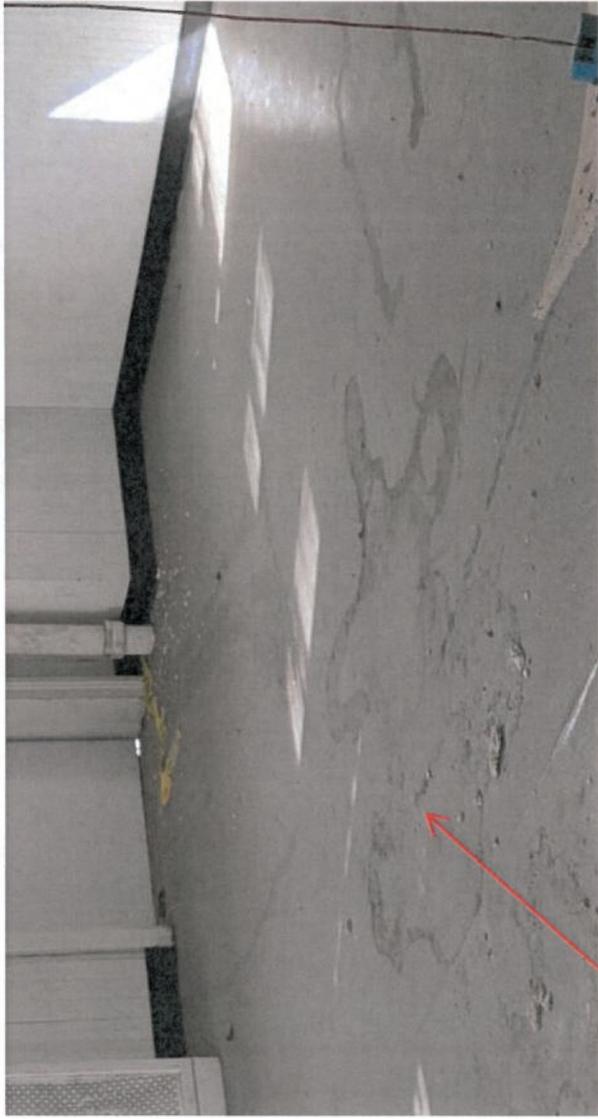
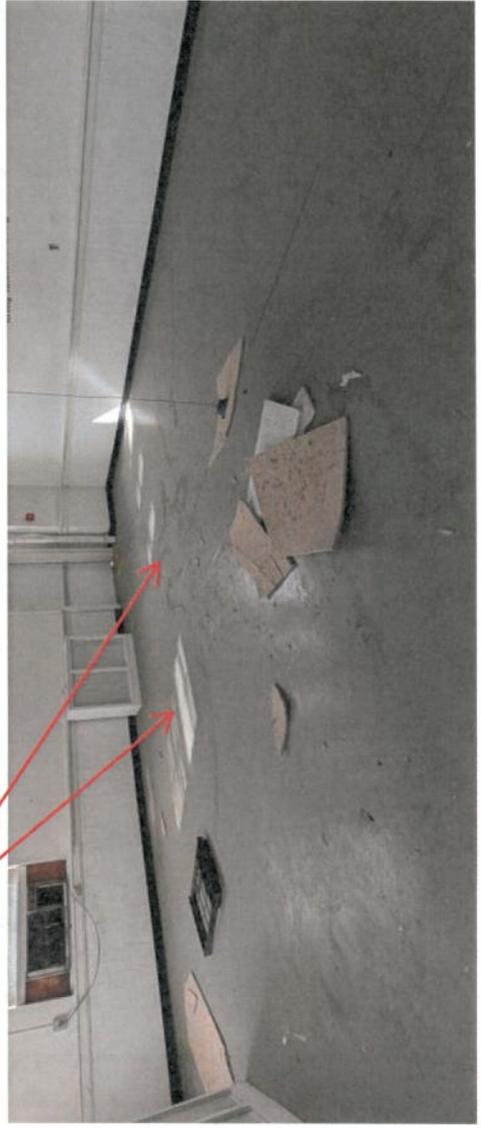
PHOTOS SET #18

Photo set #18 – On the second floor – there were stains on the floor and some of the rooms, the floor was

not levelled. The floor was bending and exhibited deflection.

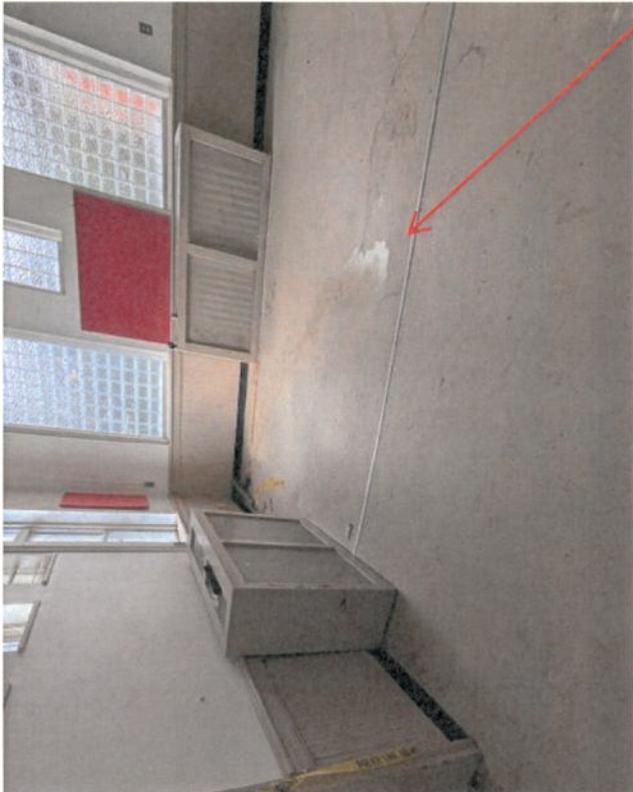
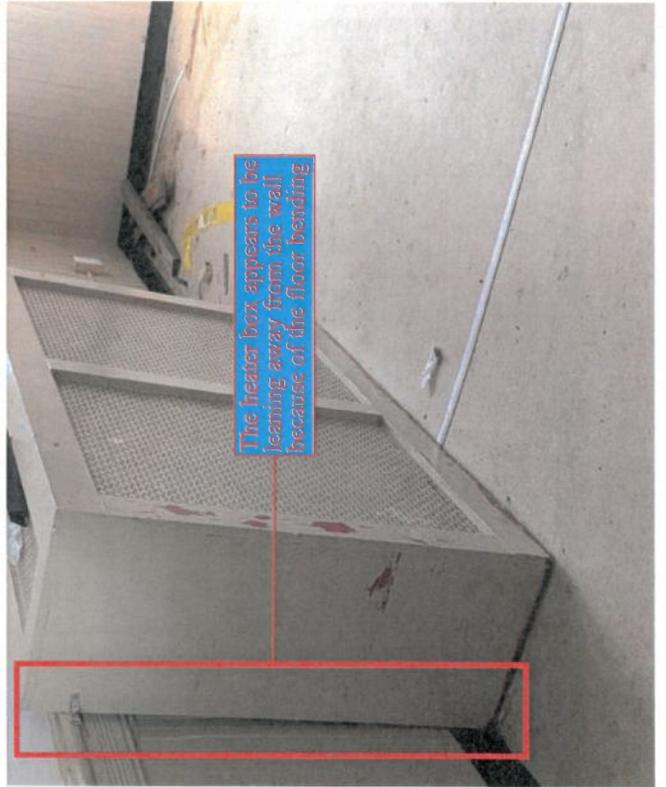
Water stains

The heater box appears to be leaning away from the wall because of the floor bending

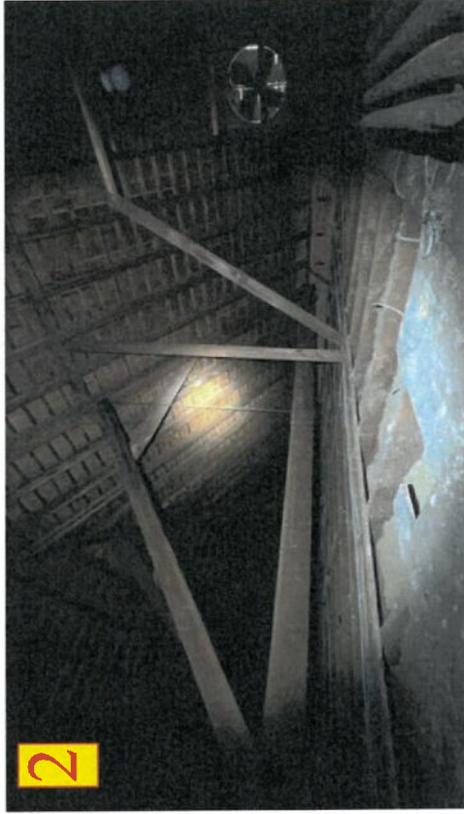
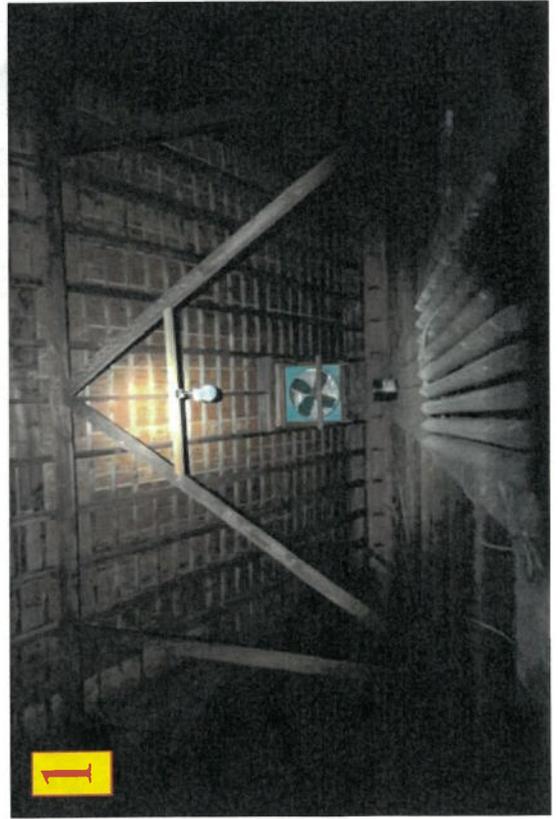
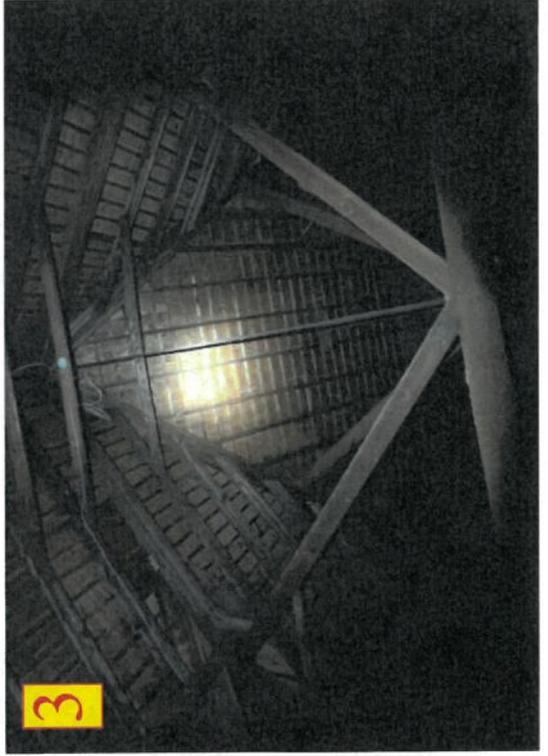
PHOTOS SET #19

Photo set #19 & #20 – There is a ladder from the second floor to access the attic and the gable roof. The gable roof is made of wood truss framing. The wood framing exhibits mold and stains indicating water damage in some areas.

The roof structure has several undulations (hip and hip line bending) and with the evidence of mold from the inside (the attic), it indicates that the roof structure is severally damaged and hence needs to be demolished and replaced. The chimney on the roof is also severally damaged. It may collapse during heavy wind conditions and hence, needs to be demolished and replaced in kind.

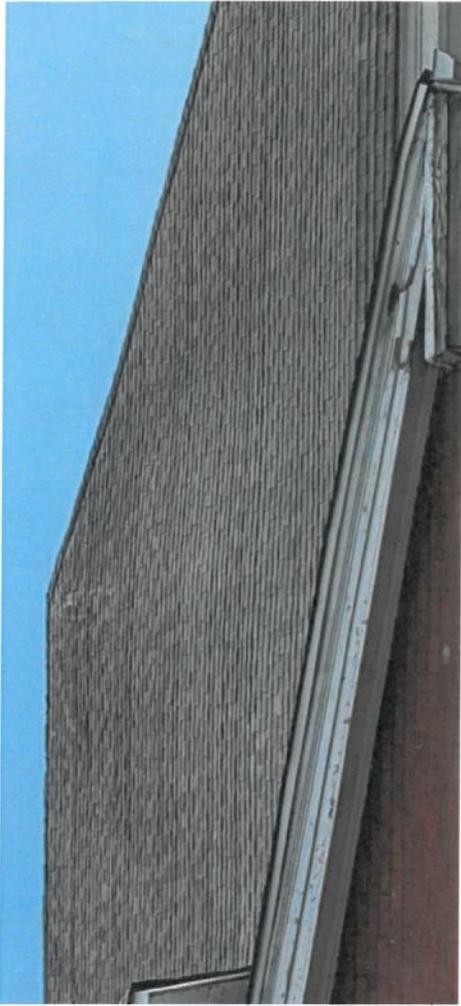
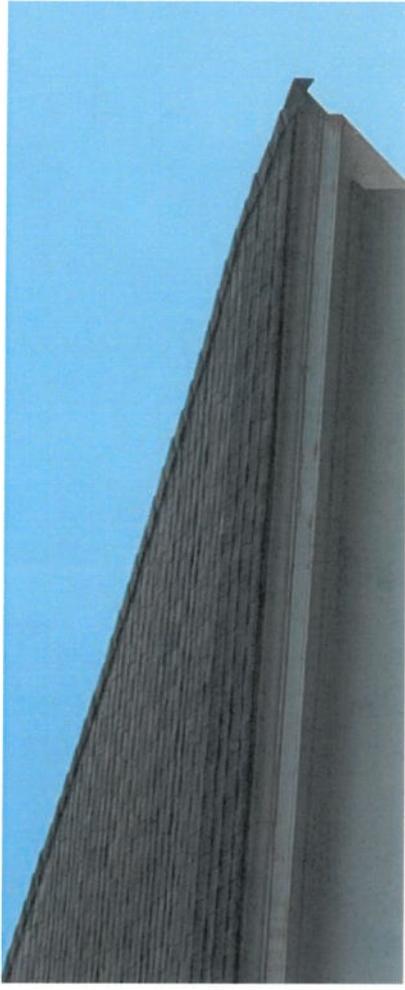
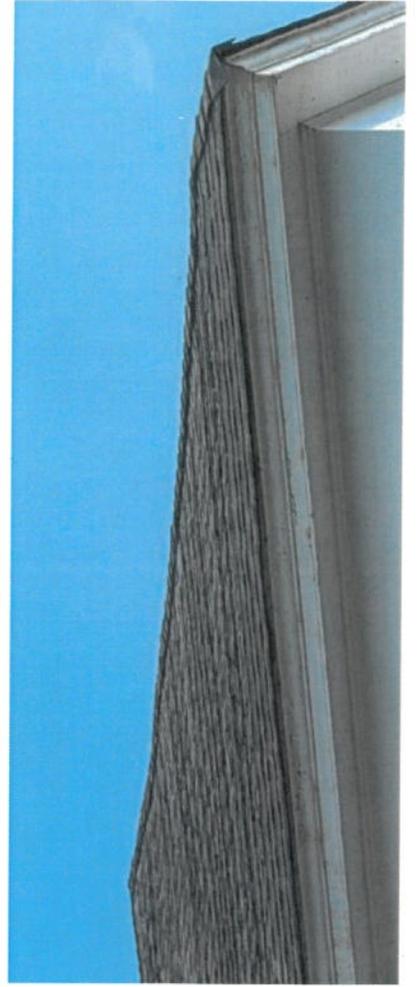
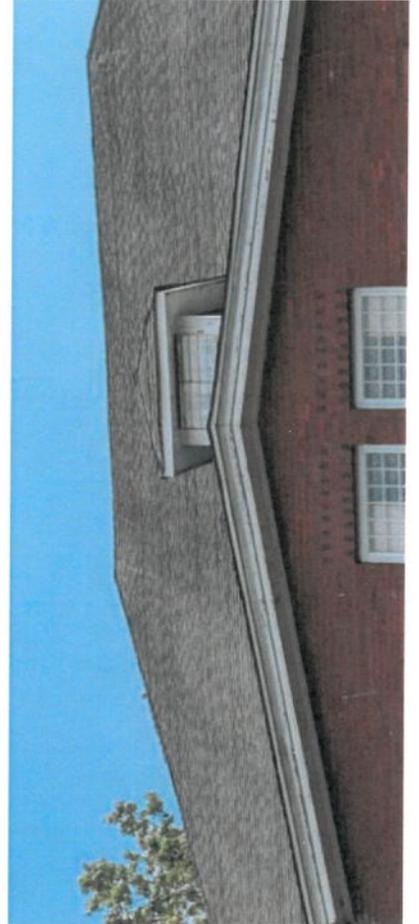
PHOTOS SET #21

Photo set #21 – When observed from outside, there seems to be several undulations in the roof such as hip bending and hip line bending.
