Re: Intensive-level Historic Architectural Survey, 230 Mercer Street (Block 60, Lot 16), Borough of Hightstown, Mercer County, New Jersey (HPO Project #19-2807)

Property Name: Mercer Street School

Survey Name: Intensive-level Historic Architectural Survey, Mercer Street School

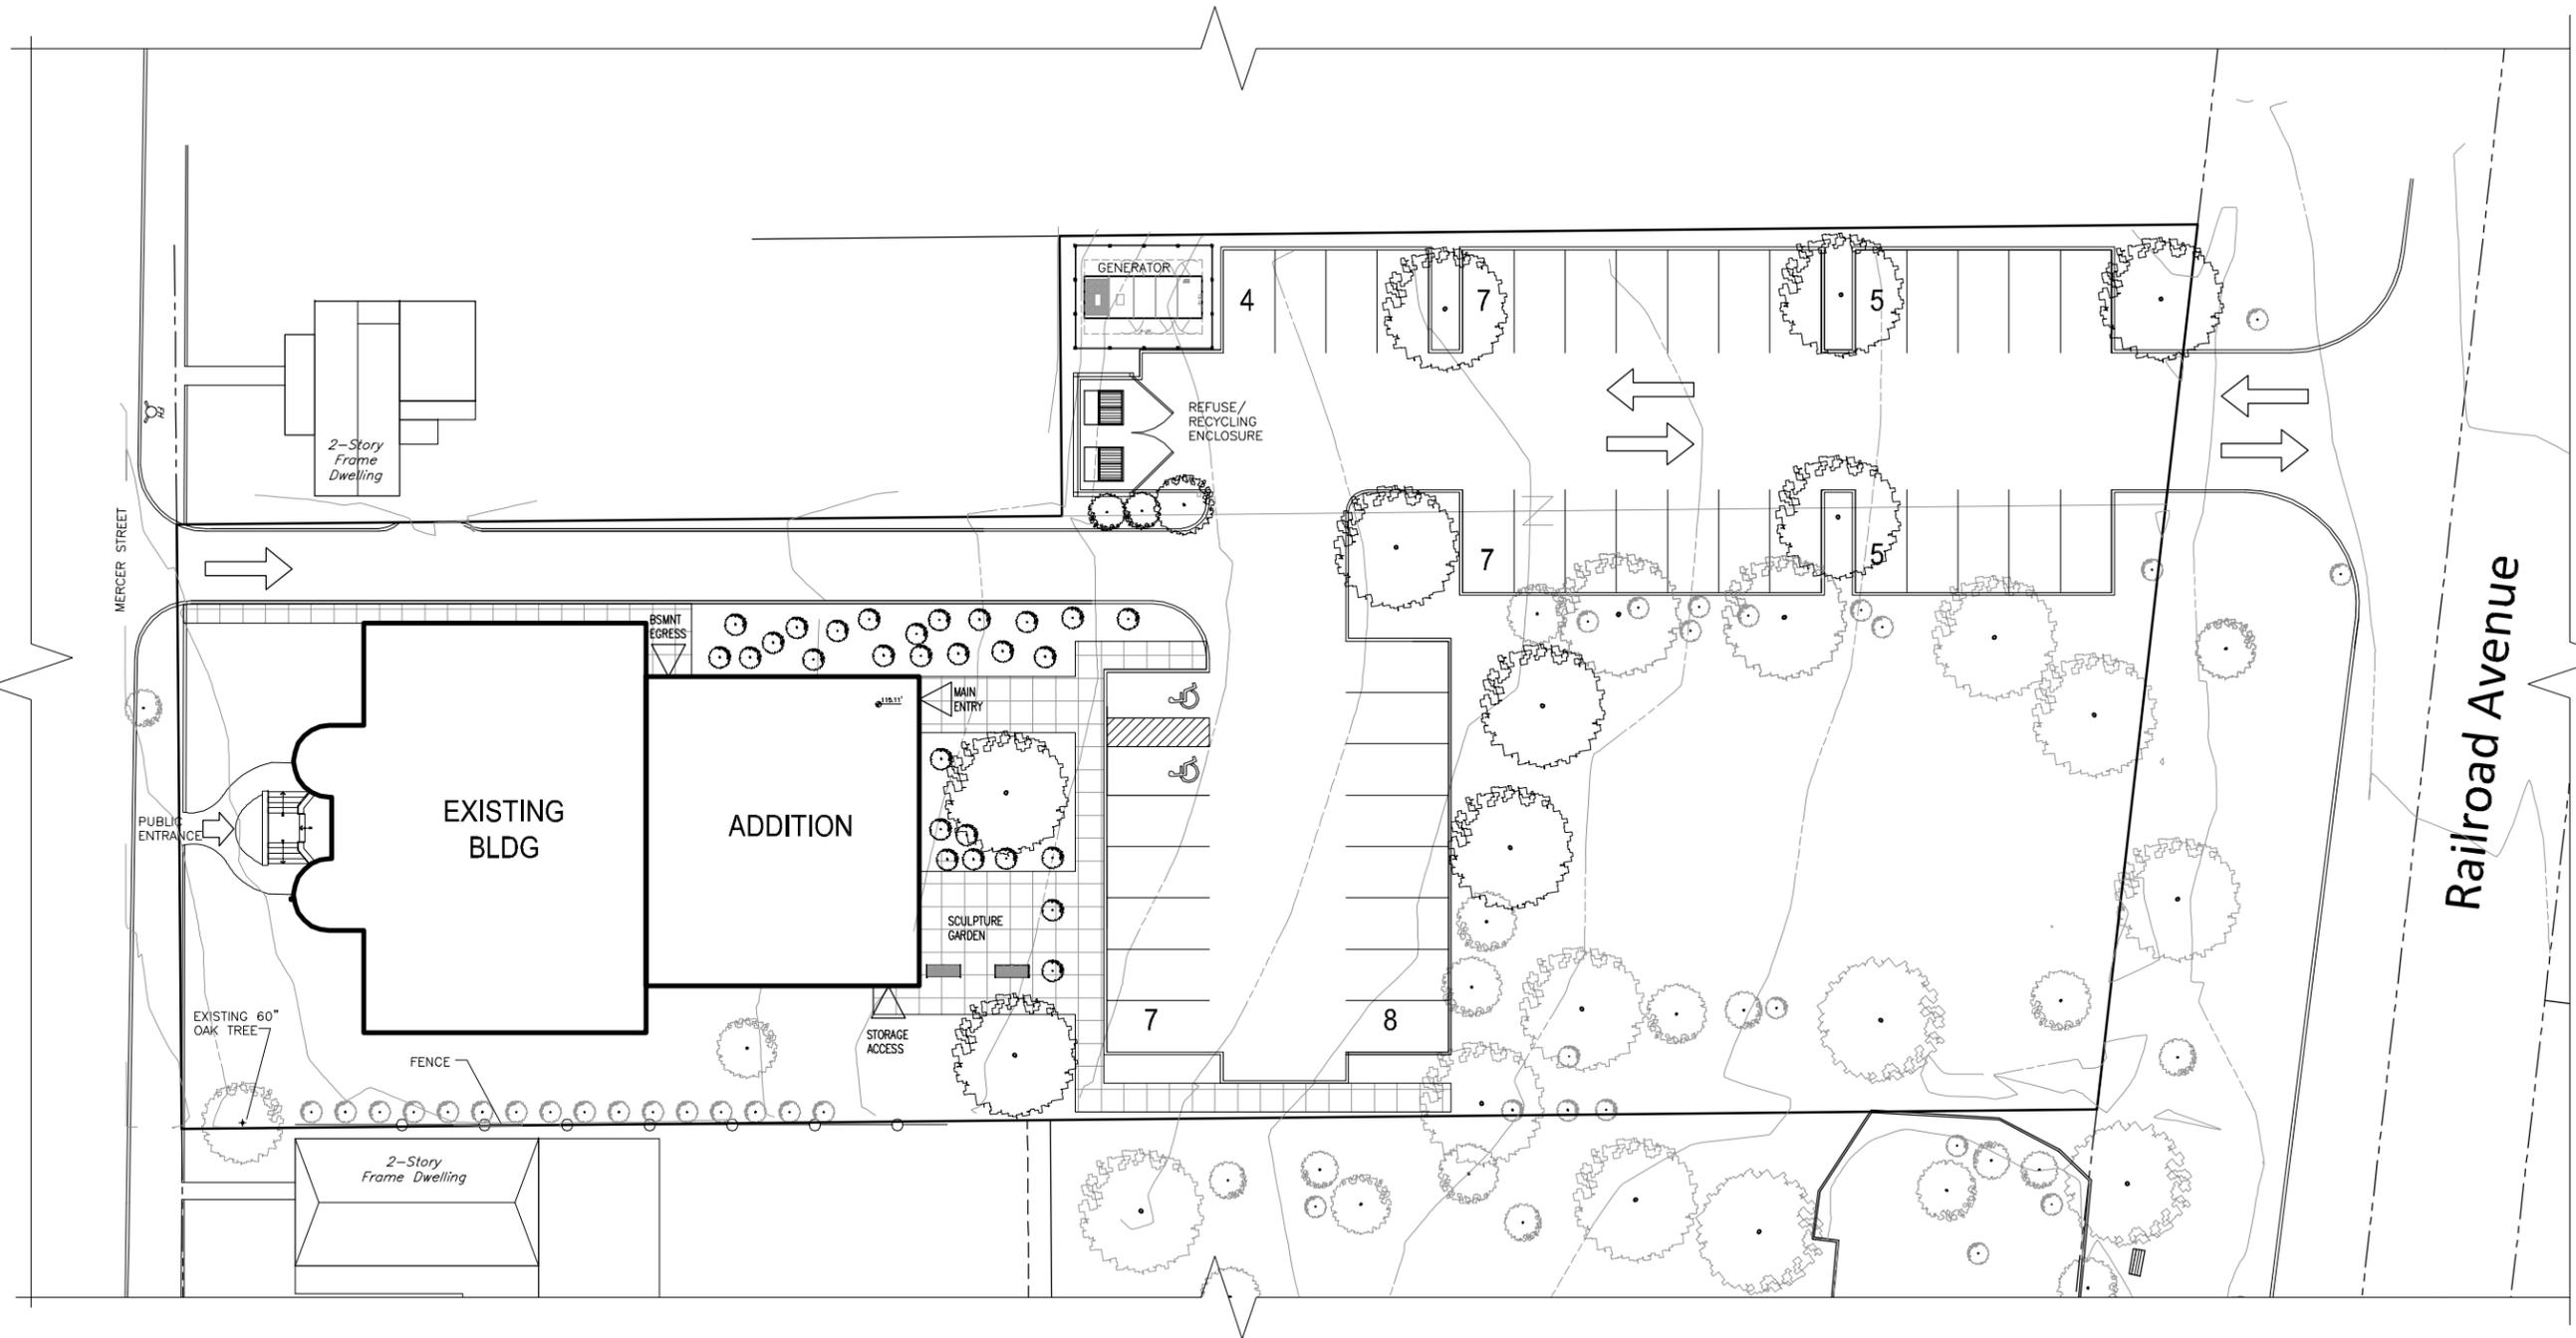
SK-27a-R1
THE MUSIAL GROUP ARCHITECTURE

SCHEMATIC SITE PLAN
 SCALE: 1/32" = 1'-0"

OPTION 7
 39 PARKING SPACES PROVIDED

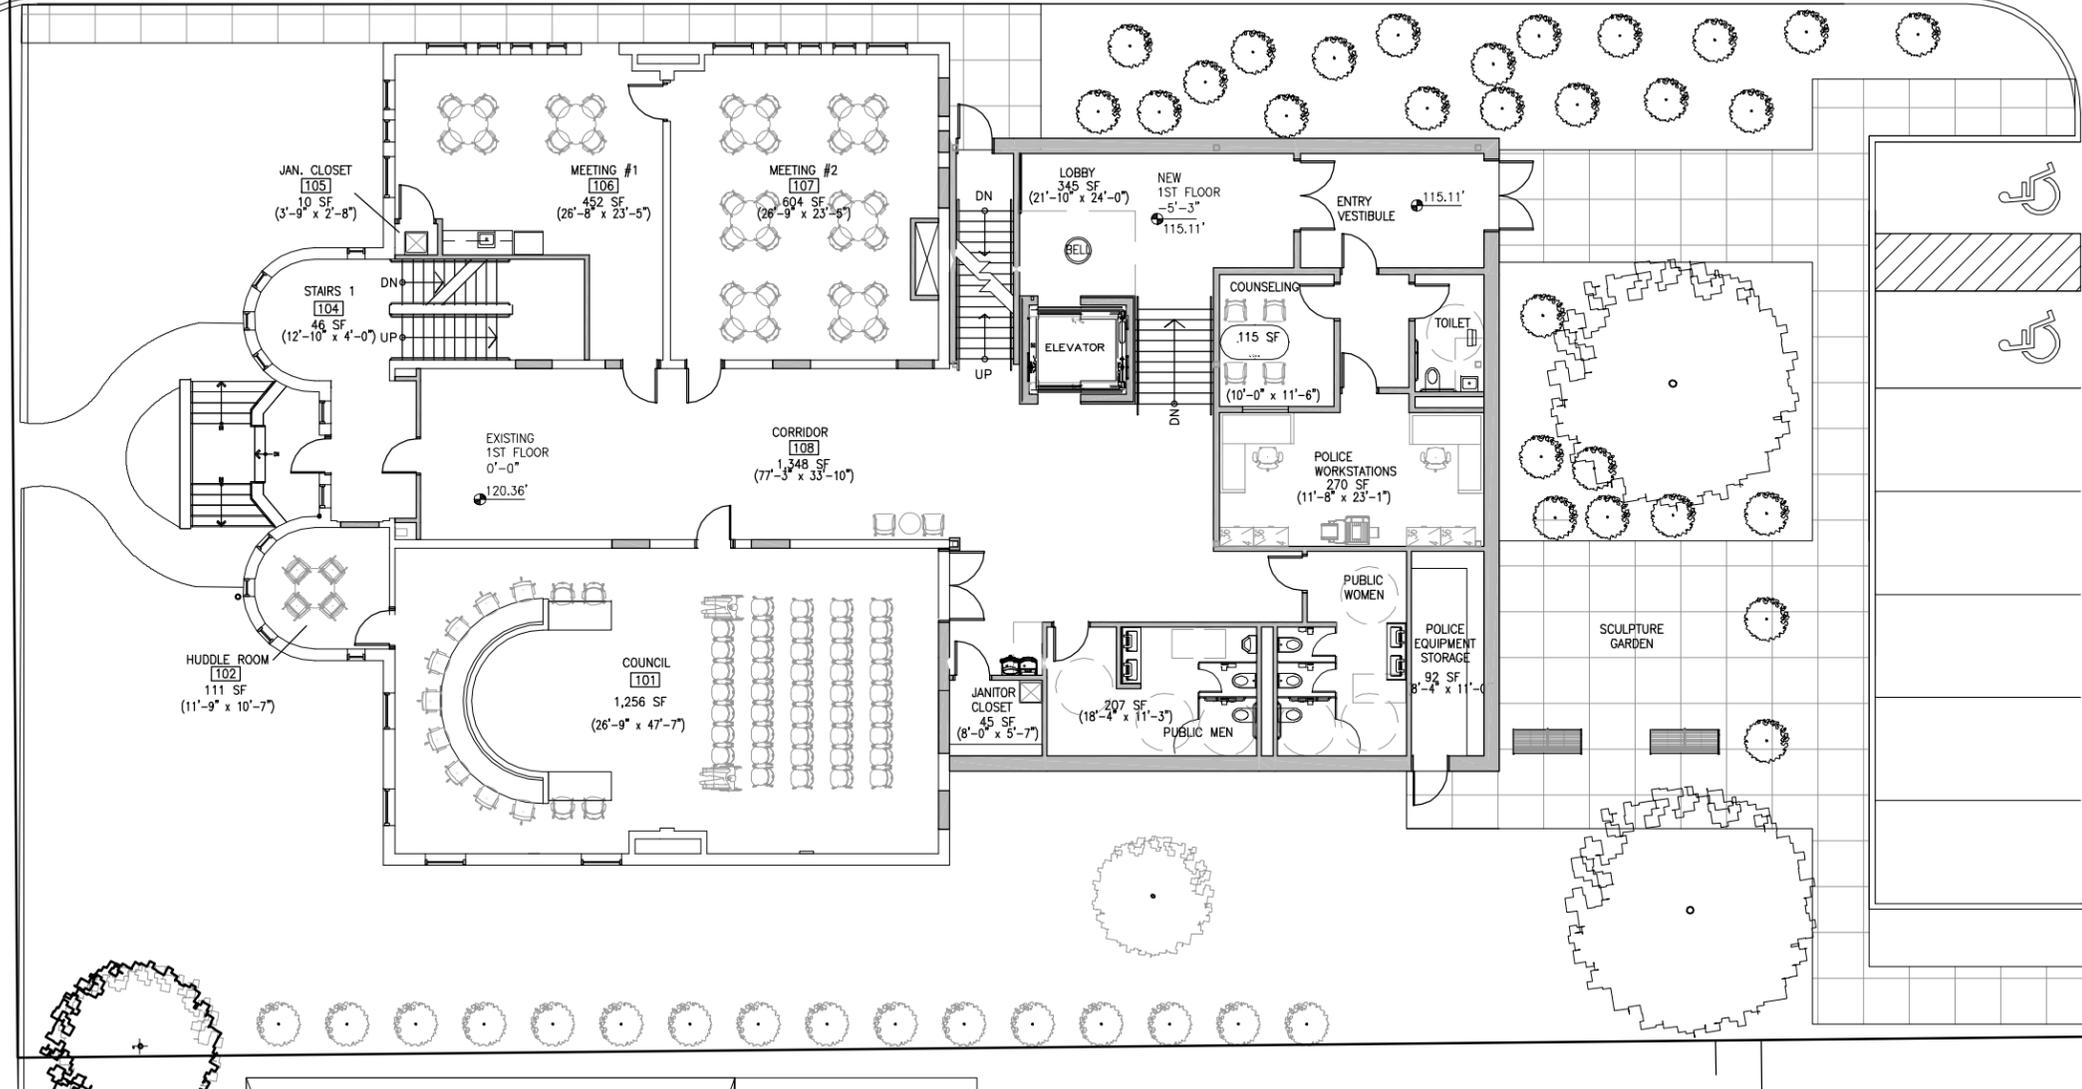
16 MARCH 2020
 Project # 118719.01
SK-27b-R1
THE MUSIAL GROUP ARCHITECTURE
 191 Mill Lane Mountainside, NJ 07092 p. 908.232.2860 f. 908.232.2845

SCHEMATIC FIRST FLOOR PLAN
 SCALE: 1/16" = 1'-0"

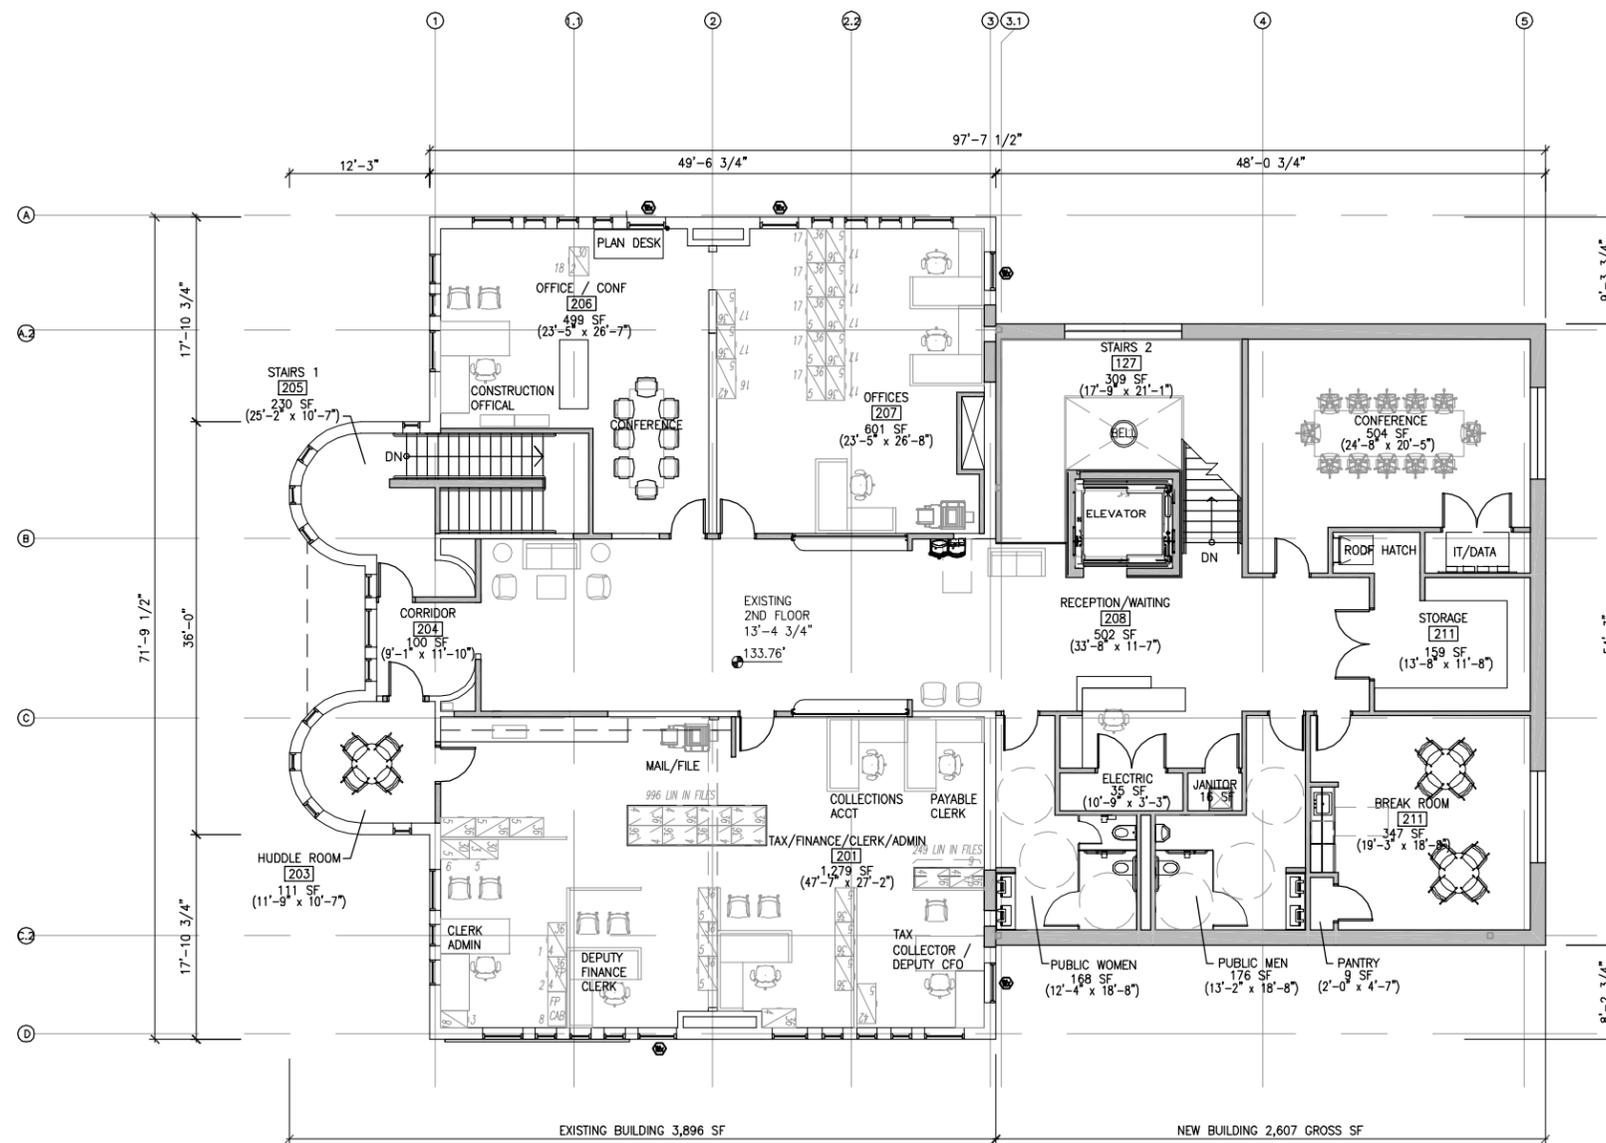
SK-27c-R1
THE MUSIAL GROUP ARCHITECTURE
191 Mill Lane Mountainside, NJ 07092 p. 908.232.2860 f. 908.232.2845

SCHEMATIC SECOND FLOOR PLAN
SCALE: 1/16" = 1'-0"

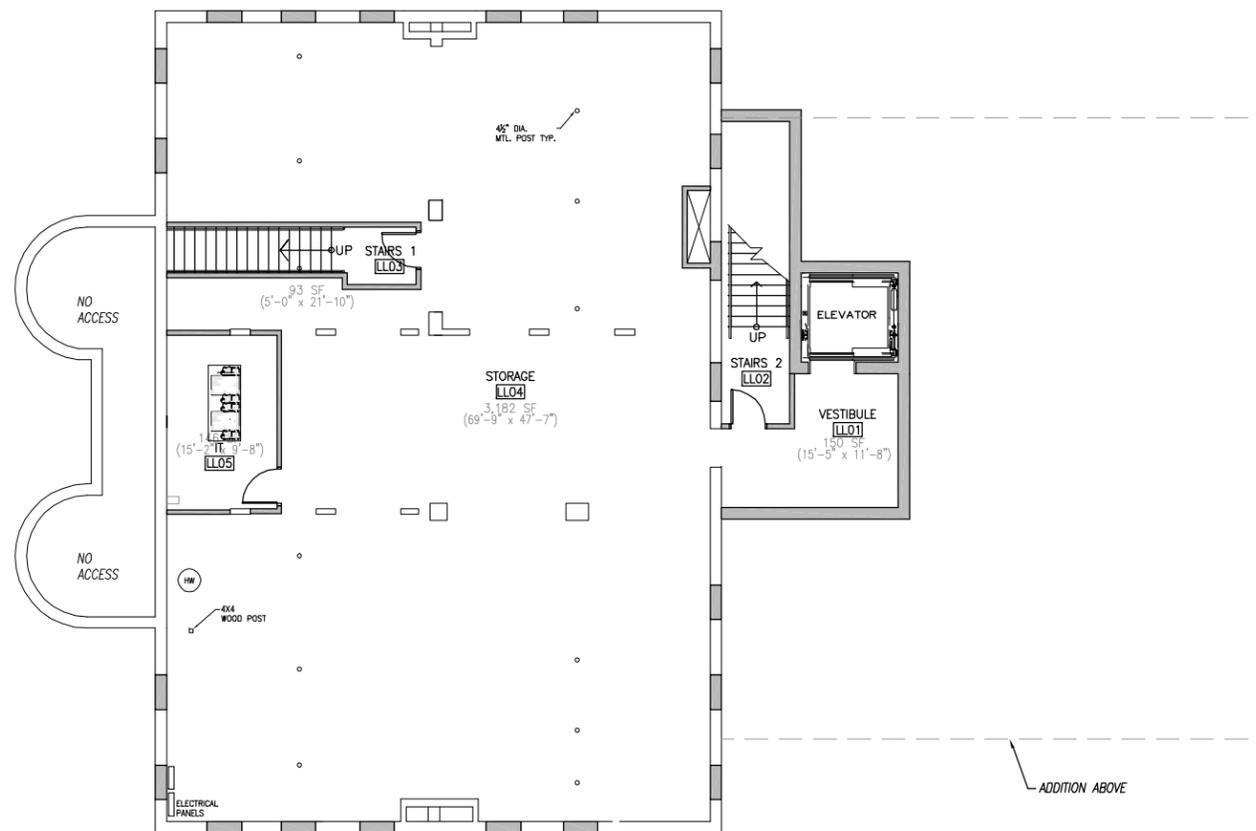
SK-27d-R1

SCHEMATIC LOWER FLOOR PLAN
 SCALE: 1/16" = 1'-0"

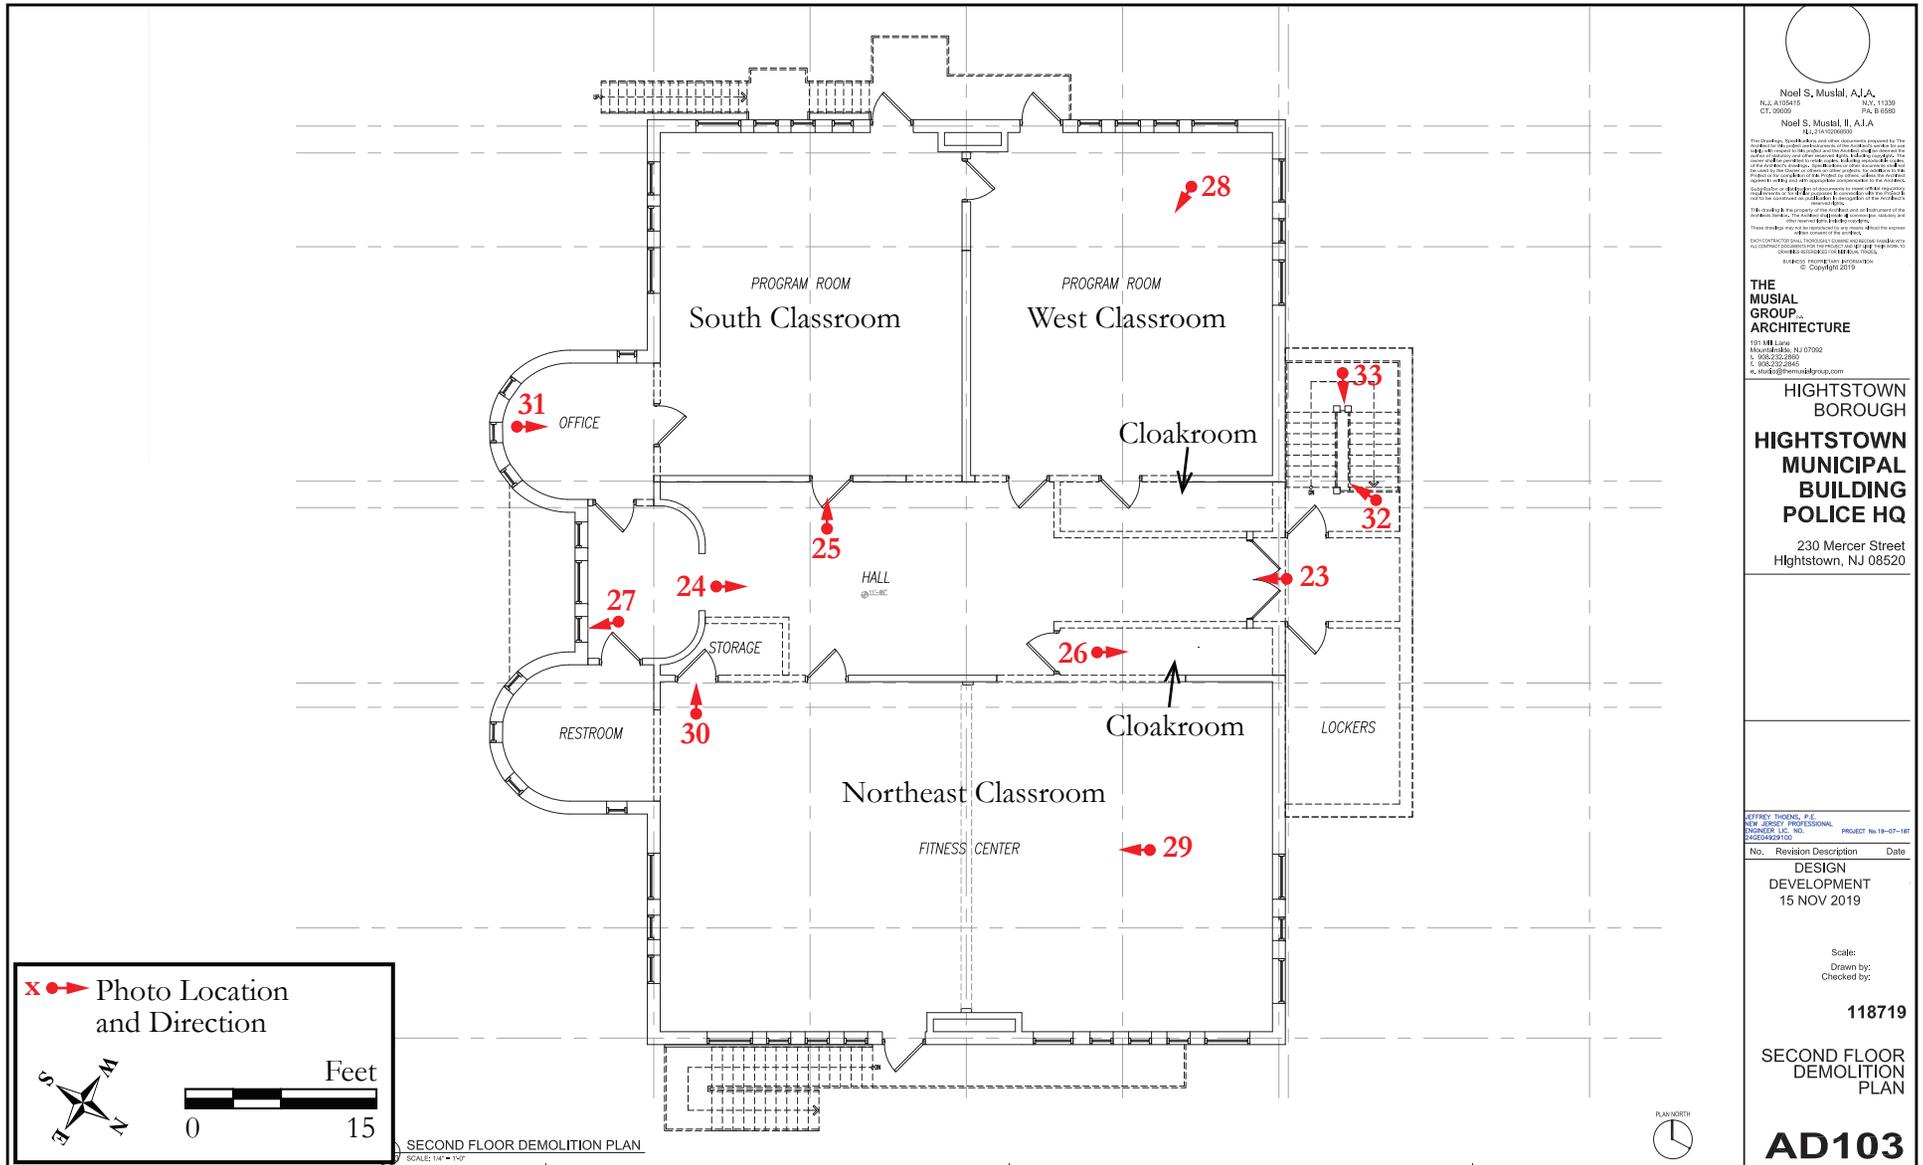
Floor Plan – Second Floor.

The second floor consists of a center hall with classrooms on either side, rooms in the towers along the southeast elevation, and a locker room in the stair tower section (Plates 23 to 33). Common features of the second floor include an acoustical tile ceiling, plastered walls with wainscoting, and a tile floor. The ceiling tile was installed over baffle grates in the ceiling that helped to ventilate the rooms by removing heated air during warm days. All windows are late twentieth-century replacement one-over-one units with modern sash locks or glass block windows on the rear elevation, with a single original window discussed below. Doors on the second floor include some original batten units accessing storage areas, a mid-twentieth-century louver door accessing a storage area, and flush metal doors dating to the mid- to late twentieth century (some with inset lights). Most modern doors feature knobs made of nickel. The classrooms retain vestigial chalk ledges indicating the original location of blackboards. Finally, decorative iron registers were returns for the heating system; original radiators along the outer walls that delivered heated air in the winter months are mostly boxed in.

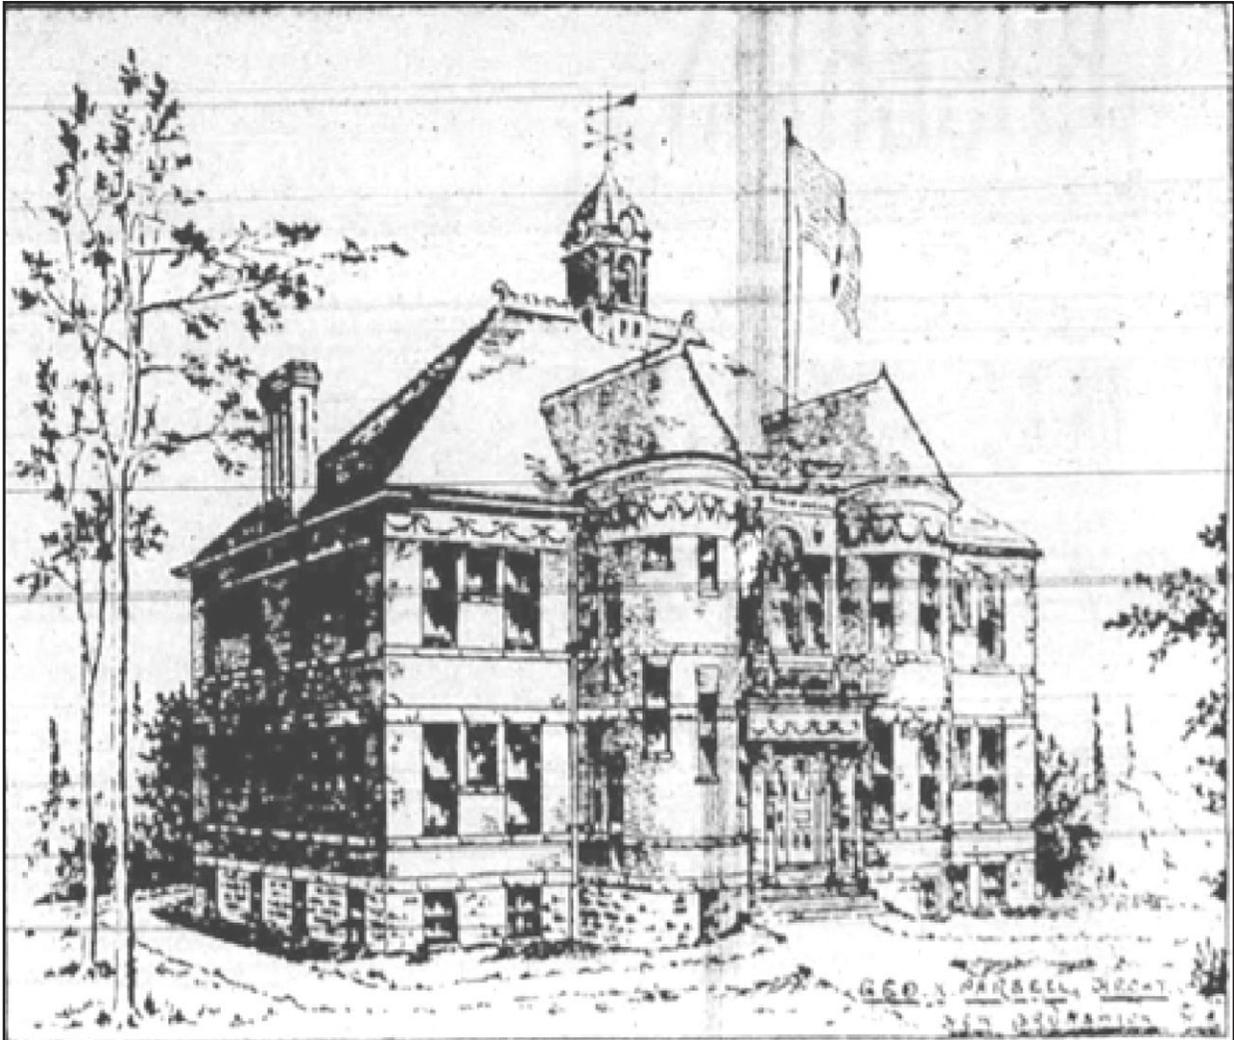
The Mercer Street Schoolhouse was built in the fall of 1894 and opened in January 1895 (Figures 4 to 7). It was built closer to Mercer Street than the Academy in order to provide a larger recreational area behind the schoolhouse. The 1852 bell was retained and was placed in the cupola of the new schoolhouse. Parsell produced a proposed sketch of the schoolhouse (Figure 4). Daniel Whitlock of New Brunswick won the contract to build the building. The cost of the building was \$12,000. During construction, architect Parsell simplified portions of the plans to save money, and a newspaper article stated that most of the planned decorative elements were omitted from the building (*Hightstown Gazette*, 3 January 1895).

Figure 4: Original sketch of the schoolhouse drawn by architect George K. Parsell (Hightstown Historical Society).

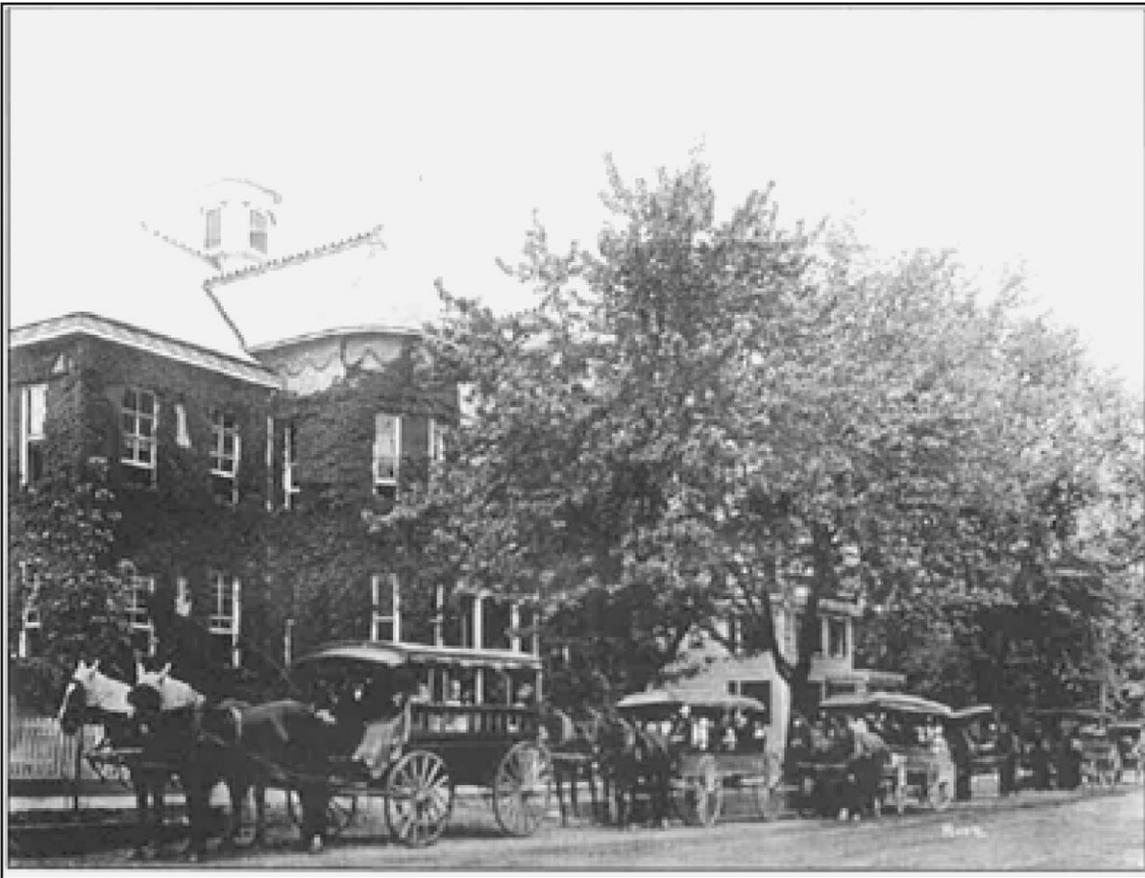
Scattered newspaper articles provide some context for the students' experience in the Mercer Street School. In the early years, school wagons delivered students; these horse-drawn wagons had two long rows of six seats (see Figure 5). The wagon servicing Perrineville was hit by a train in 1914 while bringing students to the Mercer Street School, injuring nine children (*Philadelphia Inquirer*, 6 November 1914:11).

Figure 5: Early twentieth-century photograph of the schoolhouse with horse wagons standing along Mercer Street (Hightstown Historical Society).

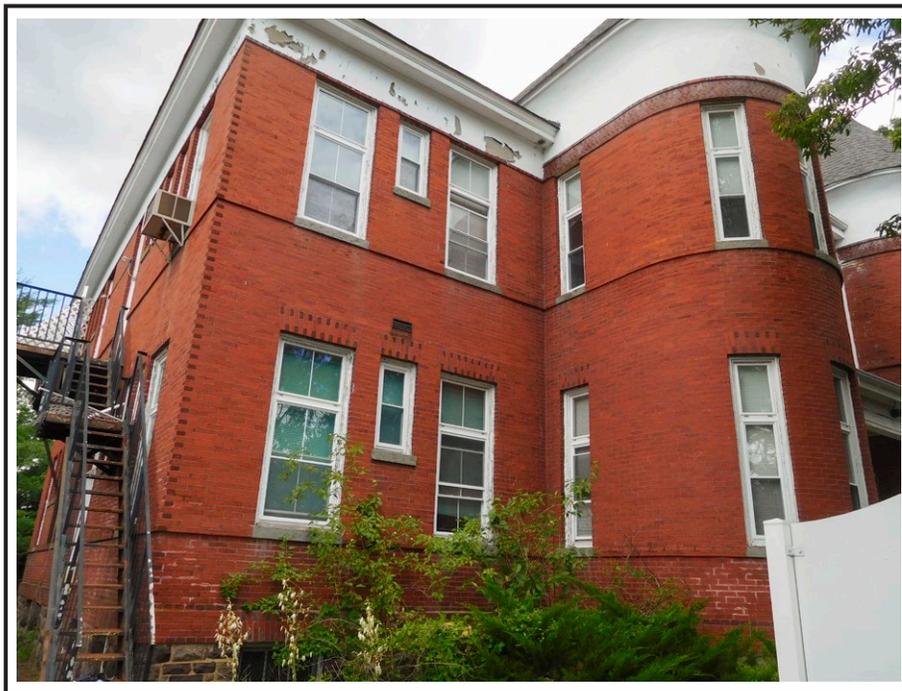
Plate: 1

Main elevation of the schoolhouse near the south corner.

The Mercer Street Schoolhouse is a two-story, seven-bay building built in 1894 with some Queen Anne style detailing but presenting an overall Colonial Revival appearance (Plates 1-12). It faces southeast onto Mercer Street. The main block of the schoolhouse has a hipped roof and two extended towers on its main (southeast) elevation, plus a stair section on its rear (northwest) elevation. The main block has the overall dimensions of 75 by 55 feet. Its hipped roof is clad with asphalt shingles; the short ridge originally featured a cupola that no longer survives. The eaves of the schoolhouse were altered when the original interior gutter system was sealed, leaving a molded cornice extending over a frieze board. A decorative interior brick chimney, now parged, is located along the northeast wall (Plate 7); a similar chimney along the southwest elevation has been reduced below the roofline. On the rear elevation, a hipped roof dormer has widely overhanging eaves and a louver on its primary face; it is located just above the ridge of the stair tower section (Plate 8).

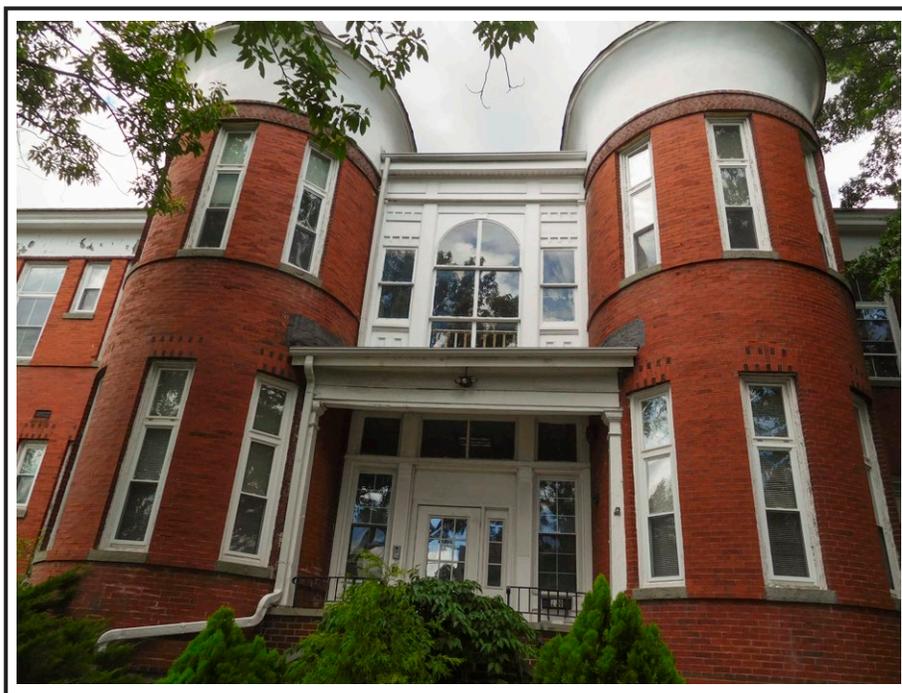
Plate: 2

Center of main elevation of the schoolhouse.

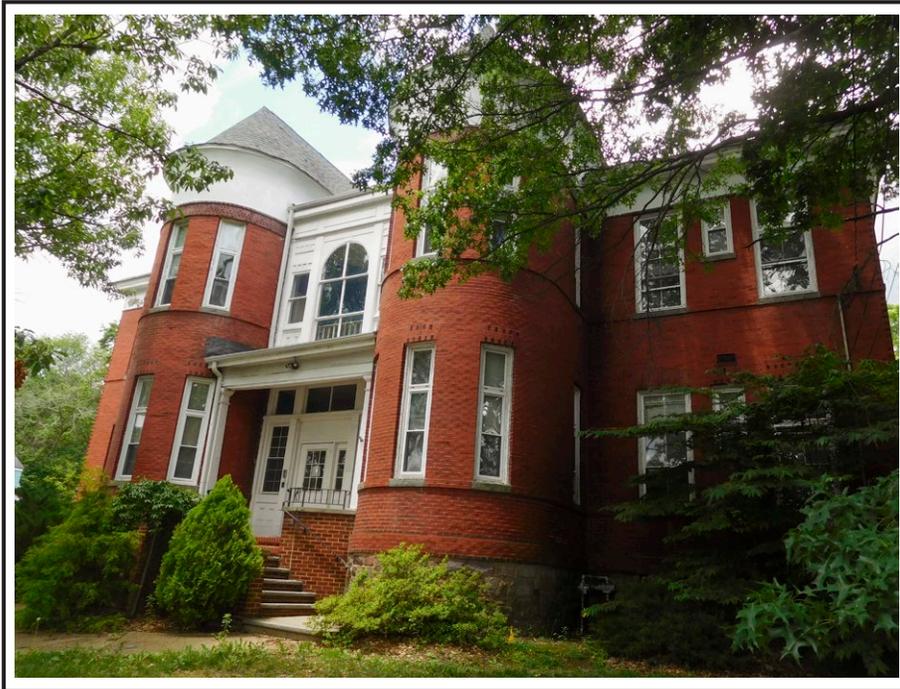
Plate: 3

Main elevation of schoolhouse.

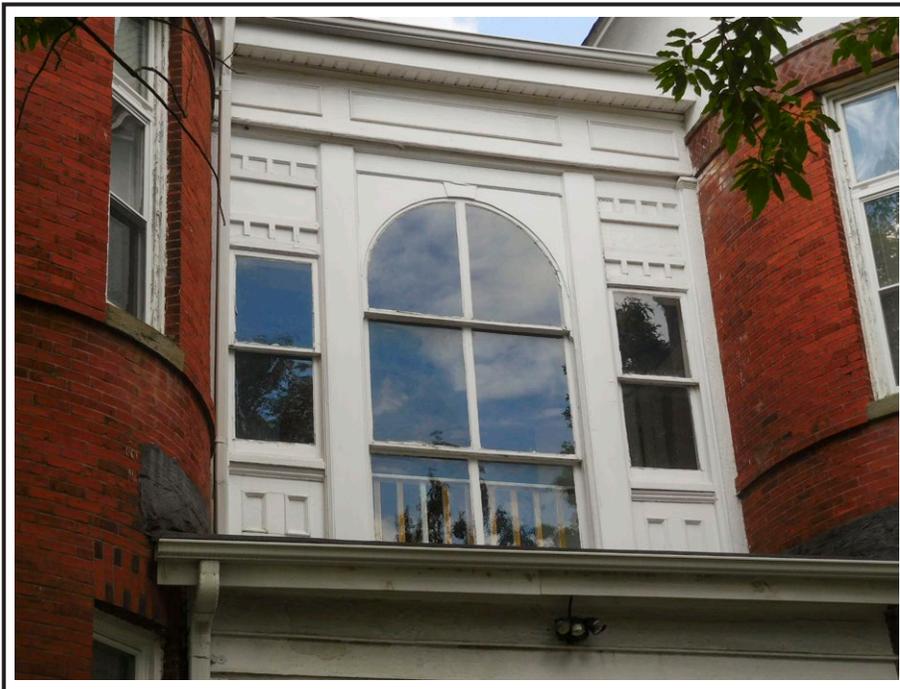
Plate: 4

Detail of the Palladian-like window in the center of the main elevation of the schoolhouse.

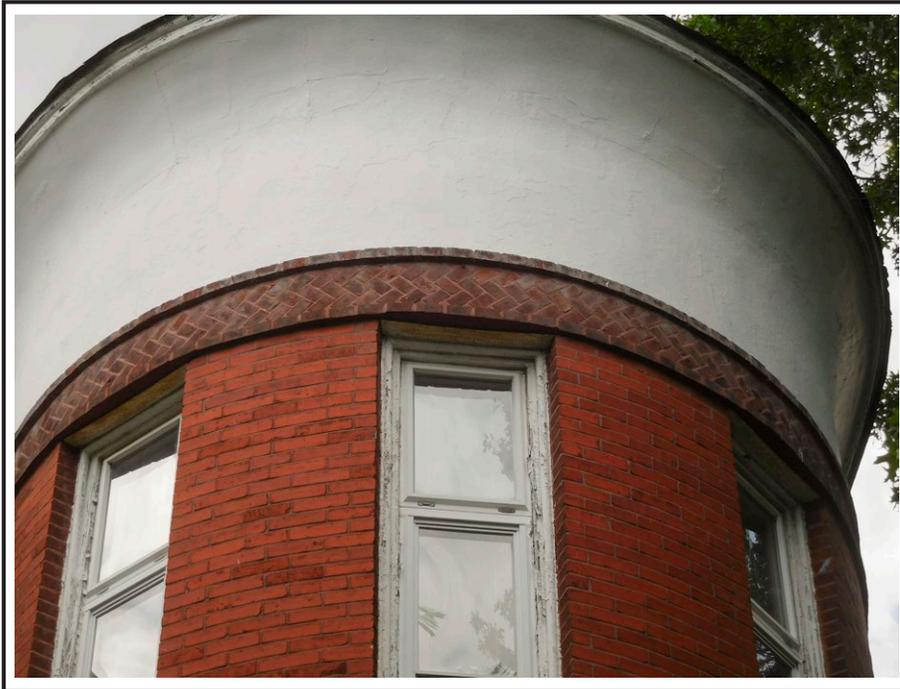
Plate: 5

Detail of the concave frieze area of the front towers.

The towers, which mirror each other, have the footprint of an elongated D. The conical roof sits on a concave frieze that originally featured plaster garlands. Below this frieze is a brick band consisting of a herring bone pattern in the center, flanked by header courses above and below (Plate 5). Each tower has three narrow windows, currently with a fixed upper sash over a double hung one-over-one sash. The platbands of the main block of the building wrap around the towers as well. Like the main block of the building, the towers have a stone foundation.

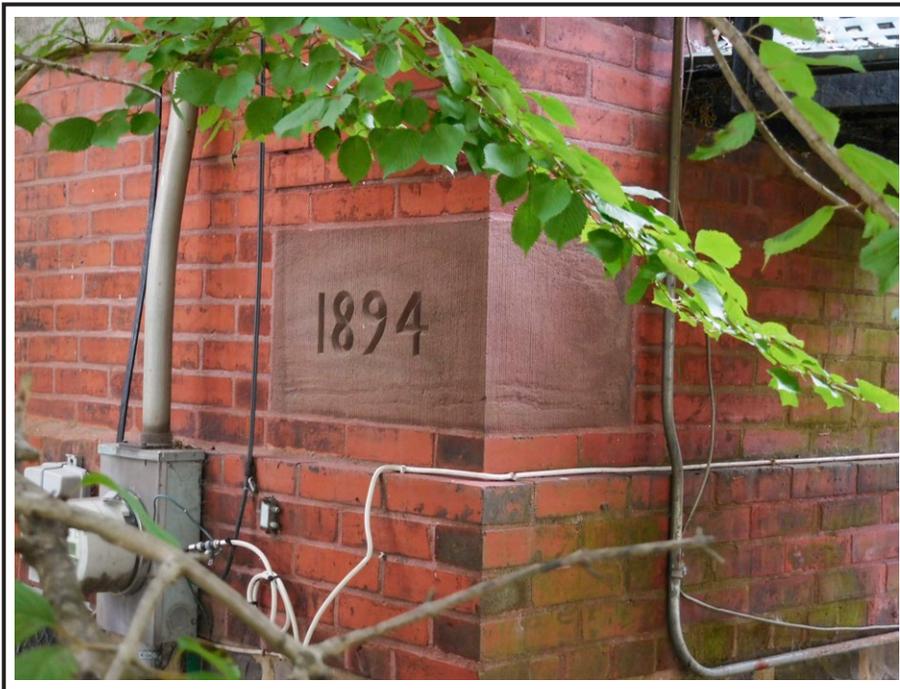
Plate: 6

Detail of the datestone, found on the main elevation near the east corner.

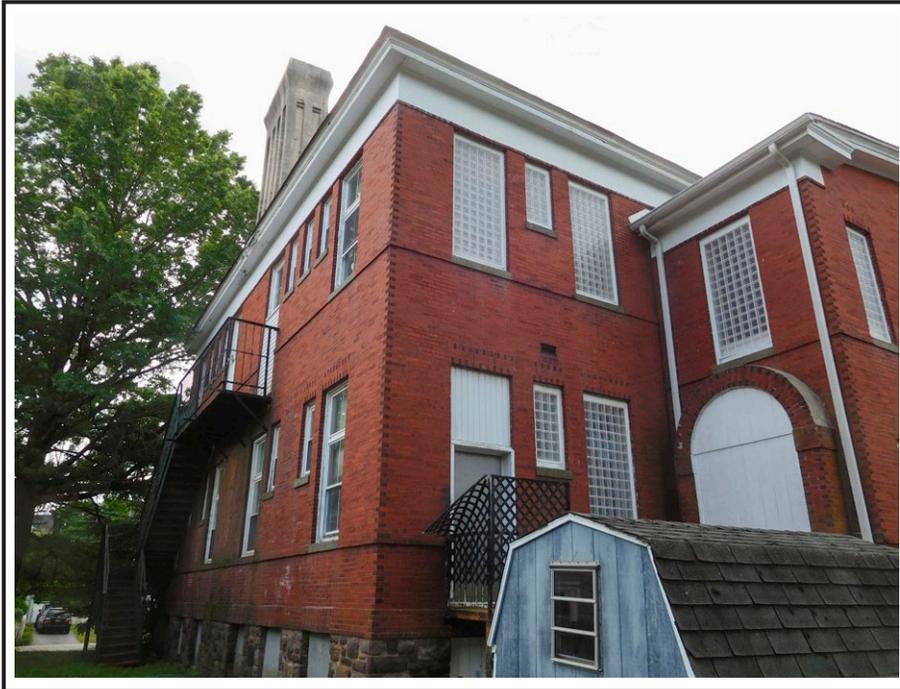
Plate: 7

Northeast elevation of schoolhouse (left) and rear (right), showing the sealed girls' entrance on the stair tower section.

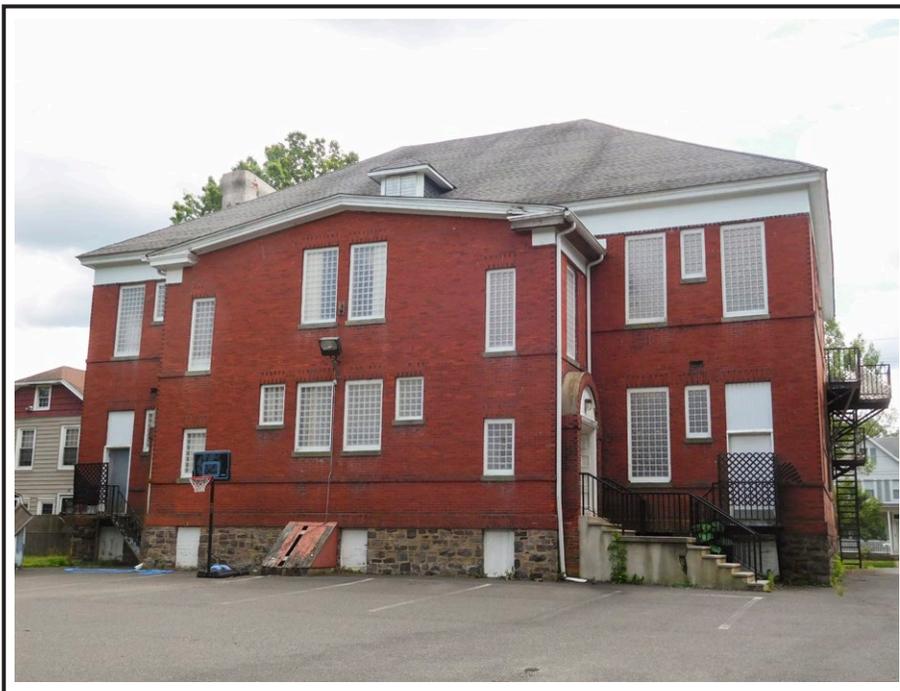
Plate: 8

The rear (northwest) elevation features the glass block windows and sealed doors near the outer corners (Plate 8). On either side of the stair tower section, smaller windows are located between larger windows on each floor level. Metal landings for the sealed doors access stairs leading down to the rear parking lot.

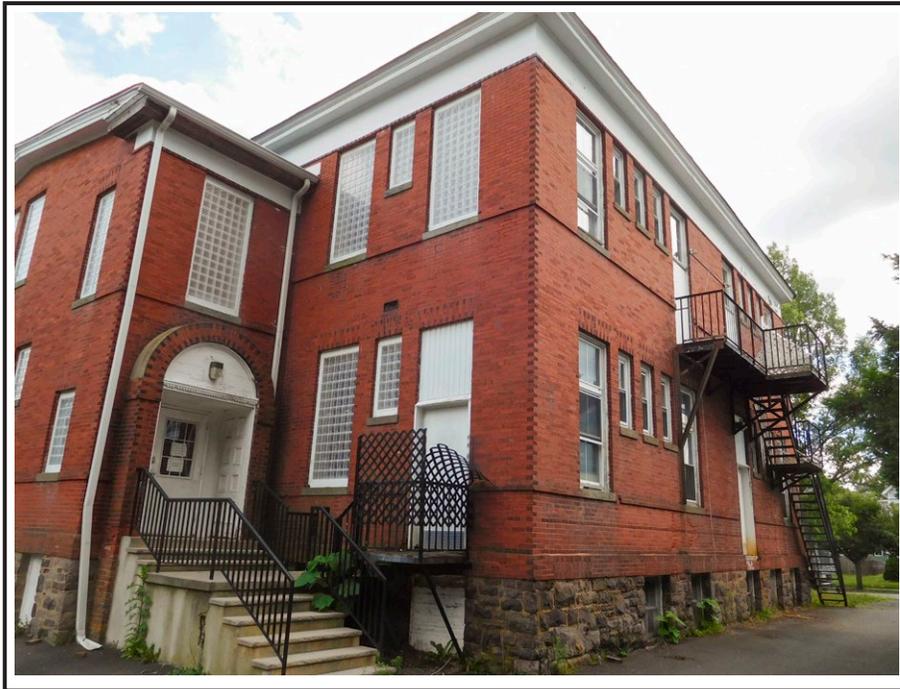
West corner of schoolhouse, with the original boys' entrance into the stair tower section (left) and the southwest elevation of the main block (right).

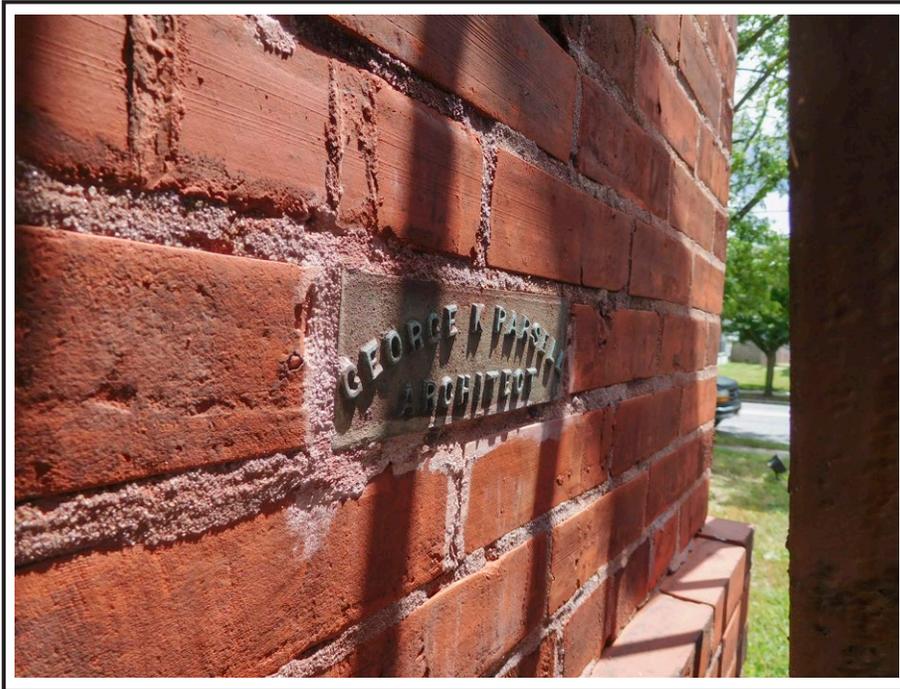
Plate: 11

Metal plaque on southwest wall of schoolhouse with name of architect (George K. Parsell).

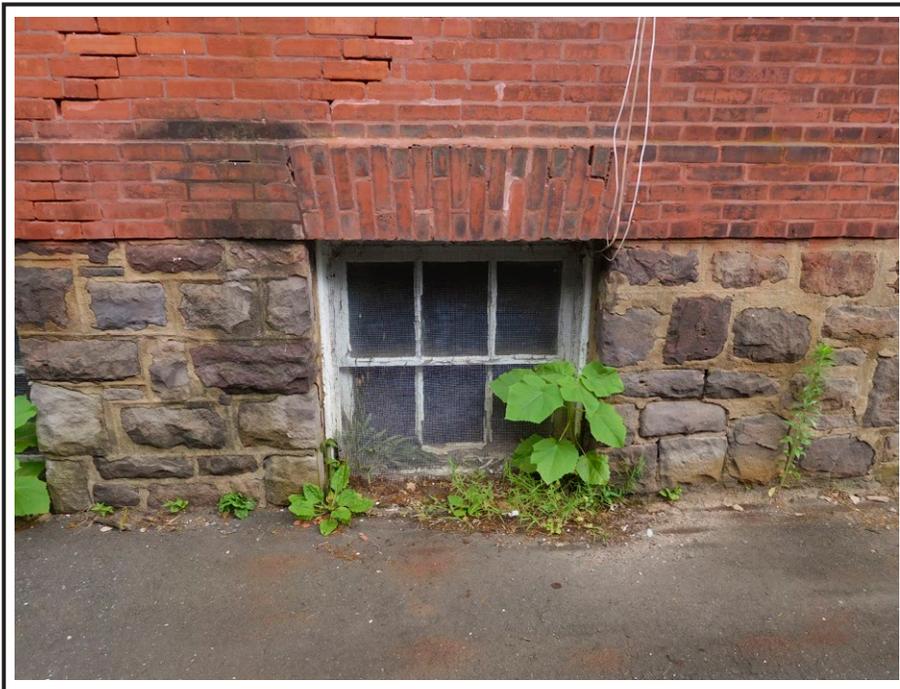
Plate: 12

Original basement window on southwest elevation of schoolhouse.

The walls of the schoolhouse are brick, laid in common bond with only a few headers, including a header course below the frieze and one atop the stone foundation. Narrow platbands extend along the window sills of the first and second floors. A small number of bricks feature glazed headers, particularly when the headers are visible at the corners. Windows are replacement units, with three primary sizes. The larger windows on the main elevation consist of a fixed two-light transom over a double hung two-over-two sash unit, with these sashes occupying the location of the original four-over-four windows. The smaller windows on the main elevation are replacement one-over-one units. On the rear (northwest) elevation, most window sashes have been removed to make way for glass block infill. Windows have a stone sill, and first floor and basement windows have a splayed brick lintel. The schoolhouse has a semi-coursed stone foundation with three-over-three basement windows that are mostly original though many are sealed (Plate 12).

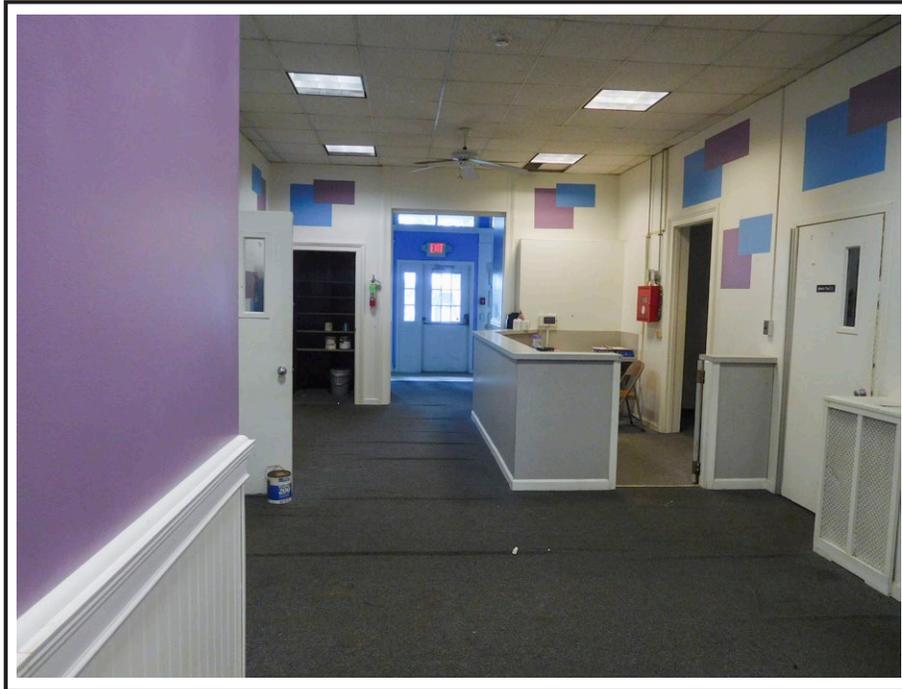
Plate: 13

First floor, center hall, as viewed from the doors off the stair tower.

The first floor was partially reconfigured in at least two campaigns in the twentieth century; its original appearance was similar to the current second floor plan (Plates 13 to 22). Today the first floor has a modified center hall plan, with classrooms flanking the center hall and offices in the towers. Common first floor features include an acoustical tile ceiling, plastered walls with wainscoting, and tile over narrow hardwood floor. Windows (as mentioned) are either replacement one-over-one units or replacement glass block units. Doors are mostly flush metal doors with brass or nickel knobs; two original doors built with five cross-panels survive on the first floor. Boxed-in radiators are located along the outer walls of the floor level.
