Re: Intensive-level Historic Architectural Survey, 230 Mercer Street (Block 60, Lot 16), Borough of Hightstown, Mercer County, New Jersey (HPO Project #19-2807)

Property Name: Mercer Street School

Survey Name: Intensive-level Historic Architectural Survey, Mercer Street School

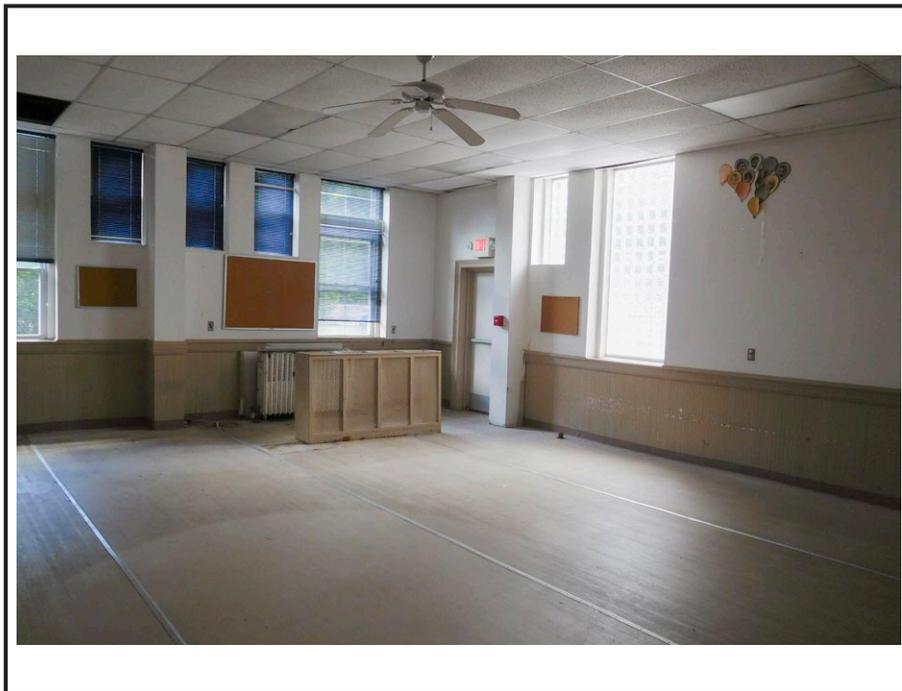
Plate: 15

West classroom, first floor, as viewed from the door off the center hall.

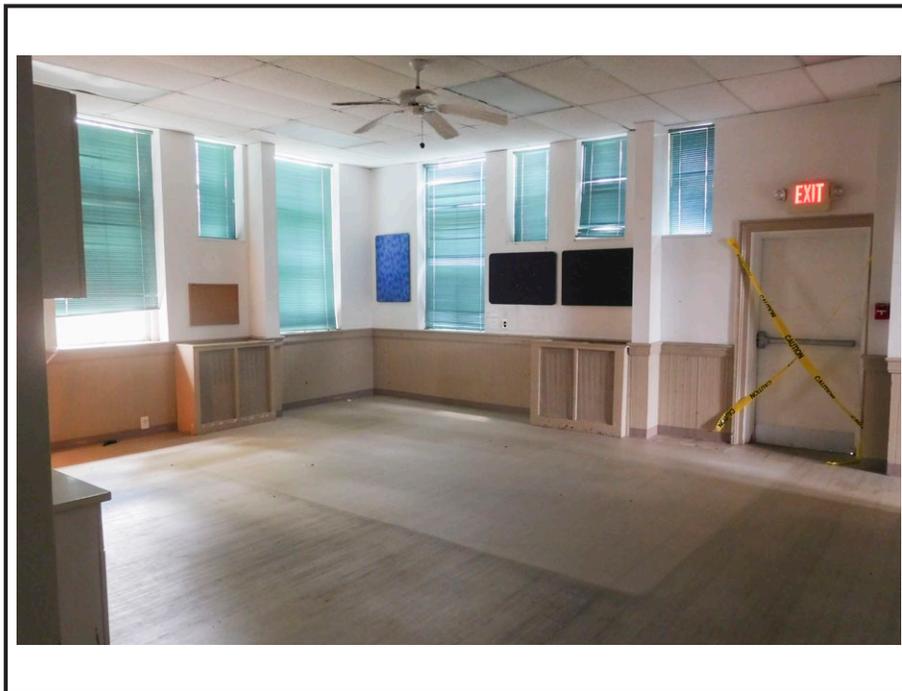
Plate: 18

South classroom, first floor, as viewed from the entrance off the center hall.

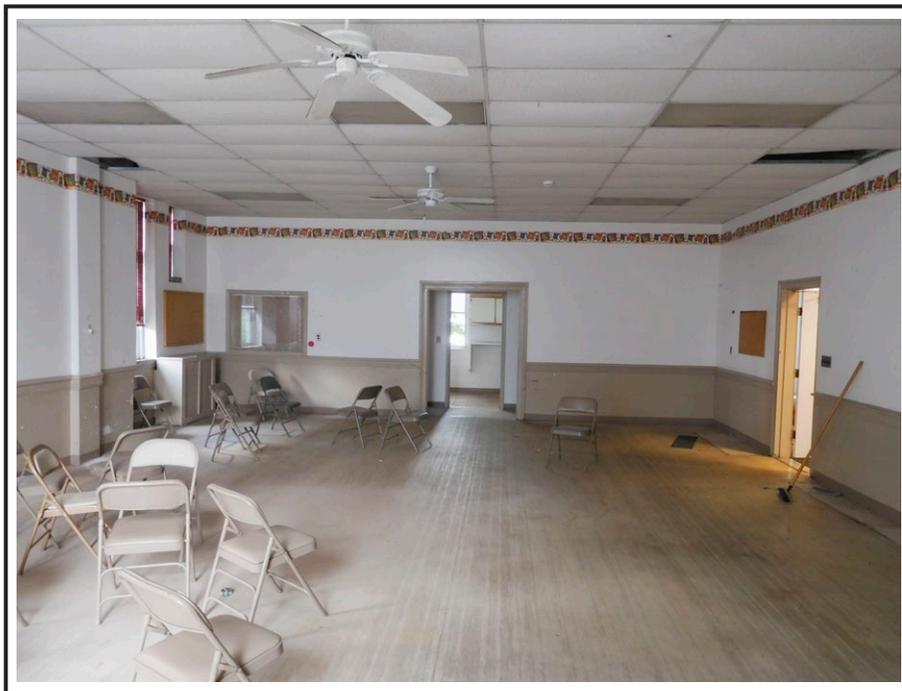
Plate: 19

The northeast side of the center hall contains one large classroom and a late twentieth-century office suite partitioned off the southeast end (Plates 19 and 20). Originally, two classrooms occupied this portion of the building, but the rooms were merged when the Masonic lodge created a banquet room and kitchen here. The current classroom has a tile ceiling, plastered walls with a beadboard wainscoting, and narrow hardwood flooring. On the northwest wall, a metal slab door near the north corner provides the only exterior access. On the southwest wall, an original five cross-paneled door with a brass knob and door plate accesses the cloakroom, a narrow space partitioned from the center hall with coat hooks on the plastered walls leading to an original batten door in the far end that accessed a shallow

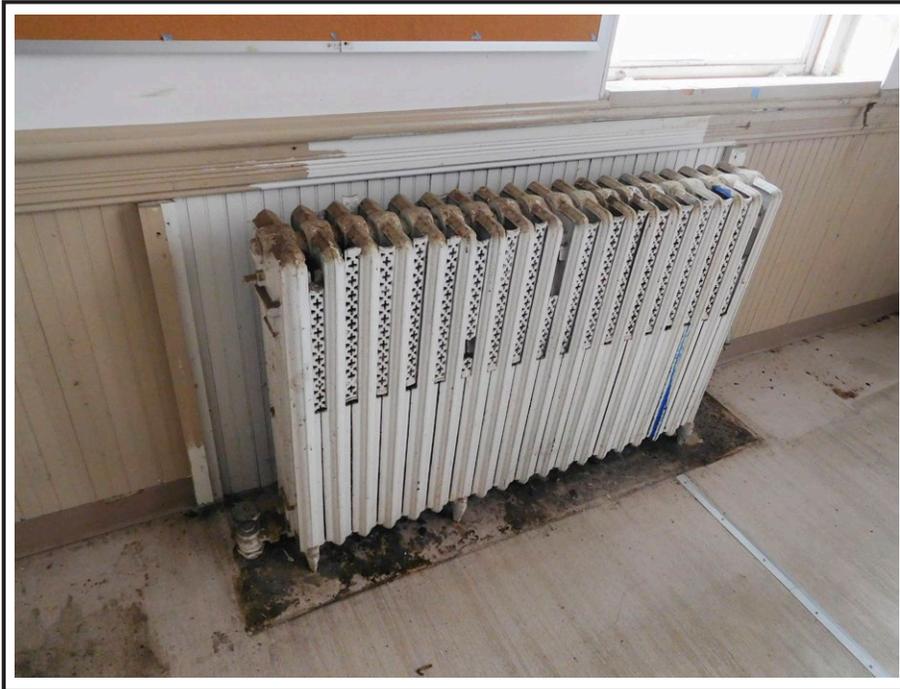
Plate: 20

Original radiator in the northeast classroom, first floor, located along the northeast wall.

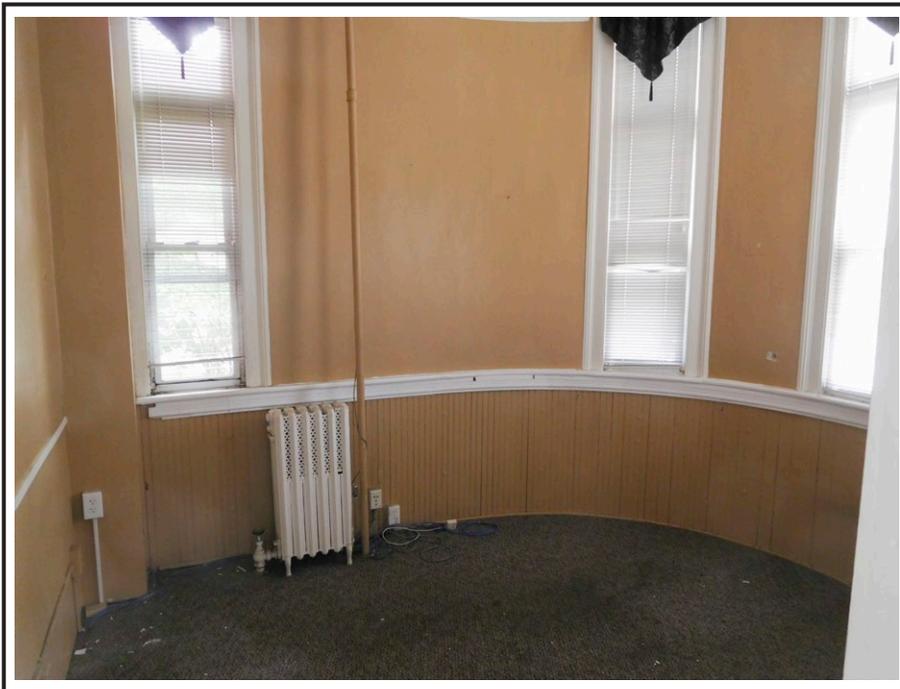
Plate: 21

The two offices in the towers have an elongated D-shaped footprint and are accessed from the southeast end of the center hall (Plate 21). The northeast office is painted beige, while the southeast office is painted white. Both rooms have a plastered ceiling and walls, beadboard wainscoting, and carpeted floors. A ledge on the northwest wall of the southeast office indicates that a small blackboard was originally located here (like the one surviving in place on the second floor).

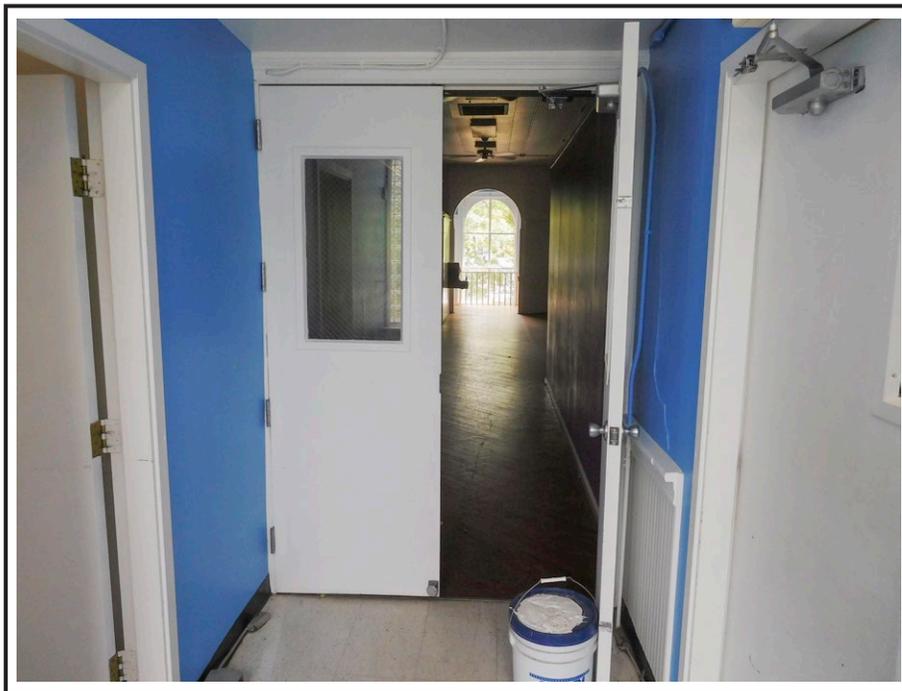
Plate: 23

Two-leaf entrance to the second floor center hall from the stair tower.

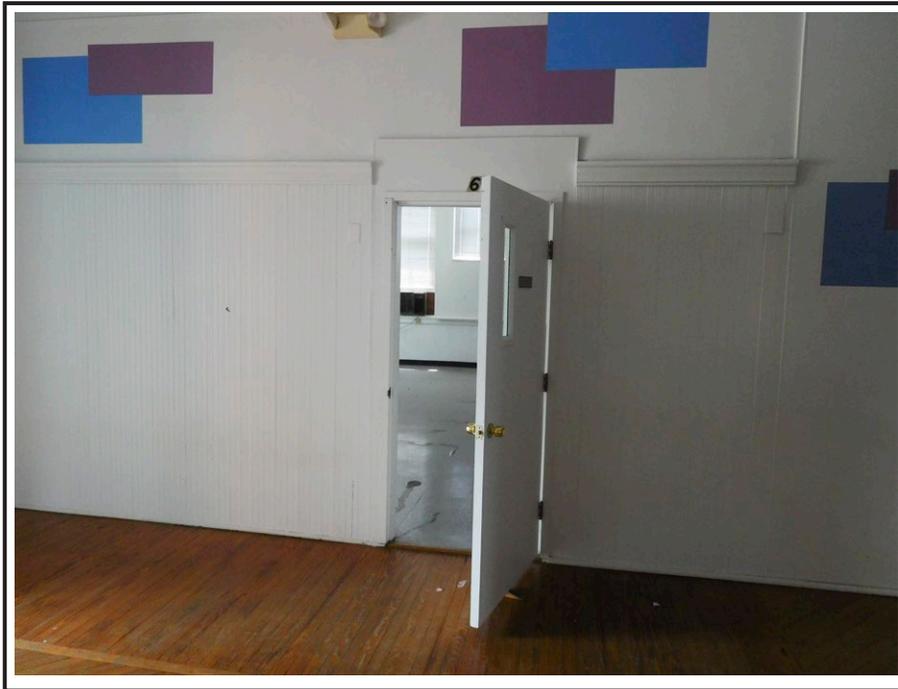
Plate: 25

Detail of the southwest wall of the center hall, second floor, showing the elevated wainscoting that was originally found inside a cloakroom.

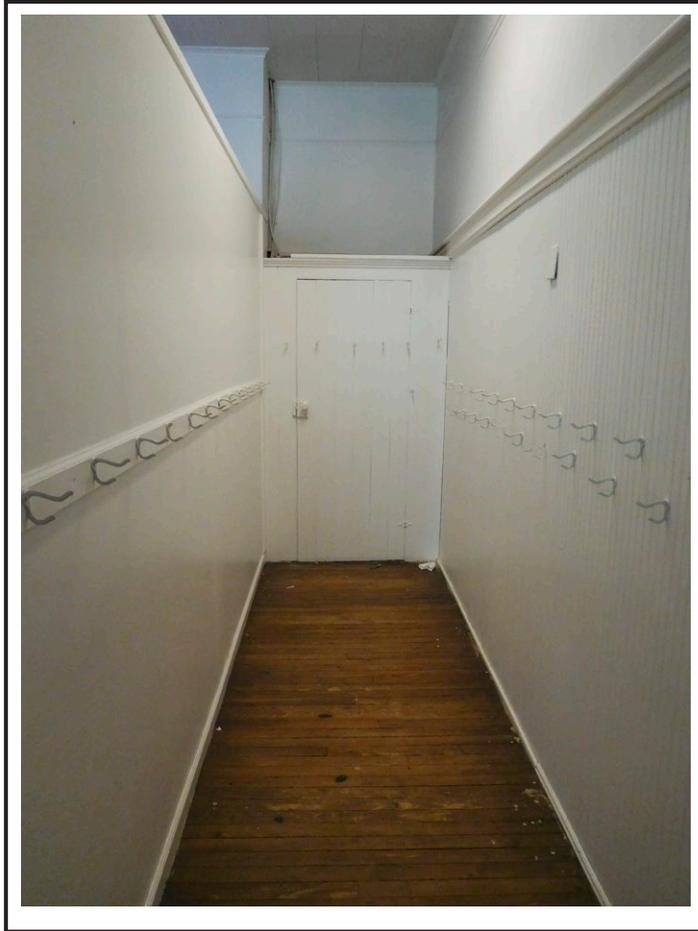
Plate: 26

The center hall is the location of three cloakroom/storage areas, each without a ceiling to permit ambient light from above (Plate 26). The long, narrow cloakrooms flank each other near the northwest end of the hall. A modern slab door with a brass knob accesses the one off the center hall (northeast side), opening into an area with coat hooks along the long side walls, including a vertical beadboard wall to the northeast and a plastered wall to the southwest. A batten door operated by a cast metal knob and a cast iron rim lock secures a closet in the end of the room. The opposite cloakroom is accessed from the west classroom, and its interior is described there. A reduced storage room in the southeast corner of the center hall is accessed from the northwest classroom and is described with that room.

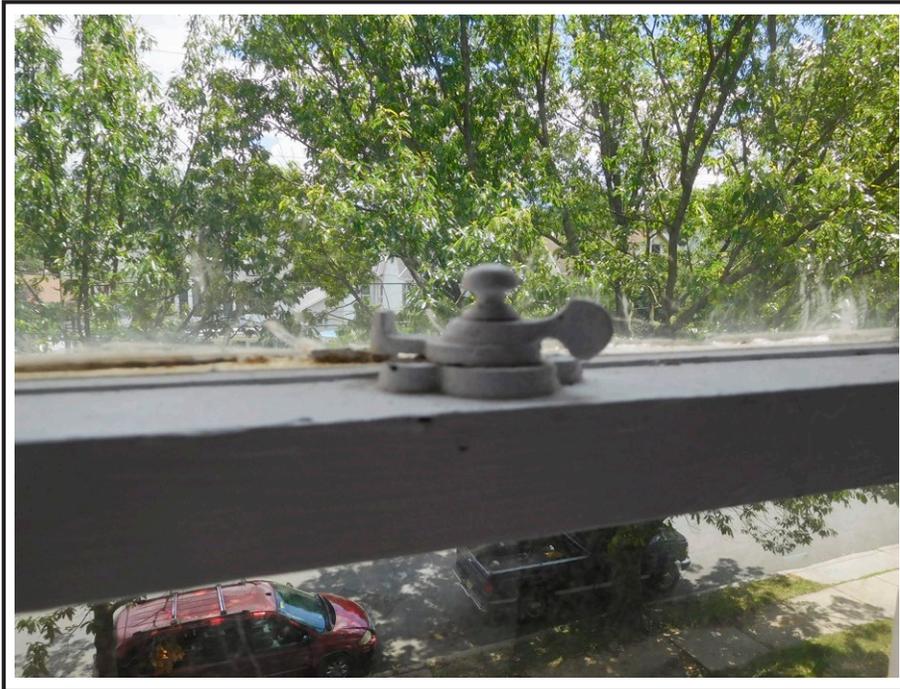
Plate: 27

Original sash lock on Palladian-like window at southeast end of second floor center hall.

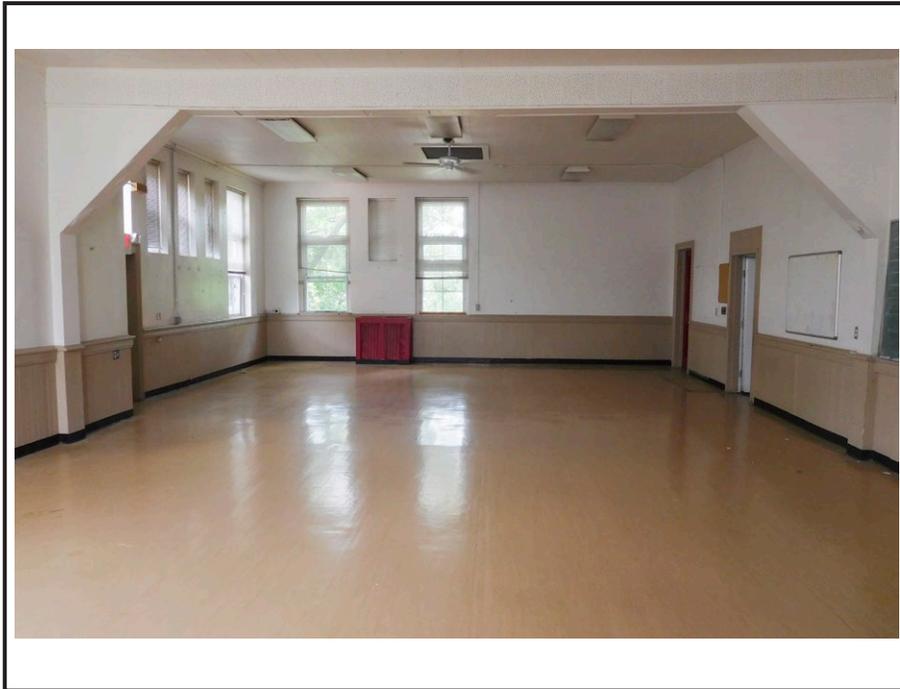
Plate: 29

The northeast classroom occupies the space on the northeast side of the center hall; it was originally two rooms, and remnants of that partition wall survive (Plate 29). A blackboard survives on the southwest wall, but it is now located where the door to the cloakroom was originally located. Materials are the same as found in other classrooms. A flush metal door on the northeast elevation leads to the fire escape system. A mid-twentieth-century louver door operated by a brass knob accesses the former cloakroom partitioned from the center hall (Plate 30); the room retains the characteristics mentioned earlier for the cloakrooms, including a batten door at the end operated by a cast iron rim lock that has lost its knob.

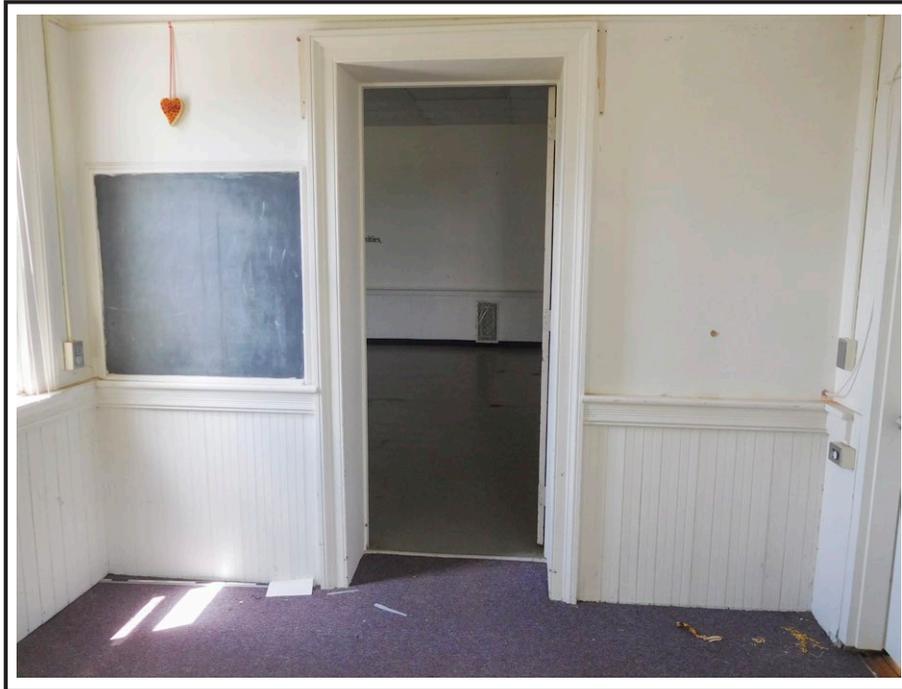
Plate: 31

South office, second floor, showing the small blackboard and the door to the south classroom.

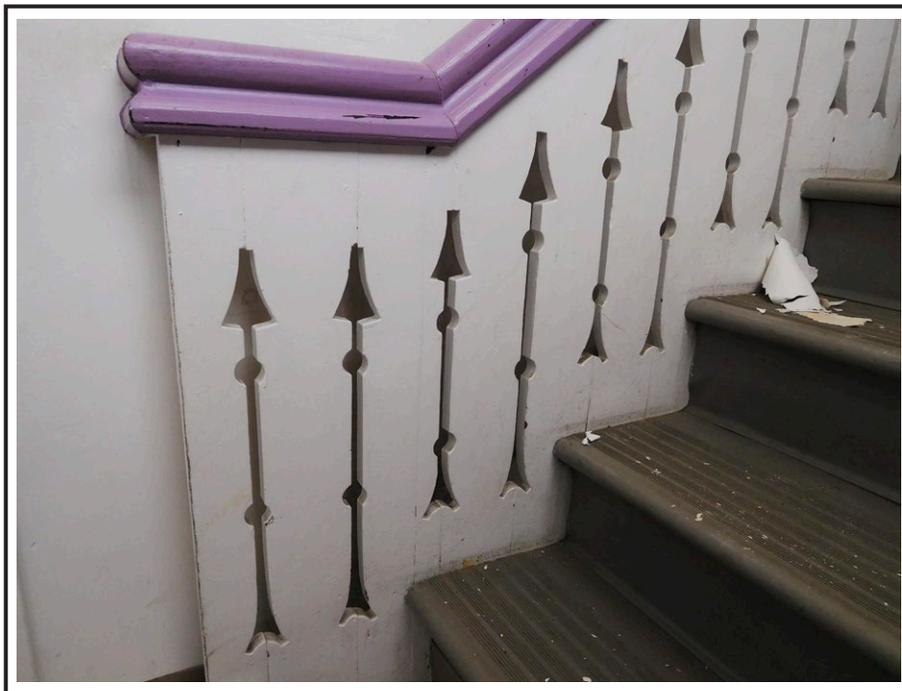
Plate: 32

Railing and banister of stairs with the jigsaw cutouts in the shape of an arrow.

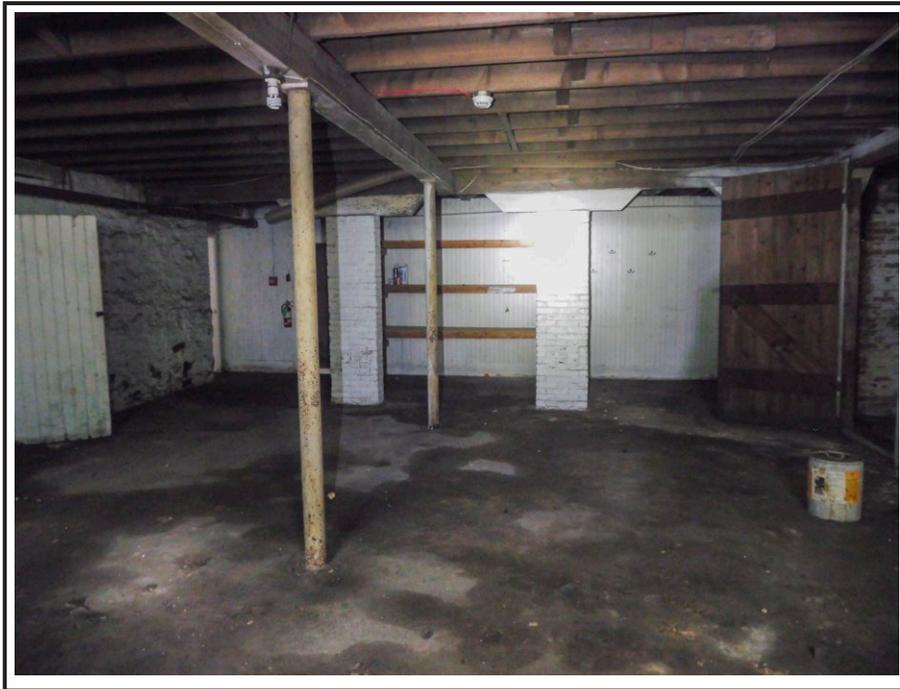
Plate: 34

The basement level consists of a grouping of unfinished spaces created by partitions installed circa 1925 when interior toilets were installed to replace the original freestanding privies behind the school building (Plate 34). The basement level was originally a primarily freespan space; the inserted partitions include a center beadboard wall and some terra cotta block walls in the northeast half.
