IMPROVEMENTS TO LINCOLN AVENUE, HAGEMOUNT AVENUE AND ROCKY BROOK COURT BOROUGH OF HIGHTSTOWN, MERCER COUNTY, NEW JERSEY

THIS PROJECT IS FUNDED THROUGH THE NJDOT MUNICIPAL AID FY2018 GRANT

- REQUESTED AMOUNT: \$749,032.00
- GRANT AMOUNT: \$746,500.00
- SCOPE OF WORK:
 - CURB
 - SIDEWALK
 - ADA CURB RAMPS
 - NEW SIGNAGE
 - MILL AND PAVEMENT OVERLAY WITH PAVEMENT REPAIRS
 - WATER AND SEWER IMPROVEMENTS
 - STORMWATER IMPROVEMENTS

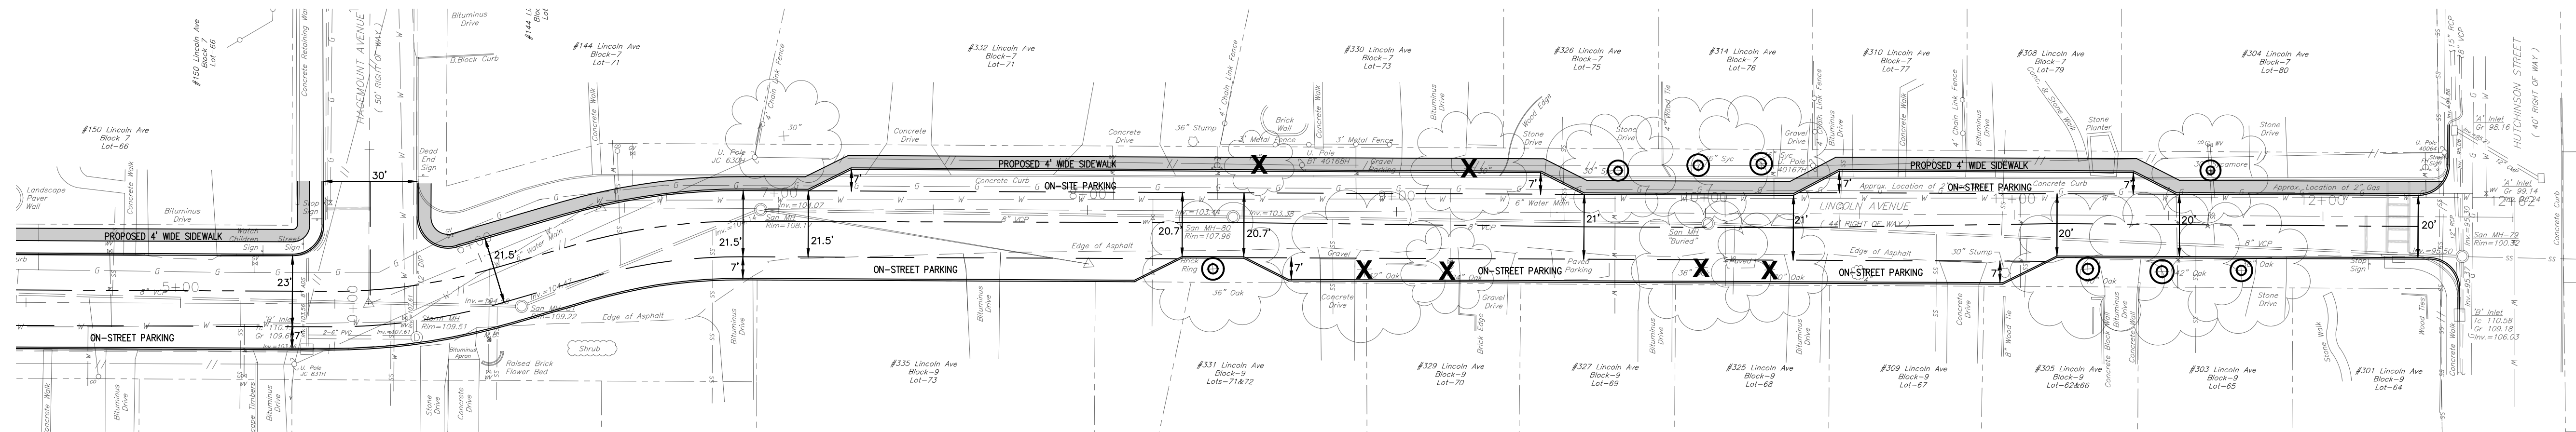
PLAN A - 21' CARTWAY WITH PARKING ON NORTH AND SOUTH SIDES

NOTE: THIS PLAN PROPOSES INSTALLATION OF 4' WIDE SIDEWALK ON THE NORTH SIDE OF LINCOLN AVENUE AND FULL REPLACEMENT OF THE NORTH AND SOUTH CURBLINES. THERE IS PROPOSED PARKING ON THE NORTH AND SOUTH SIDES. THE ROAD WIDTH VARIES FROM 20' TO 23'.

PLAN B AVOIDS REMOVAL OF THE ABOVE 7 INDICATED TREES. IT IS EXPECTED THAT THERE WILL BE DAMAGE TO THE TREES WHICH ARE TO REMAIN.

NOTE: THE CONCEPT LAYOUTS SHOWN ON THIS PLAN ARE BASED ON A TREE EVALUATION BY D. ZAISER OF THE BOROUGH ENVIRONMENTAL COMMISSION AS OUTLINED IN A MEMO DATED JUNE 24, 2018.

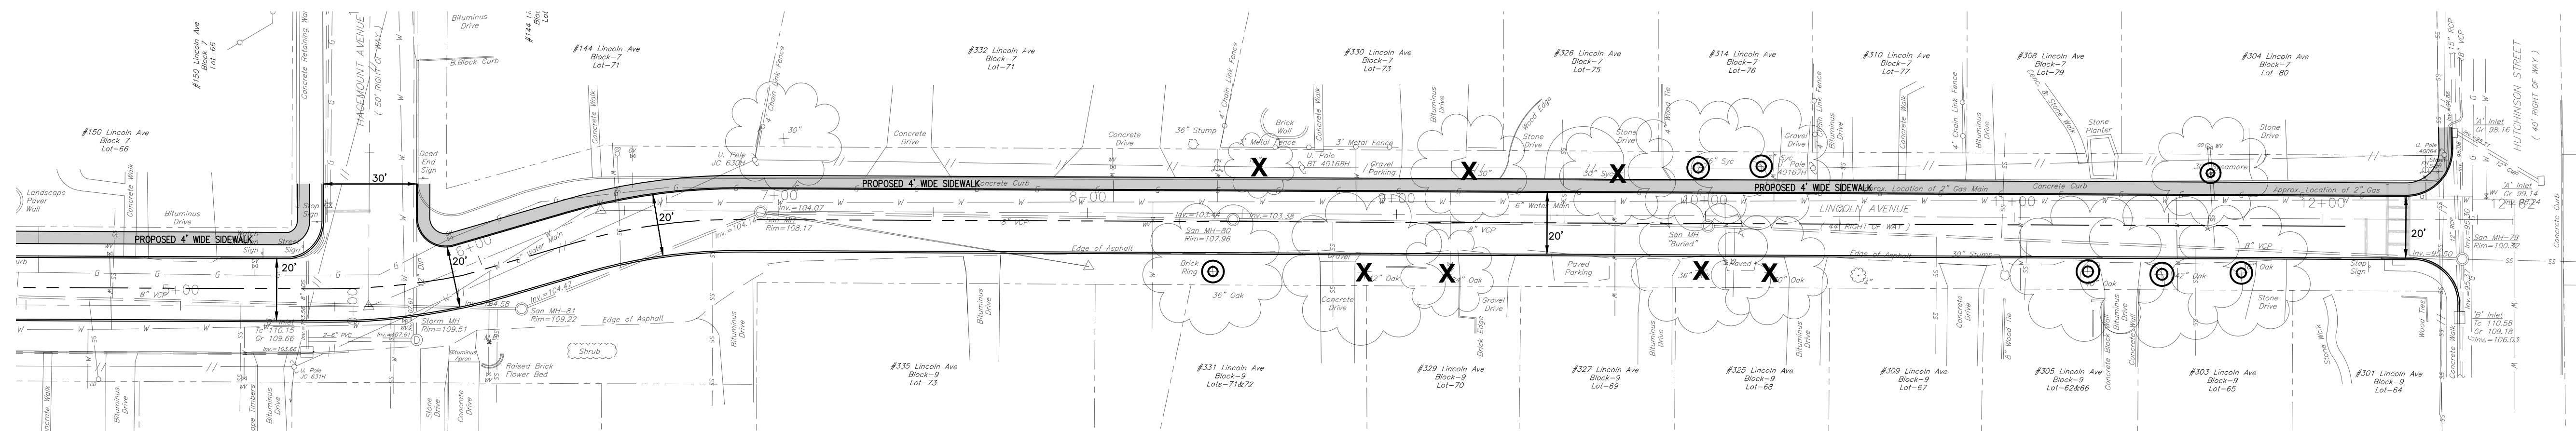
PLAN B - 20' CARTWAY WITH NO PARKING, TREE REMOVAL

NOTE: THIS PLAN PROPOSES INSTALLATION OF 4' WIDE SIDEWALK ON THE NORTH SIDE OF LINCOLN AVENUE AND FULL REPLACEMENT OF THE NORTH AND SOUTH CURBLINES. THERE IS NO PROPOSED PARKING. THE ROAD WIDTH IS 20' WIDE THROUGHOUT.

PLAN B AVOIDS REMOVAL OF THE ABOVE 7 INDICATED TREES. THE TREE AT 326 LINCOLN AVENUE WILL REQUIRE REMOVAL. IT IS EXPECTED THAT THERE WILL BE DAMAGE TO THE TREES WHICH ARE TO REMAIN.

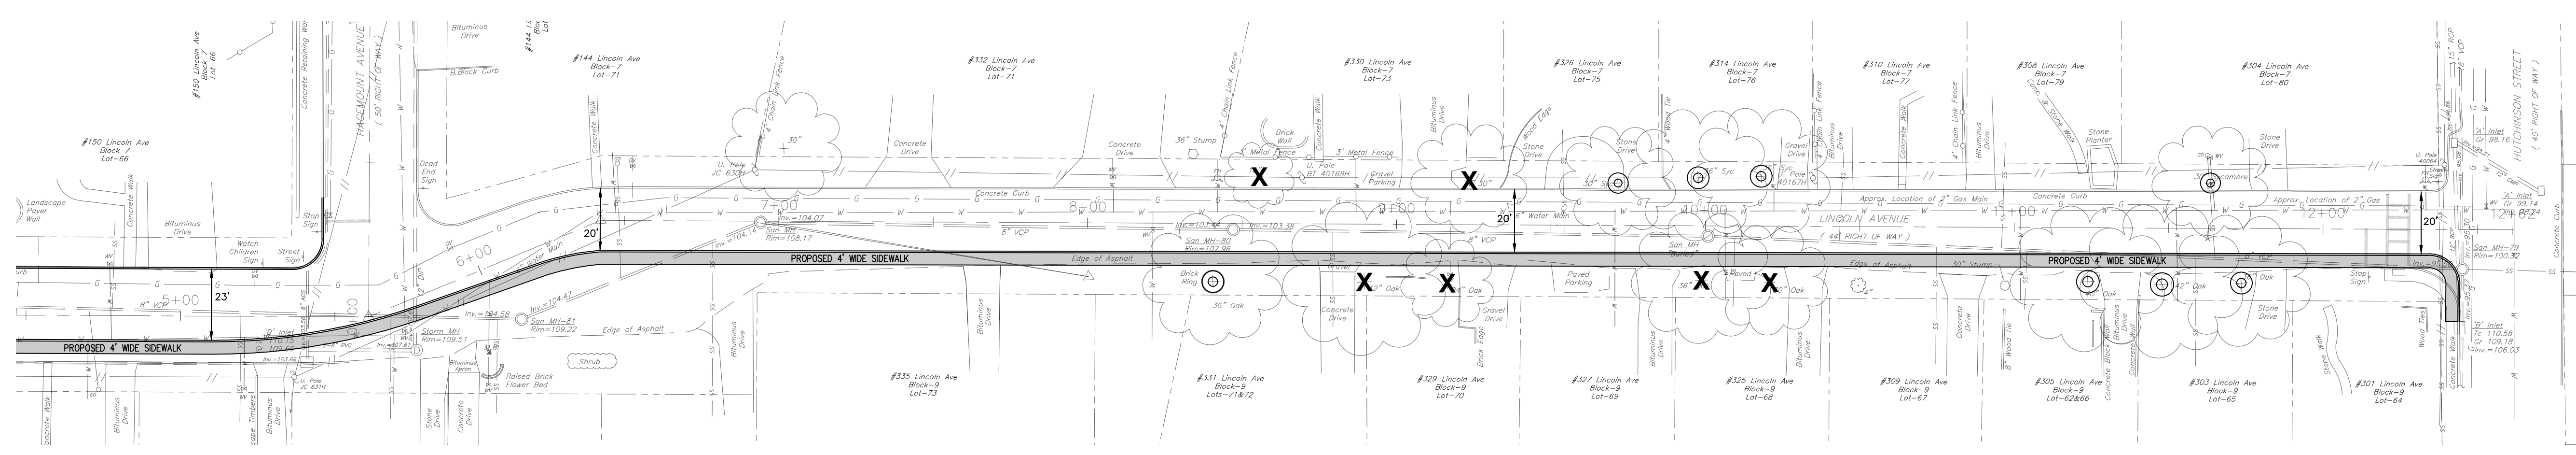
PLAN C - 20' CARTWAY WITH NO PARKING

NOTE: THIS PLAN PROPOSES INSTALLATION OF 4' WIDE SIDEWALK ON THE SOUTH SIDE OF LINCOLN AVENUE AND REPLACEMENT OF THE SOUTH CURBLINE. THERE IS NO PROPOSED PARKING. THE ROAD WIDTH IS 20' WIDE THROUGHOUT.

PLAN C AVOIDS REMOVAL OF THE ABOVE 7 INDICATED TREES. IT IS EXPECTED THAT THERE WILL BE DAMAGE TO THE TREES WHICH ARE TO REMAIN.

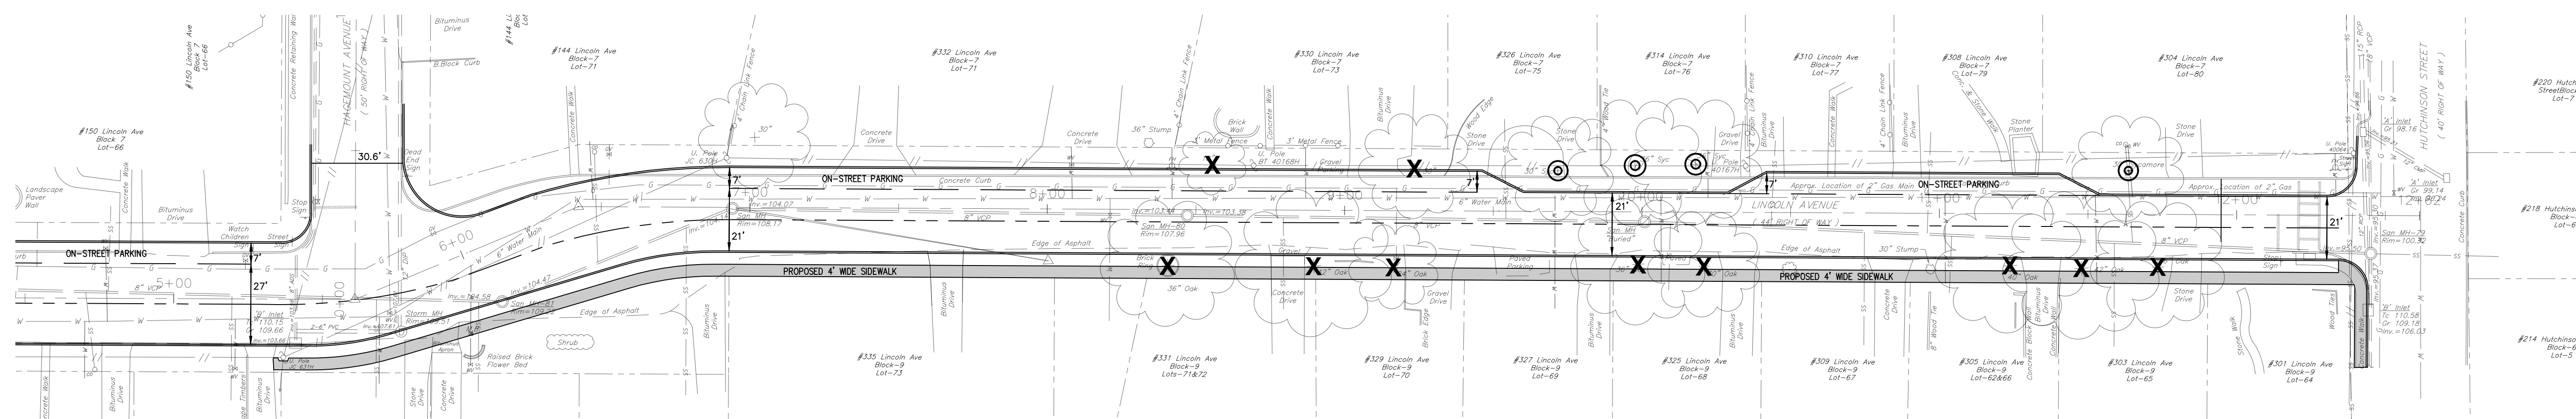
PLAN D - 21' CARTWAY WITH PARKING ON NORTH SIDE

NOTE:
THIS PLAN PROPOSES INSTALLATION OF 4' WIDE SIDEWALK WITH 4' WIDE GRASS BUFFER ON THE SOUTH SIDE OF LINCOLN AVENUE AND FULL REPLACEMENT OF THE NORTH AND SOUTH CURBLINES. THERE IS PROPOSED PARKING ON THE NORTH SIDE. THE ROAD WIDTH IS 21' WIDE THROUGHOUT.

PLAN D AVOIDS REMOVAL OF THE ABOVE 4 INDICATED TREES. IT IS EXPECTED THAT THERE WILL BE DAMAGE TO THE TREES WHICH ARE TO REMAIN.

NOTE: THE CONCEPT LAYOUTS SHOWN ON THIS PLAN ARE BASED ON A TREE EVALUATION BY JOHN STANLEY OF TIMBERWOLF TREE SERVICE, INC. IN A LETTER DATED APRIL 3, 2019.

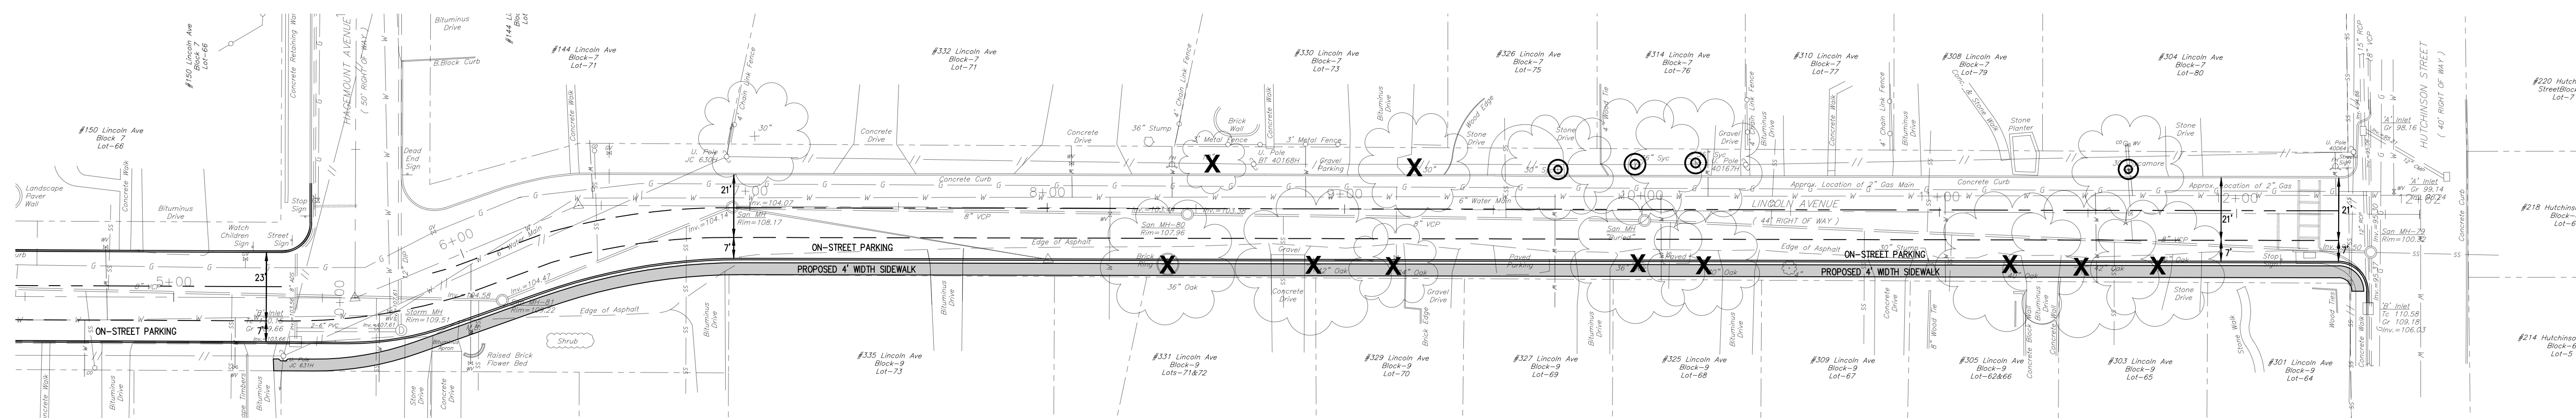
PLAN E - 21' CARTWAY WITH PARKING ON SOUTH SIDE

NOTE:
THIS PLAN PROPOSES INSTALLATION OF 4' WIDE SIDEWALK WITH 1' TO 5' WIDE GRASS BUFFER ON THE SOUTH SIDE OF LINCOLN AVENUE AND REPLACEMENT OF THE SOUTH CURBLINE. THERE IS PROPOSED PARKING THROUGHOUT THE SOUTH SIDE. THE ROAD WIDTH IS 21' WIDE THROUGHOUT.

PLAN E AVOIDS REMOVAL OF THE ABOVE 4 INDICATED TREES. IT IS EXPECTED THAT THERE WILL BE DAMAGE TO THE TREES WHICH ARE TO REMAIN.

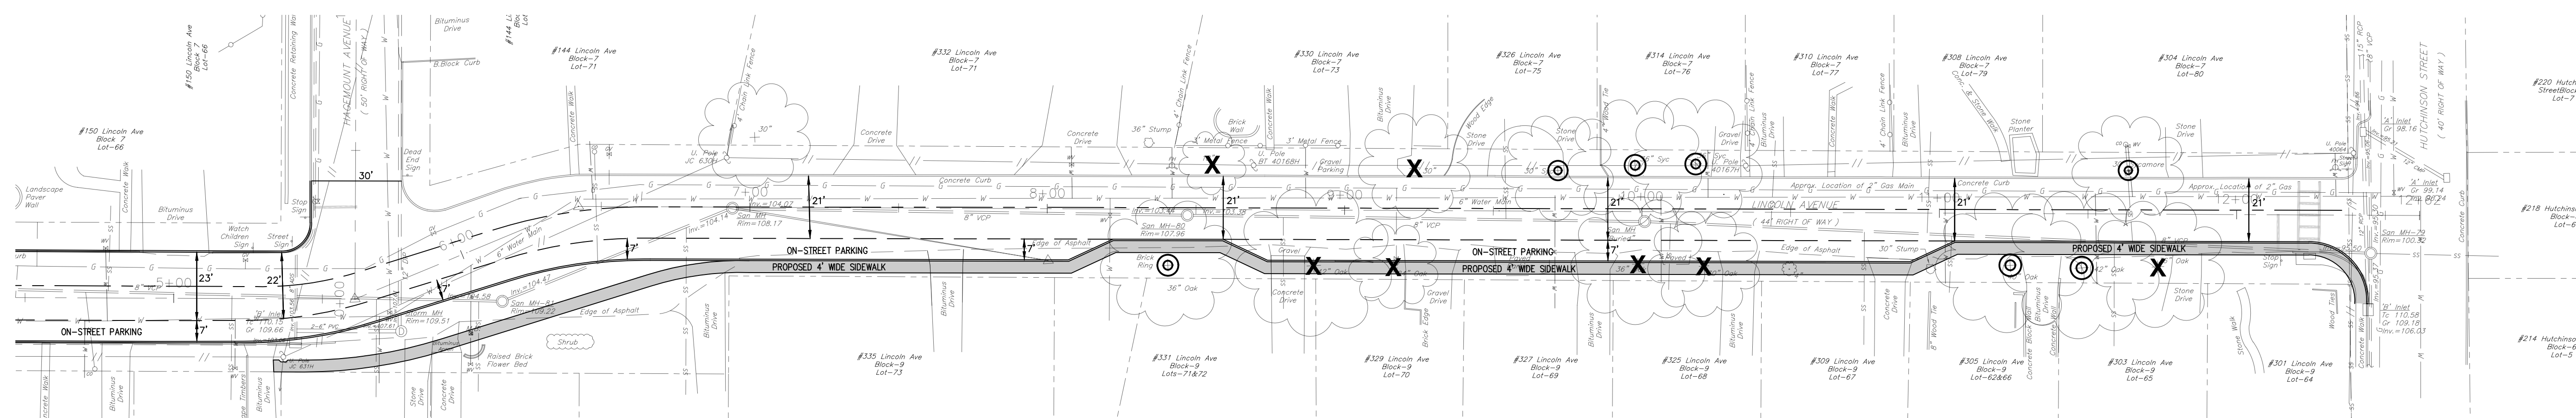
PLAN F - 21' CARTWAY WITH PARKING ON SOUTH SIDE

NOTE:
THIS PLAN PROPOSES INSTALLATION OF 4' WIDE SIDEWALK ON THE SOUTH SIDE OF LINCOLN AVENUE AND REPLACEMENT OF THE SOUTH CURBLINE. THERE IS PROPOSED PARKING ON THE SOUTH SIDE. THE ROAD WIDTH IS 21' WIDE THROUGHOUT.

NOTE: THE CONCEPT LAYOUTS SHOWN ON THIS PLAN ARE BASED ON A TREE EVALUATION BY KEVIN L. SCIBILIA OF FORESTRY CONSULTING, LLC. AS OUTLINED IN A LETTER DATED APRIL 20, 2019.
